GEOLOGICAL STUDIES FOR THE PLANNING
AND CONSTRUCTION OF TUMUT 2 UNDERGROUND
POWER STATION

By David H. Stapledon, B.Sc.
Engineering Geologist, Snowy Mountains
Hydro-Electric Authority, Australia.

Thesis for the Degree of
Master of Science, submitted
to the University of Adelaide
Economic Geology Department.

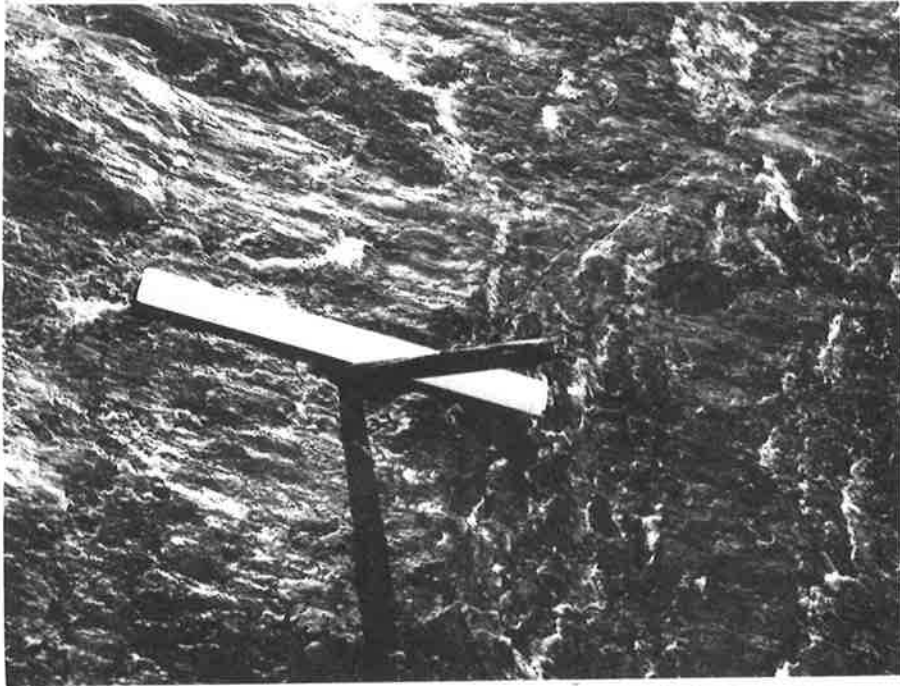
PLATE 7. Face of typical slickensided joint in granitic gneiss. The joint surface is coated with as much as 0.2 inch of calcite and chlorite. Ridges of calcite, on the right hand side, indicate the sense of the most recent movement.

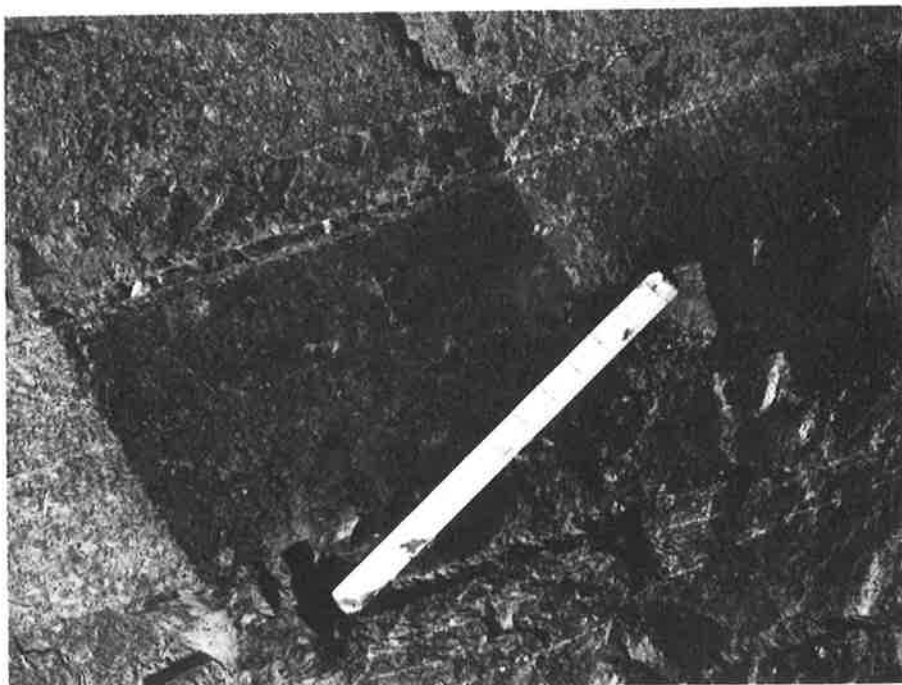
PLATE 8. Typical joints in a porphyry dyke. The joints are very flat and straight and have rough surfaces, which are coated with as much as 0.05 inch of calcite.

(Plate 8), most of the joints were tightly closed, and their surfaces were almost planar when viewed broadly, but in detail were quite rough. Slickensiding was far less common than in the granitic rocks. Joints were usually cemented by calcite, which commonly contained fine clusters of pyritic grains, and a few were limonite stained. They were spaced between 0.5 and 6 inches apart, predominantly 2 inches, and most of them terminated near the dyke contacts (Plate 6).

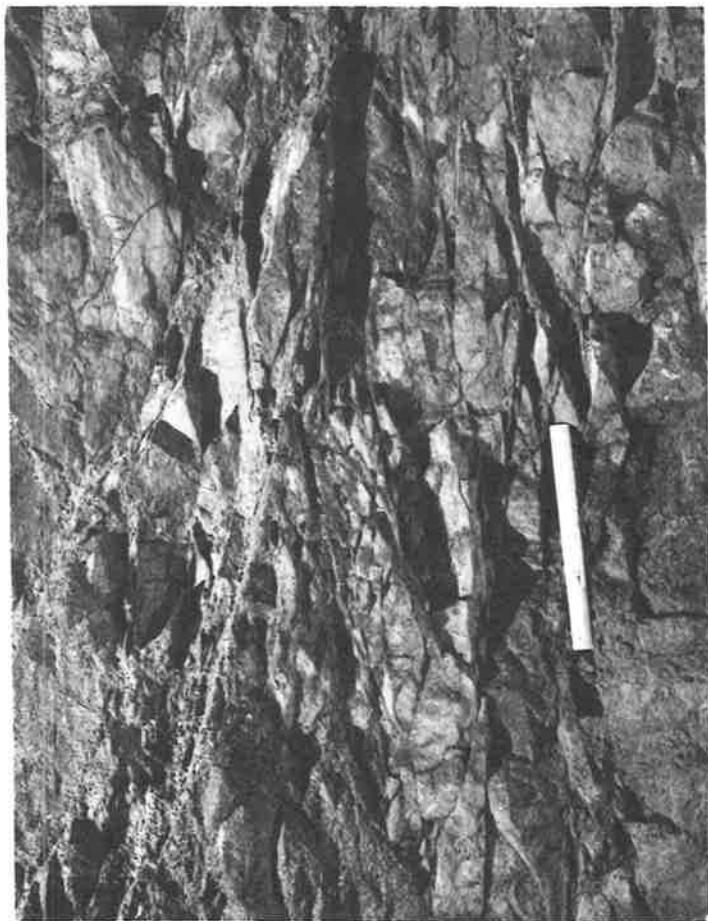
PLATE II, Sheared zone in granitic gneiss, exposed in wall of Transformer Hall.

SHEARED ZONE: Zone, planar or almost so, in which the rock is intersected by closely spaced, nearly parallel joints, usually slightly curved and intersecting, giving rise to thin, platy or wedge-shaped joint blocks. The joint surfaces are generally slickensided or smooth, and are commonly coated with chlorite or calcite or both.

In most sheared zones at Tumut 2, the joints were tightly closed, weakly cemented by chlorite. The rock in the sheared zones was therefore flakey, but firm and compact, unless loosened during excavation. Behaviour of such zones depended to a large extent upon their orientation in relation to the excavation surface.

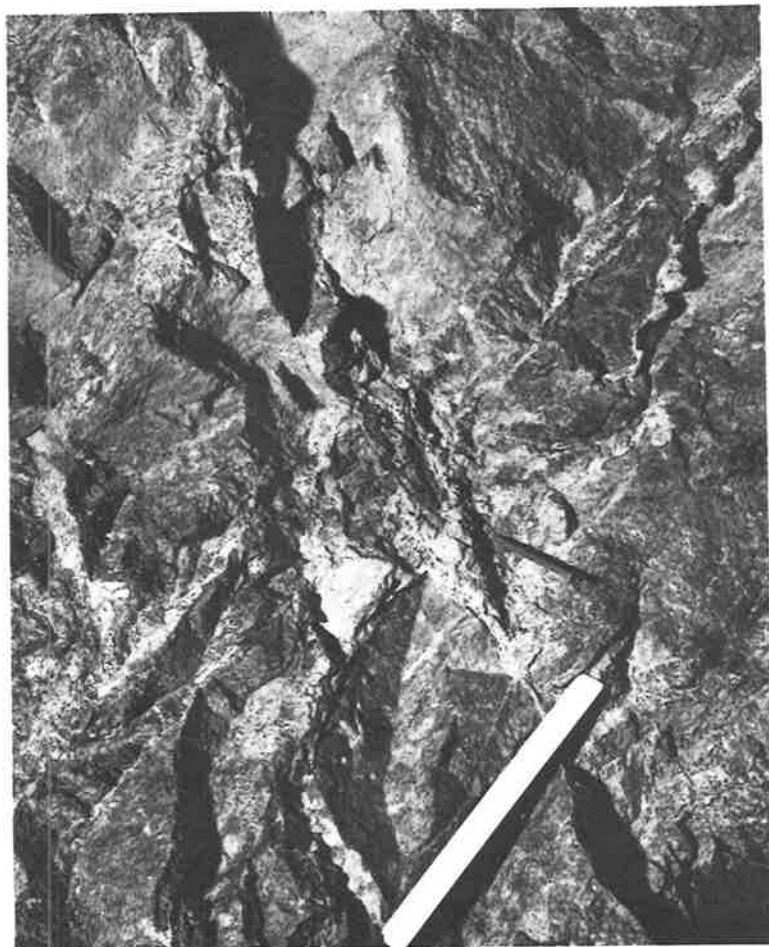
PLATE 12. Intersection of three crushed seams, ranging from 0.1 to 0.5 in., exposed in Tumut 2 Tailwater Tunnel. The gneiss near the seams and their intersection is softened due to chemical alteration.

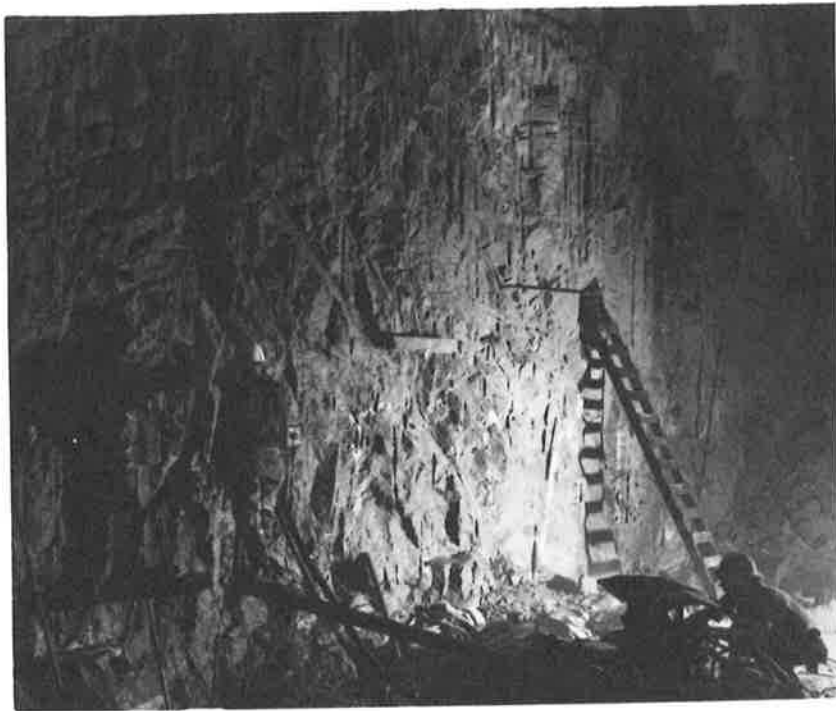
PLATE 15. Granite in the central portion of the Machine Hall downstream wall, showing breakage along line-drill holes and across the rock fabric.

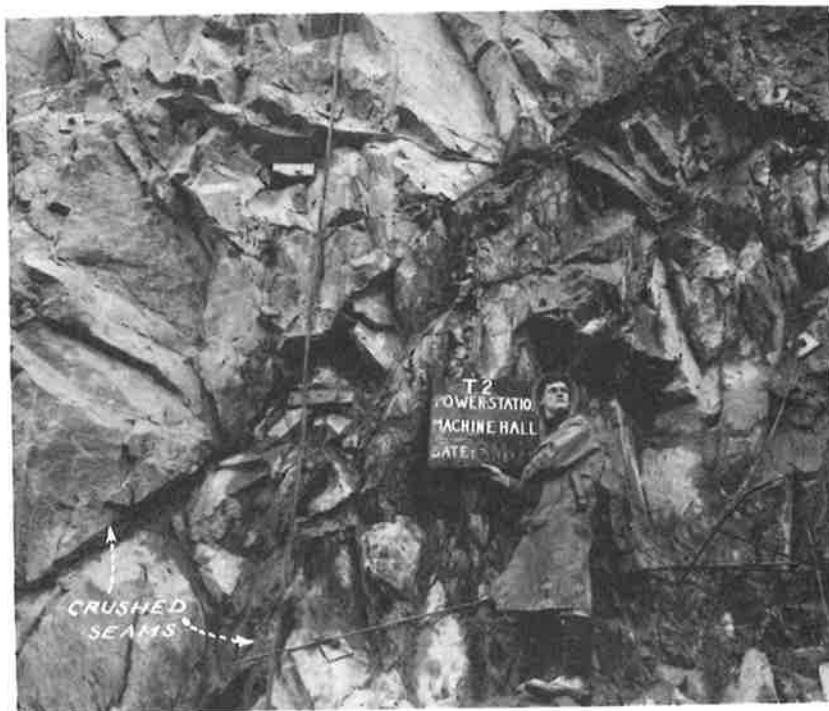
PLATE 16. Granitic gneiss at the Control Building end of the downstream wall. The rock has broken along joints and minor faults, rather than across its own fabric. Few traces of line drill holes remain.

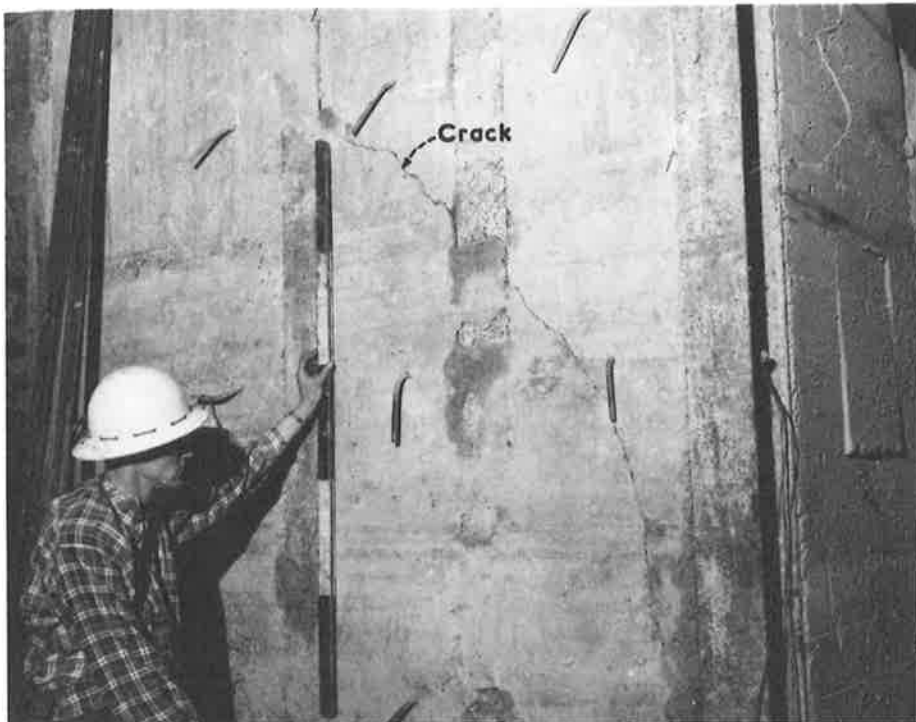
PLATE 17.

Crack open as much as 0.05 inch developed in the reinforced concrete collar of Penstock Tunnel No. 6, during excavation of the Machine Hall.

As the portal of each penstock and draft tube tunnel became exposed by the deepening, cracks similar to that shown on Plate 17 developed in their 10-foot long concrete collars. The worst cracking was seen in Draft Tube No. 8 tunnel, where several cracks with total opening of 0.2 inches occurred. The cracks were in some places en-echelon, and in every instance were dipping steeply (50° to 80°) towards the Machine Hall excavation, and indicated slight rock movements towards the Machine Hall. In some places the bond between the concrete collar and the rock was clearly broken, and hence the concrete movements had probably only reflected part of the actual rock movements which occurred. There was no definite evidence that additional rock failure occurred further back along the tunnels during the deepening. Small movements could have occurred along joints, some of which were slightly open both before and after the deepening. Moye (1958) describes similar cracking in concrete collars in the penstock tunnels at Tumut 1. Rock failure which occurred further back along the penstock tunnels is also described. This occurred both along joints and by spalling across the rock fabric.
