ADELAIDE IN-DEPTH ACCIDENT STUDY

1975-1979

PART 6: CAR ACCIDENTS

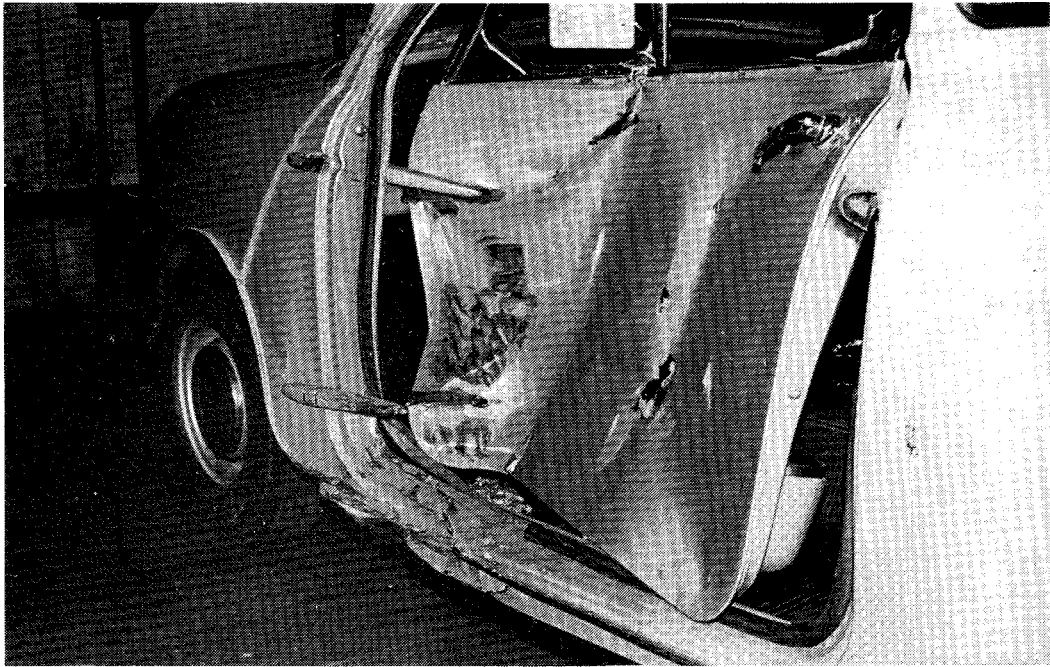
FIGURE 4.1: Hinge failures and latch separation (Accident 038)

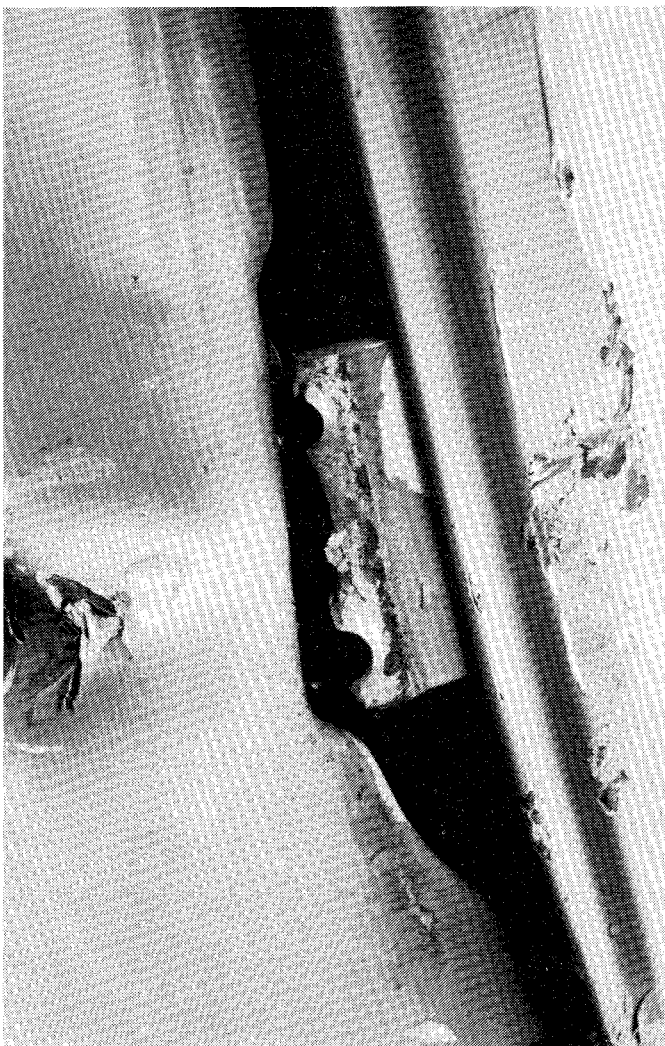
FIGURE 4.2:

Lower hinge fractured at point
of attachment to B-pillar
(Accident 012)

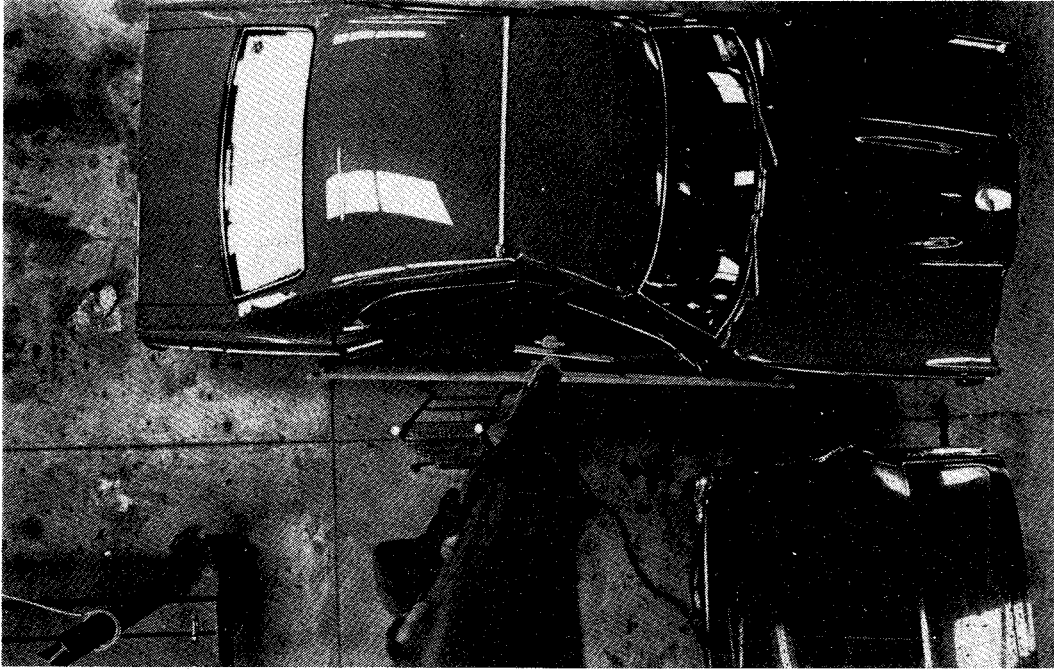
FIGURE 4.5: Deformation of side of Ford Cortina in a two-car collision (Accident 169, see also Fig. 4.6)

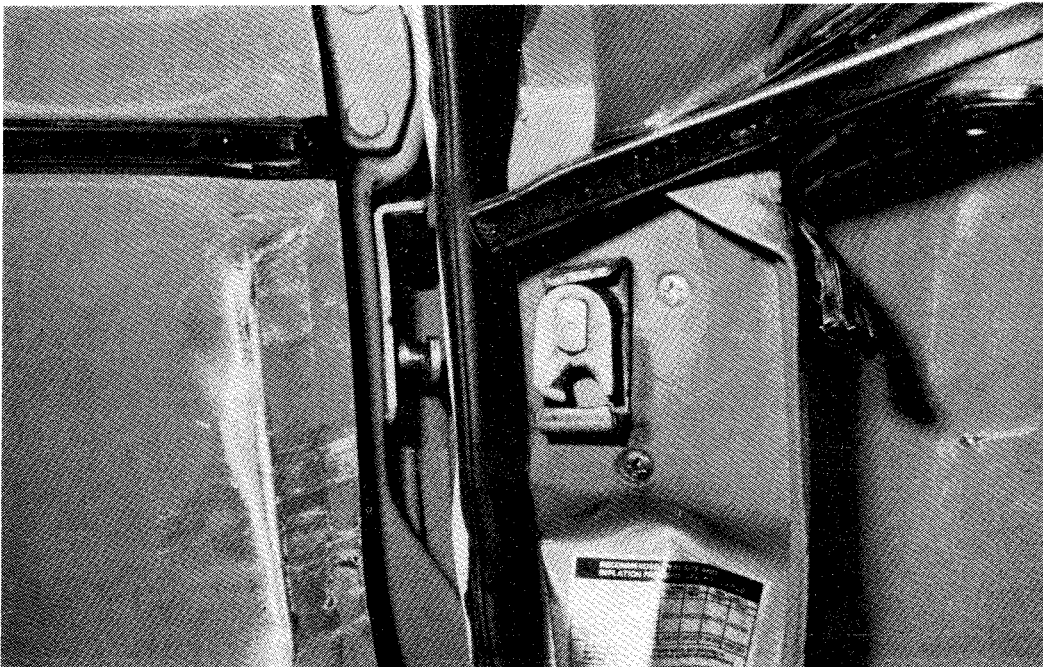
FIGURE 4.6: Separation of door latch without significant damage to the latch (see Fig. 4.5)

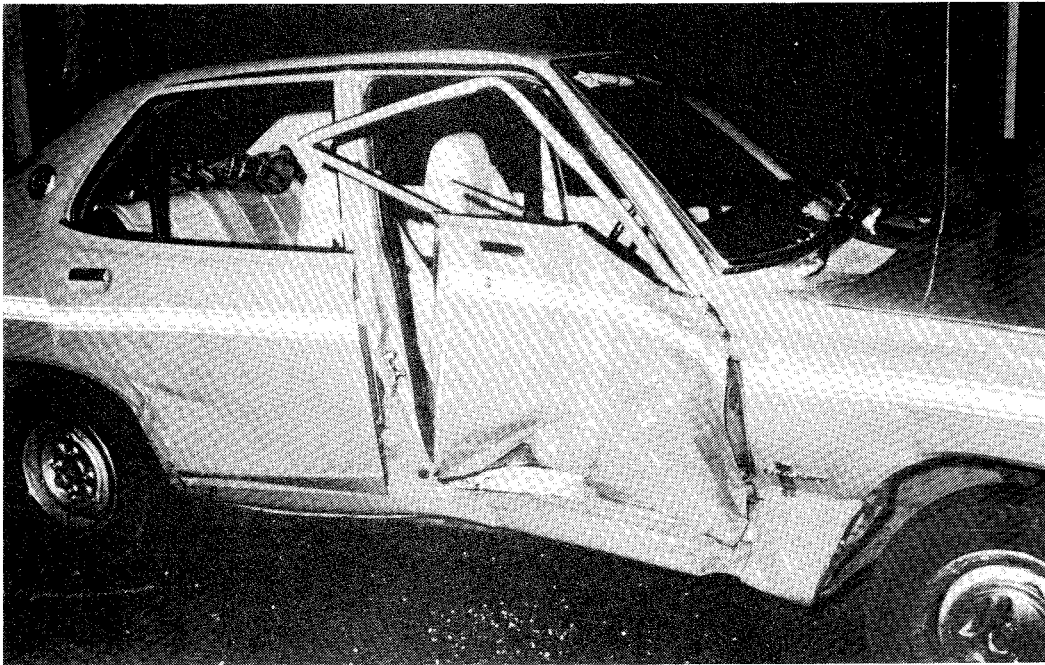
FIGURE 4.7: Damage resulting from a two-car collision. Note separation of door latch (Accident 230, see also Figures 4.8 to 4.11)

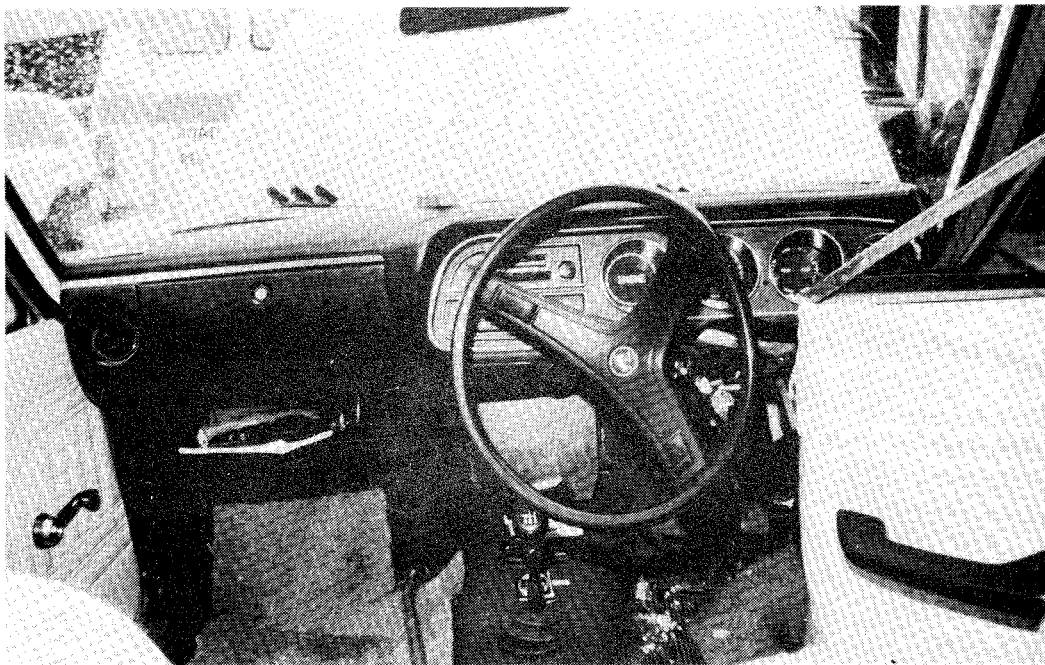
FIGURE 4.8: Extent of intrusion of damaged door (see Figures 4.7 to 4.11)

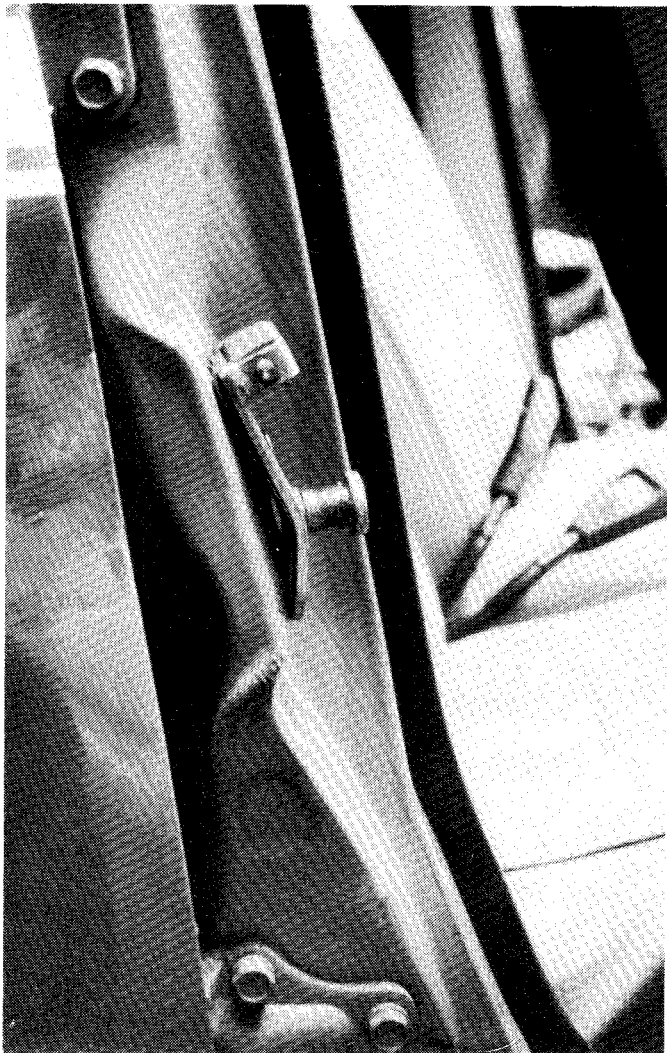
FIGURE 4.9:

Deformation of striker mounting plate (See Figures 4.7 to 4.11)

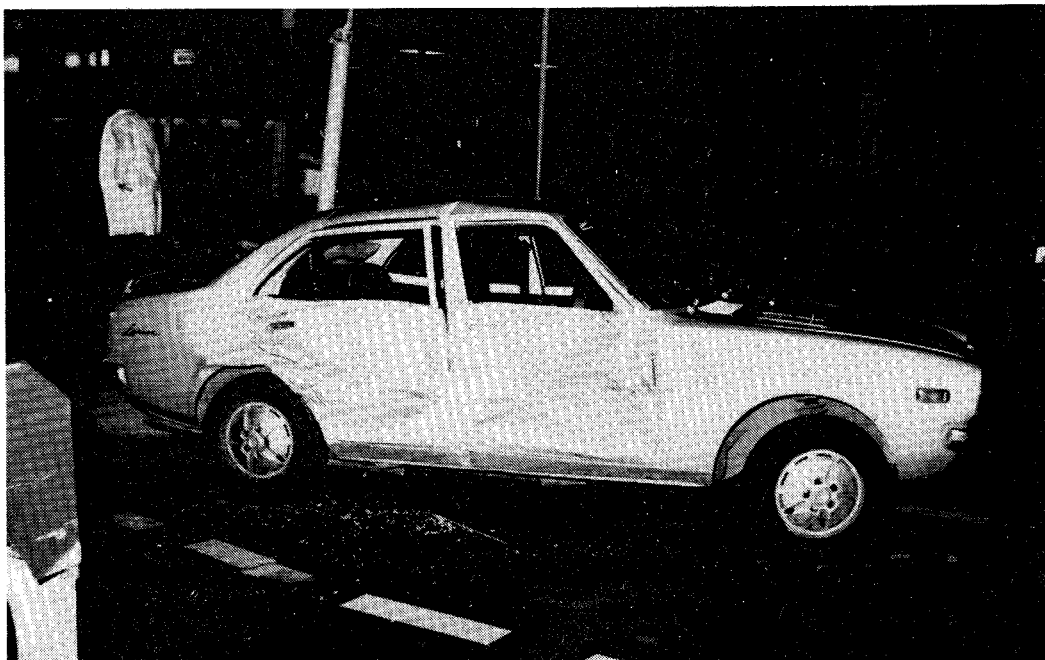
FIGURE 4.12: Deformation resulting from a collision with
a HQ Holden sedan (Accident 173, See also
Figures 4.13 to 4.15)

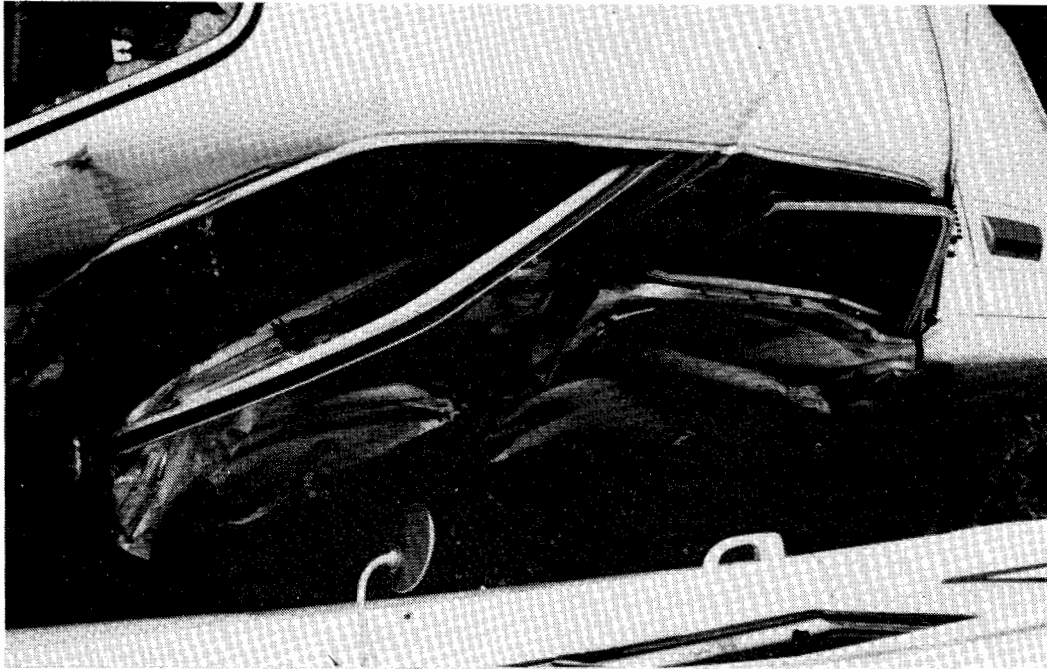
FIGURE 4.13: Top view of damage to car shown in Figure 4.12.

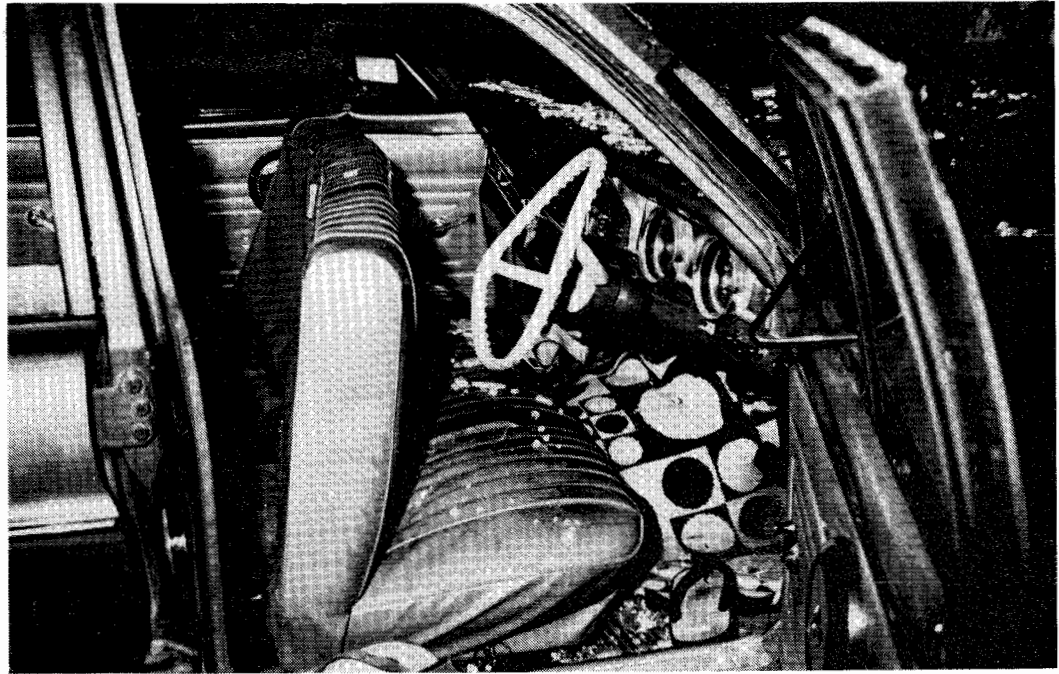
FIGURE 4.16: Damage to front seat of 1968 XY Ford Falcon following collision with a tree. Seat loaded by unrestrained rear seat occupants (Accident 236).

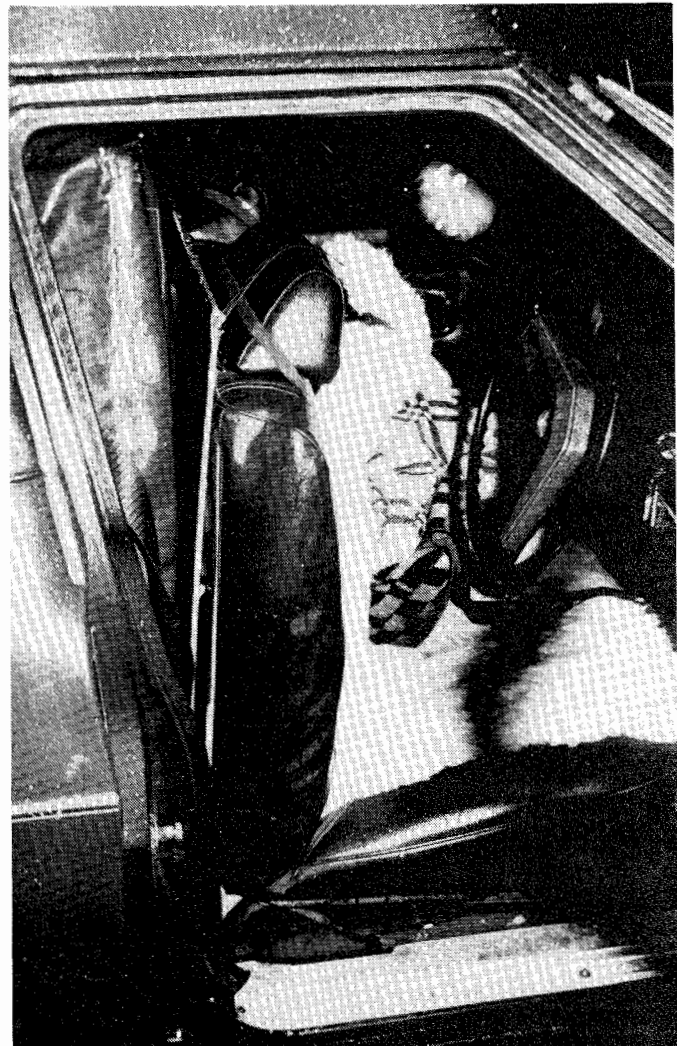
FIGURE 4.17:
Electronic organ in the cargo area of a Holden panel van pushed the seat back forwards in a frontal collision (Accident 066, see also Figure 4.18)

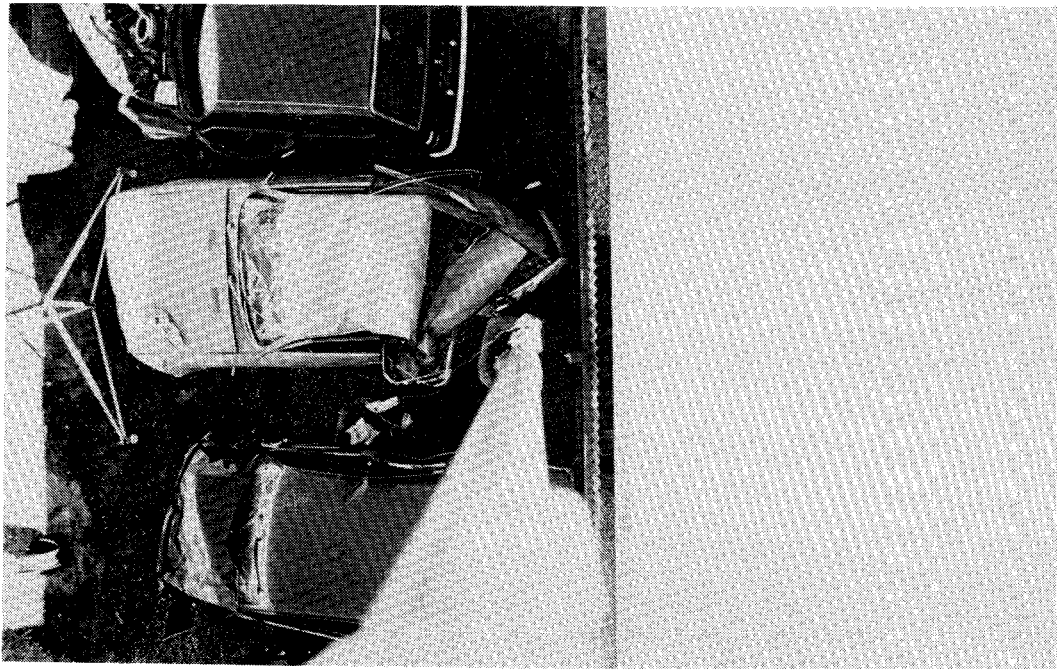
FIGURE 4.19: Extent of damage to Fiat 124 coupe in Accident 029
(see also Figures 4.20 to 4.23)

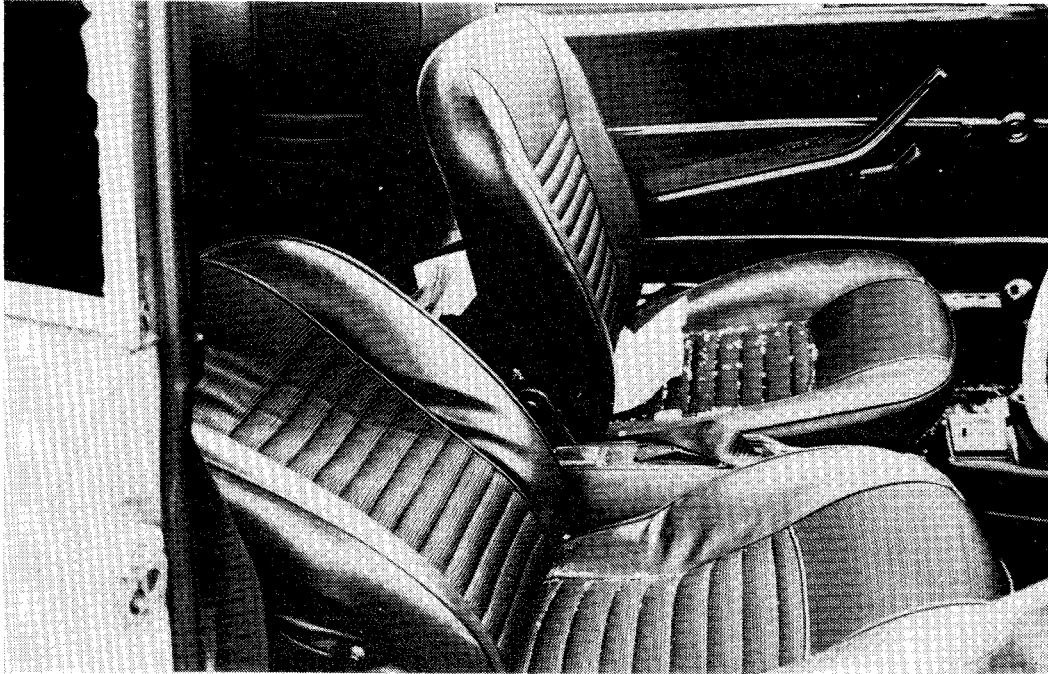
FIGURE 4.20: Damage to back of driver's seat Accident 029
(See Figures 4.19 and 4.21 to 4.23)

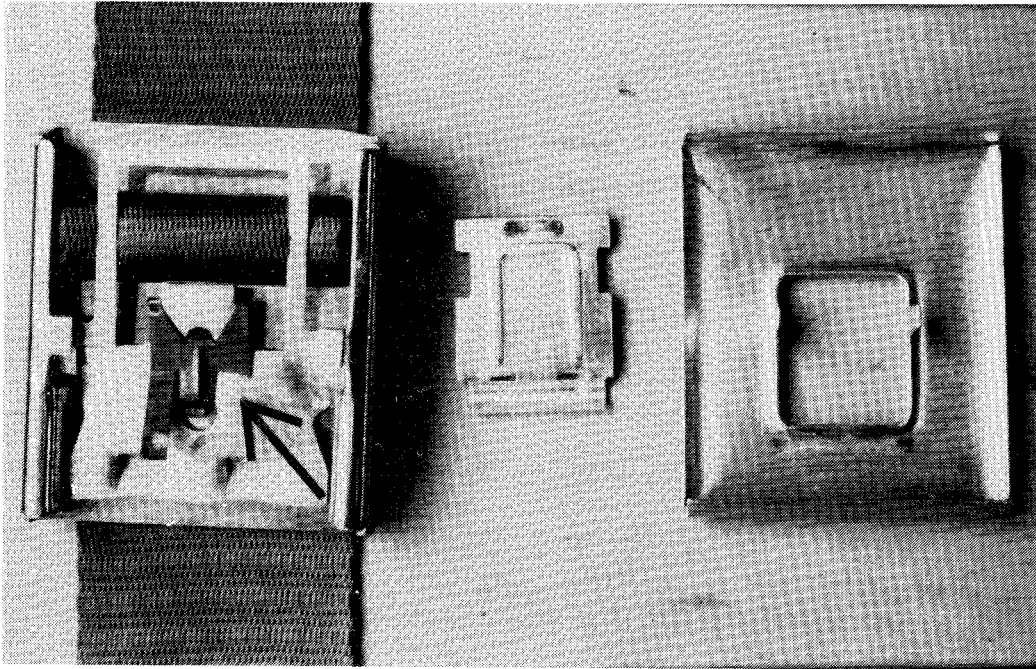
FIGURE 4.24: Components of defective buckle of a seat belt fitted to a 1972 Renault 16TL. The H-shaped spring has the lower right leg missing (arrowed). (Accident 122)

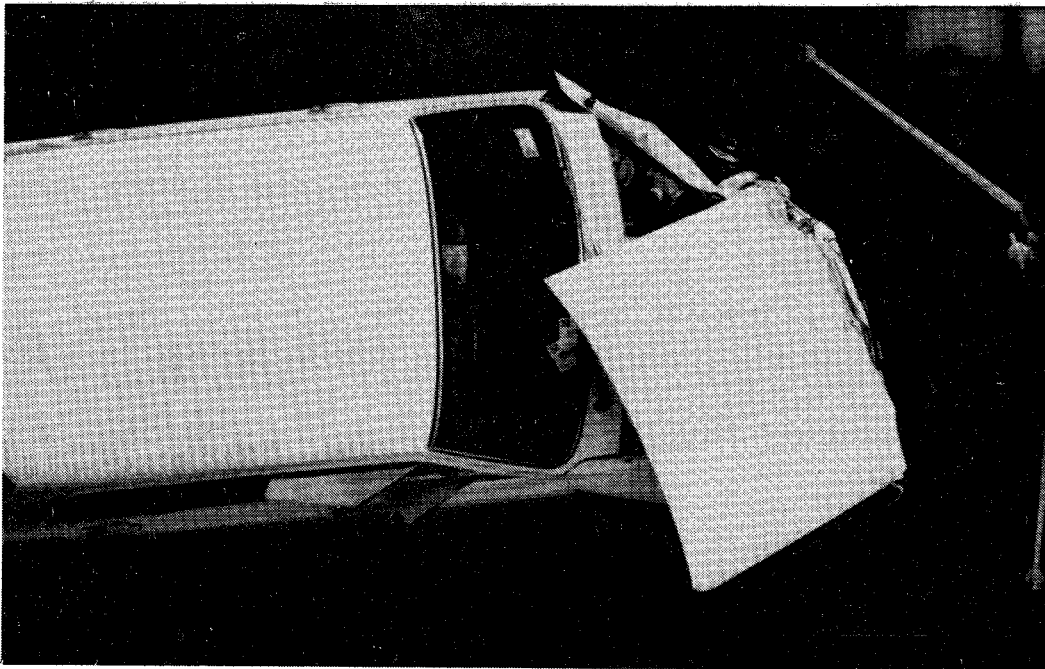
FIGURE 4.25: Overhead view of damage to Mazda involved in Accident 061 (See Figures 4.26, 4.64)

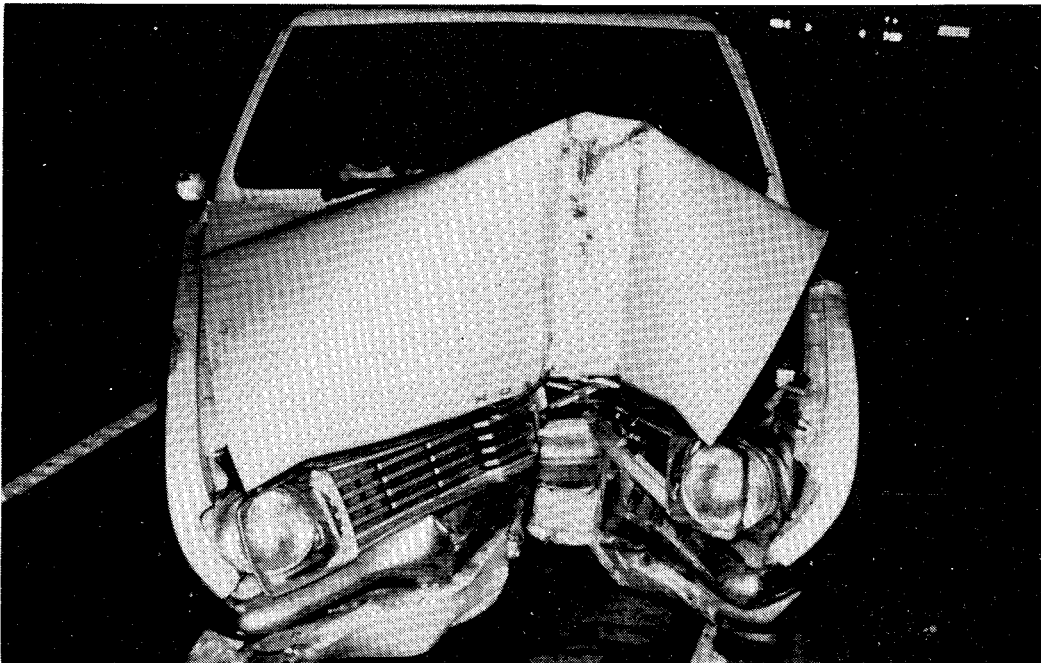
FIGURE 4.27: Damage to car involved in frontal impact with utility pole (Accident 096, See Figures 4.28, 4.29)

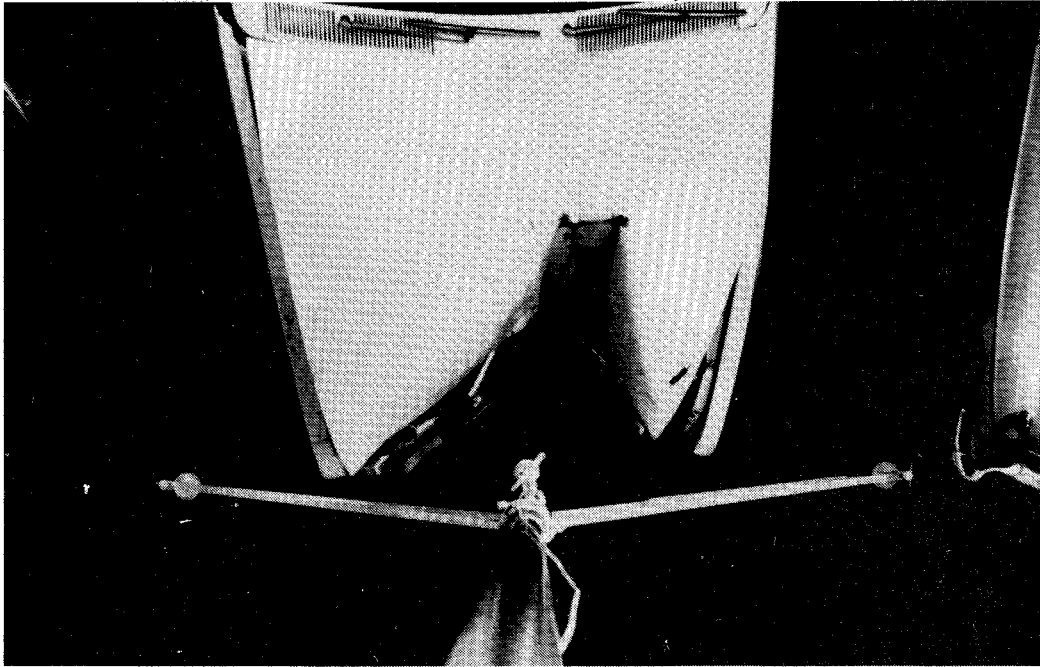
FIGURE 4.28: Overhead view of damage caused by impact with utility pole (Accident 096, See Figure 4.27 etc.)

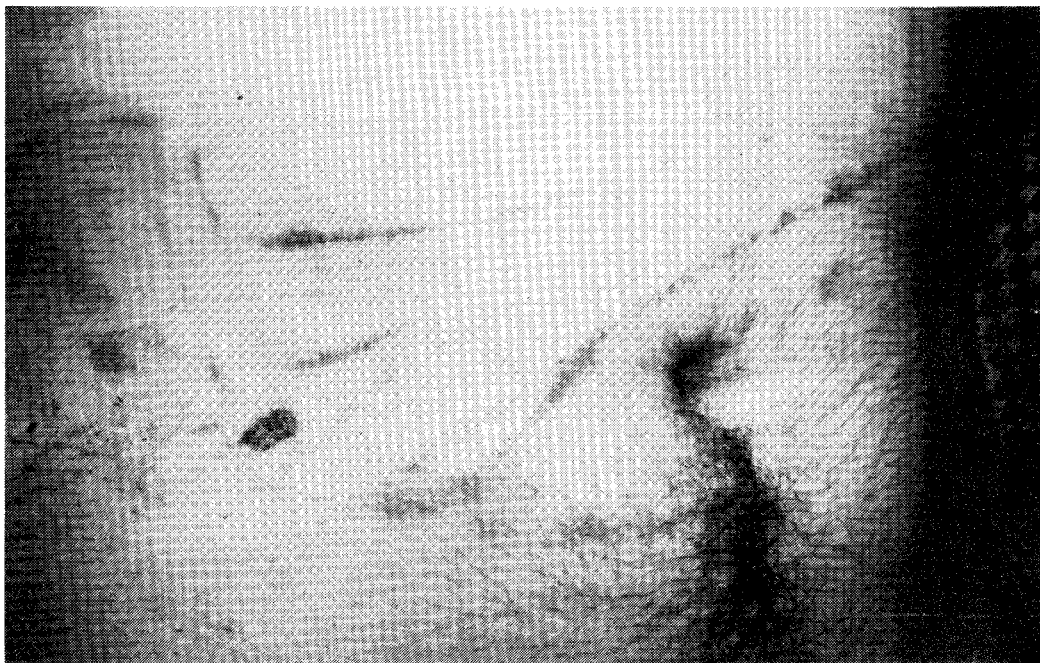
FIGURE 4.29: Seat belt loading marks to abdomen of left front passenger (Accident 096, See Figures 4.27, 4.76)

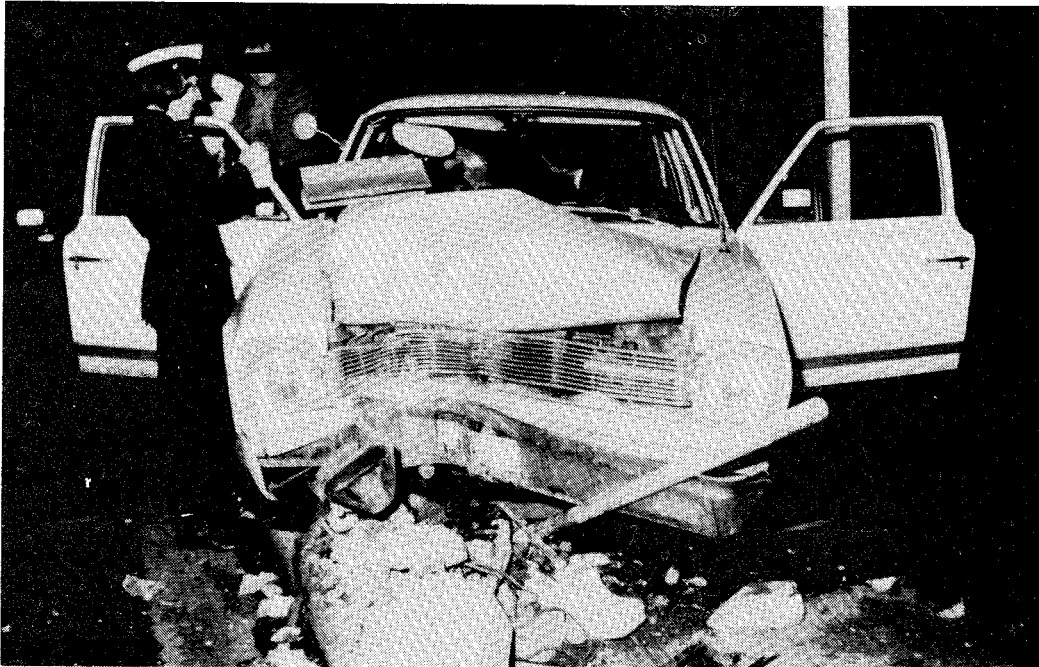
FIGURE 4.30: Damage to car involved in frontal impact with utility pole (Accident 094, See Figures 4.31, 4.60)

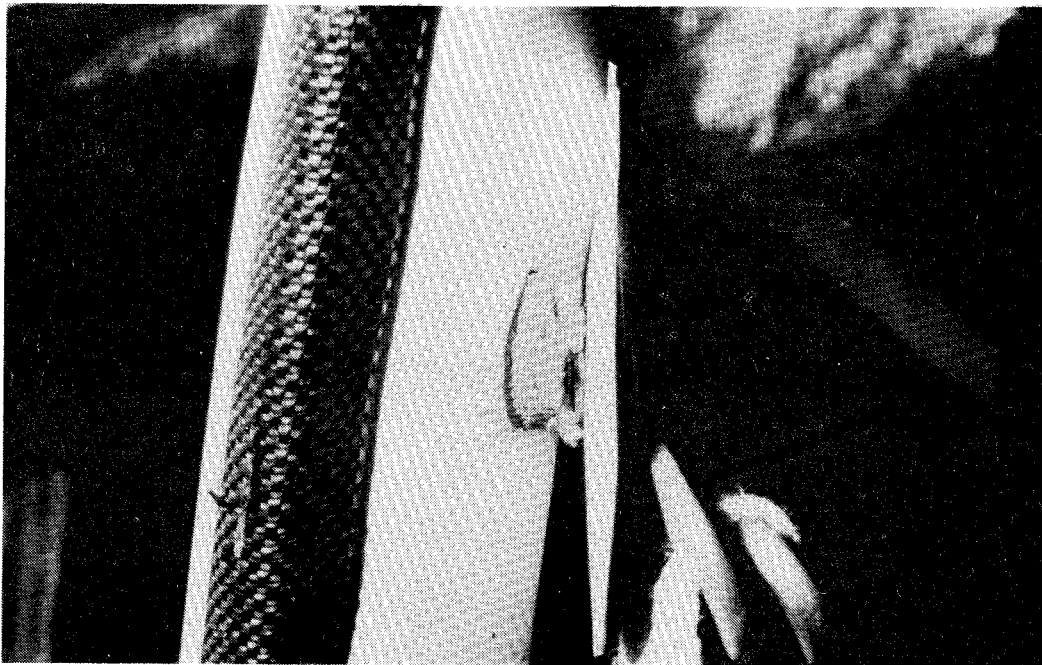
FIGURE 4.31: Yielding of the inner skin of the B-pillar seat belt anchorage (Accident 094, See Figure 4.30)

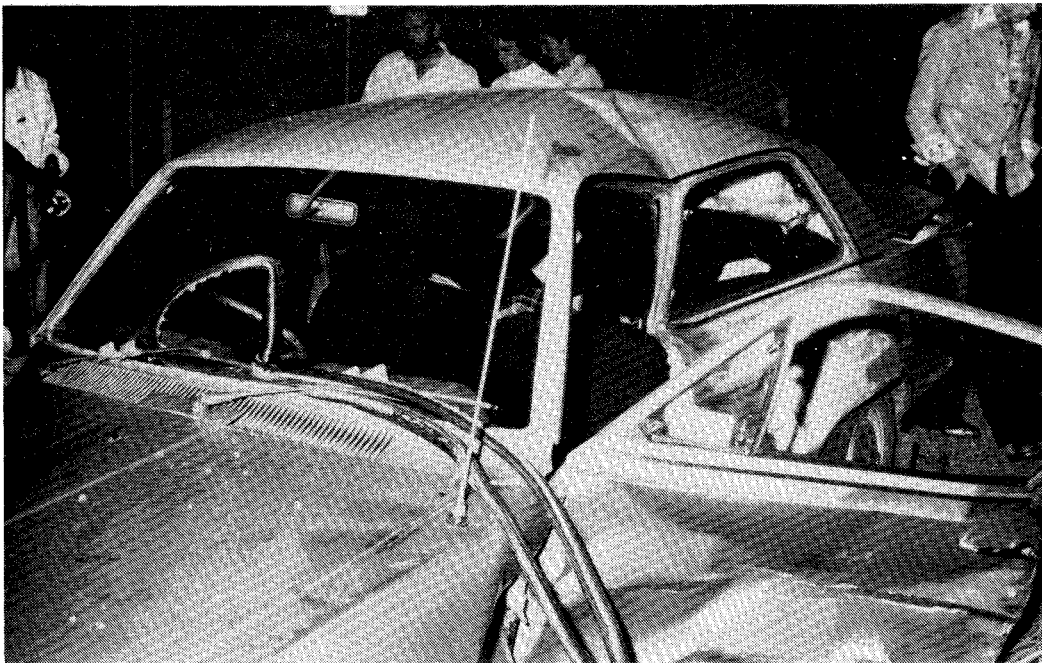
FIGURE 4.33: Damage to car referred to in Figure 4.32.

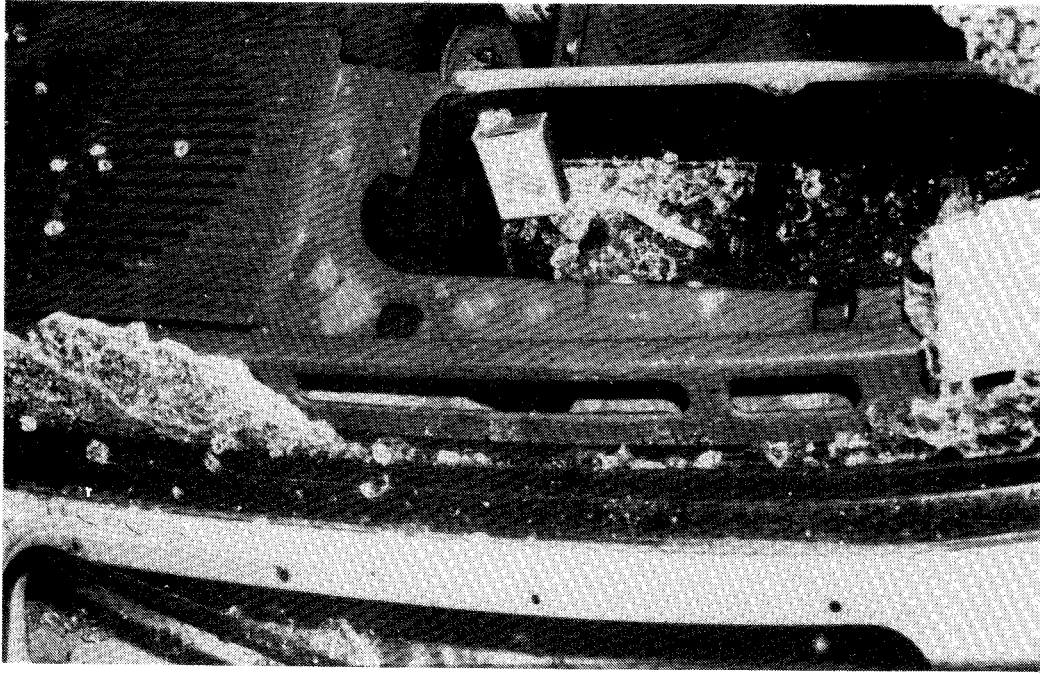
FIGURE 4.34: Lower edge of windshield frame and retained fragments of shattered toughened glass struck by face of unrestrained front seat passenger (glove box lid is open and grill is missing from plenum chamber in front of the windshield) (Accident 121)

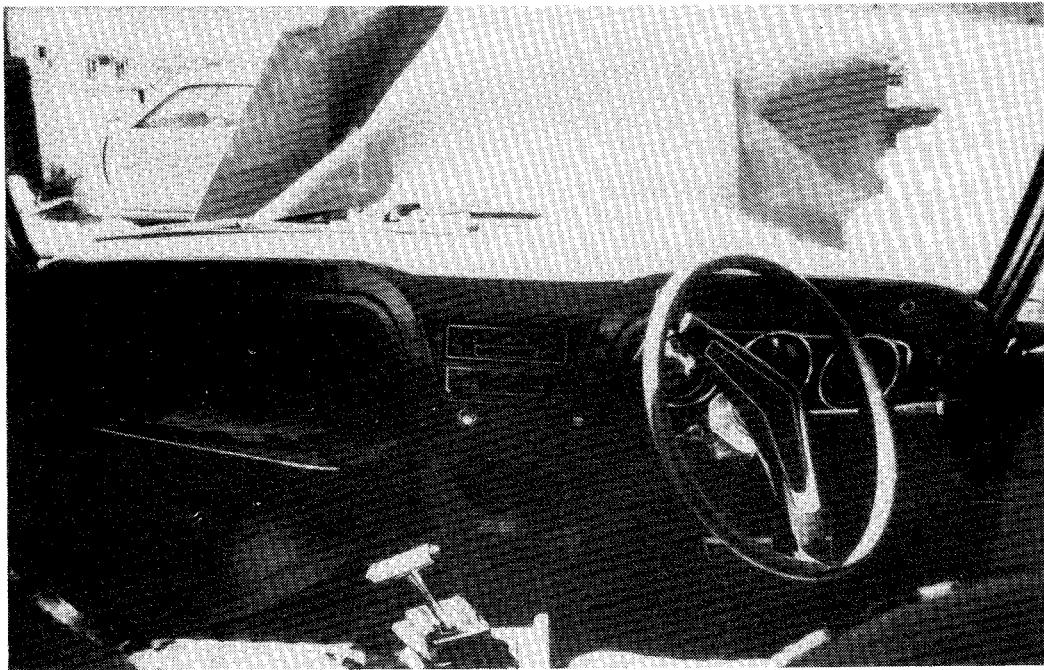
FIGURE 4.36: Damage to toughened glass windshield caused by impact by head of driver (See Figure 4.35)

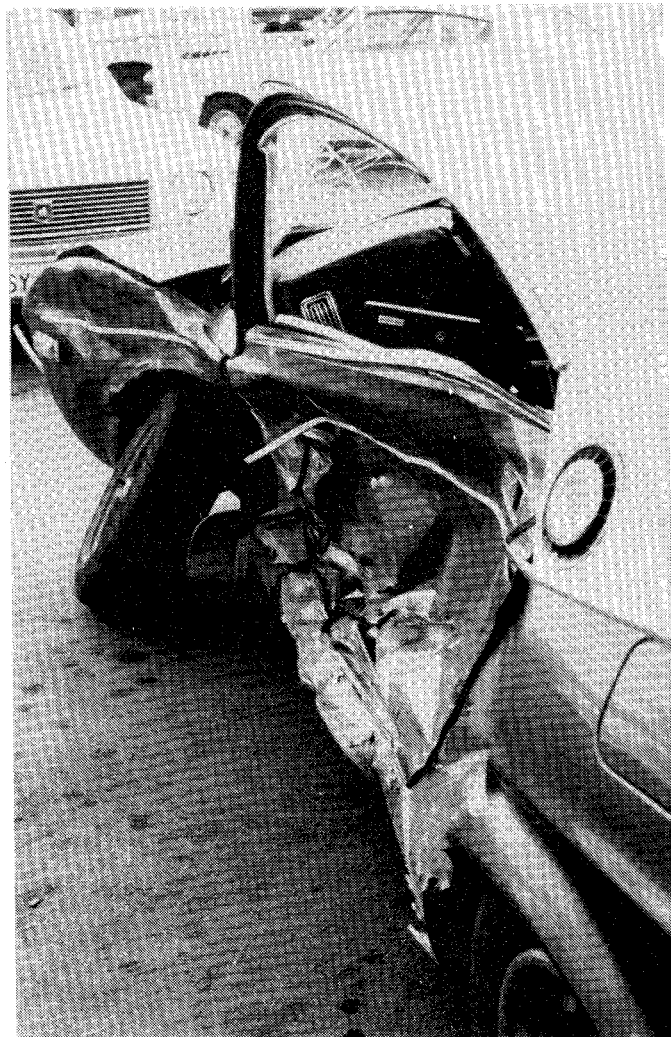
FIGURE 4.37:
Deformation of left side of Mazda 929 coupe in Accident 124 (See Figures 4.38, 4.39 and 4.78)

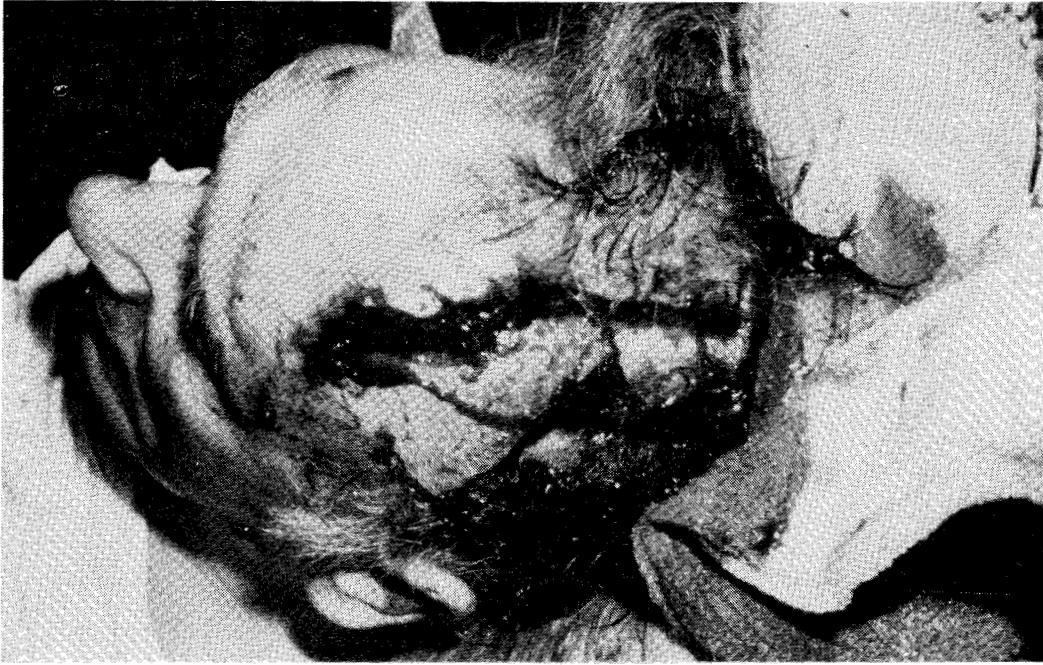
FIGURE 4.40: Lacerations caused by impact with A-pillar shown in Figure 4.39.

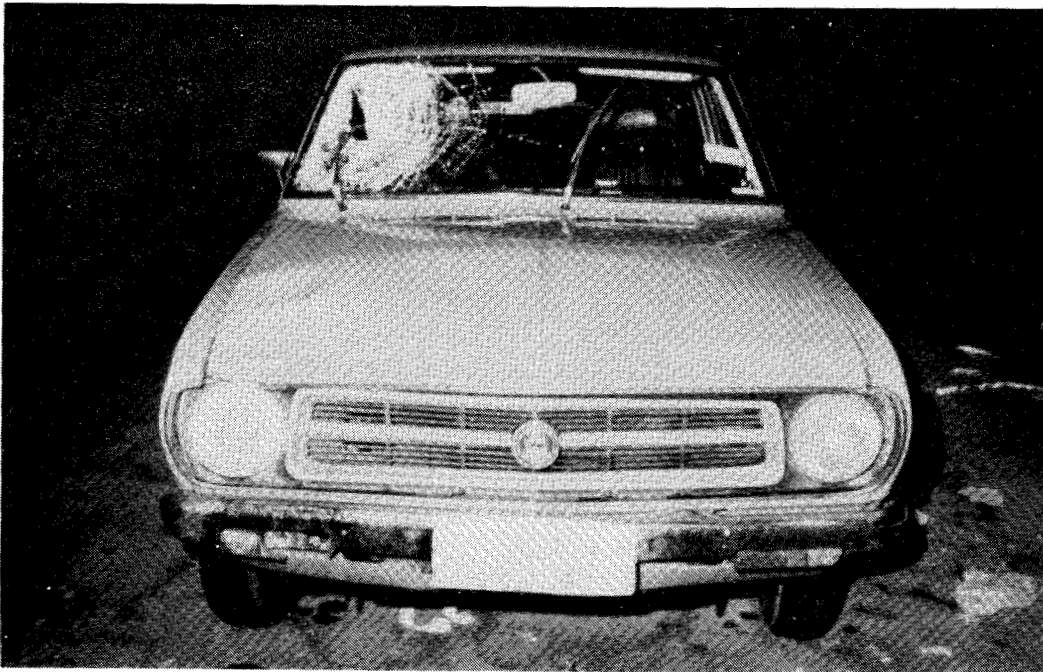
FIGURE 4.41: Datsun 1200 following impact with pedestrian. (Accident 144, See Figures 4.42, 4.43)

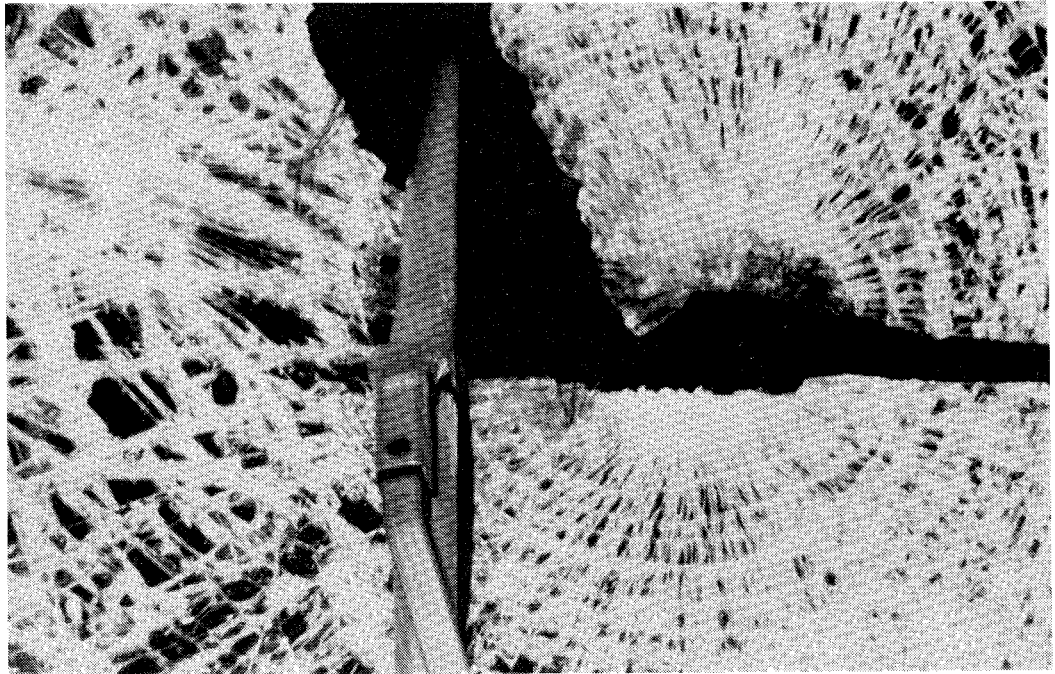
FIGURE 4.42: Detail of fracture of laminated glass caused by impact with head of pedestrian (Accident 144, See Figures 4.41, 4.43)

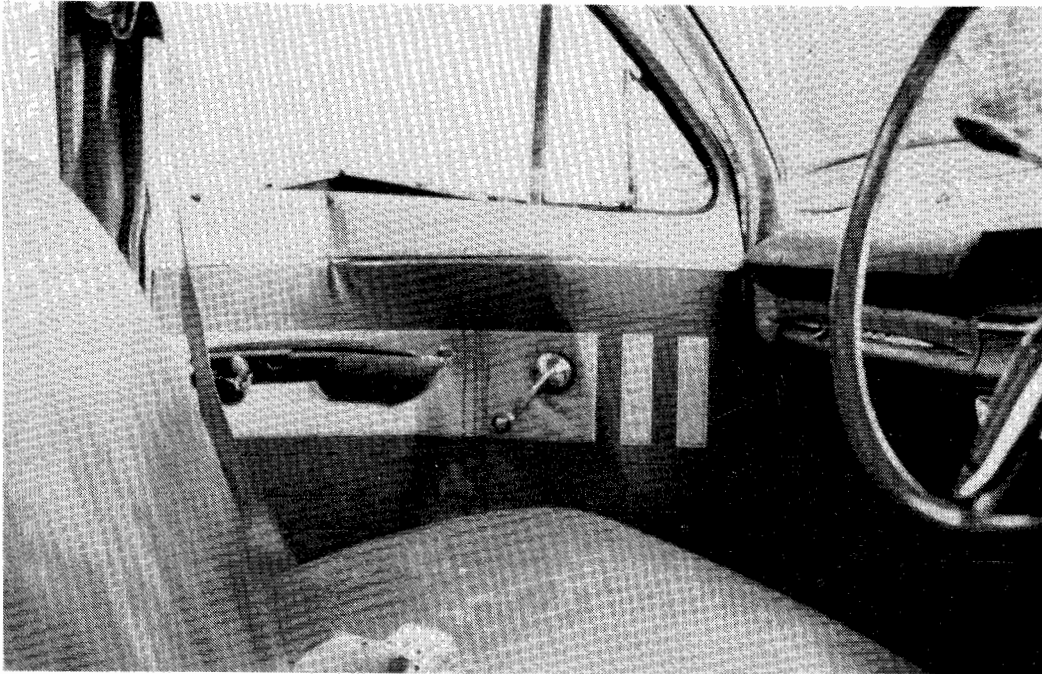
FIGURE 4.44: Damage to door caused by left front passenger being thrown against it (Accident 020, see Figure 4.45)

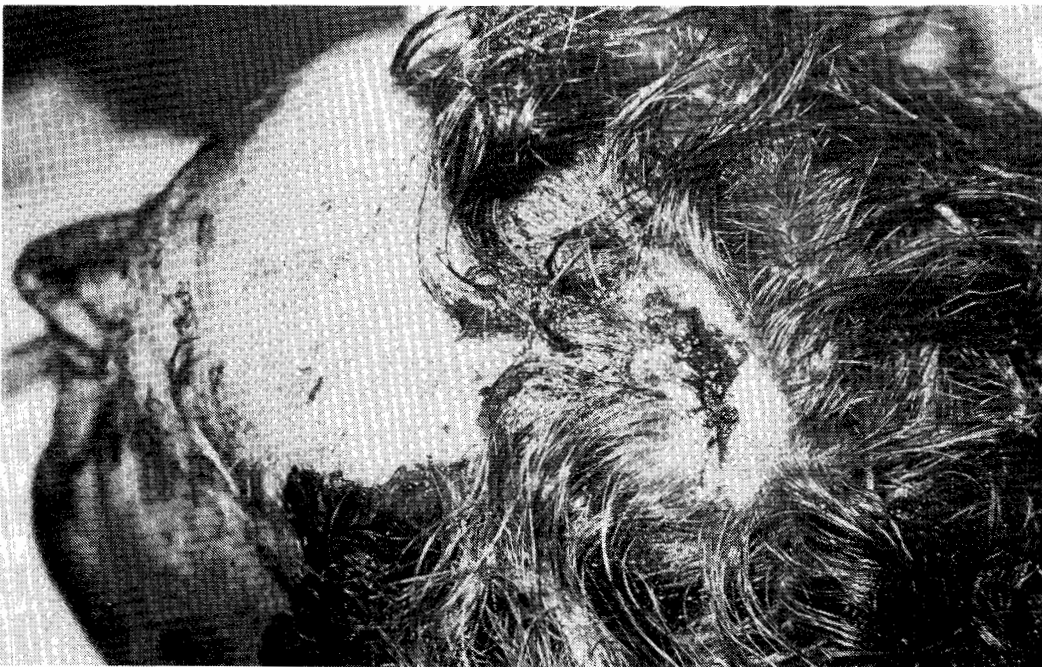
FIGURE 4.45: Minor scalp laceration from head impact with toughened glass side window (See Figure 4.44)

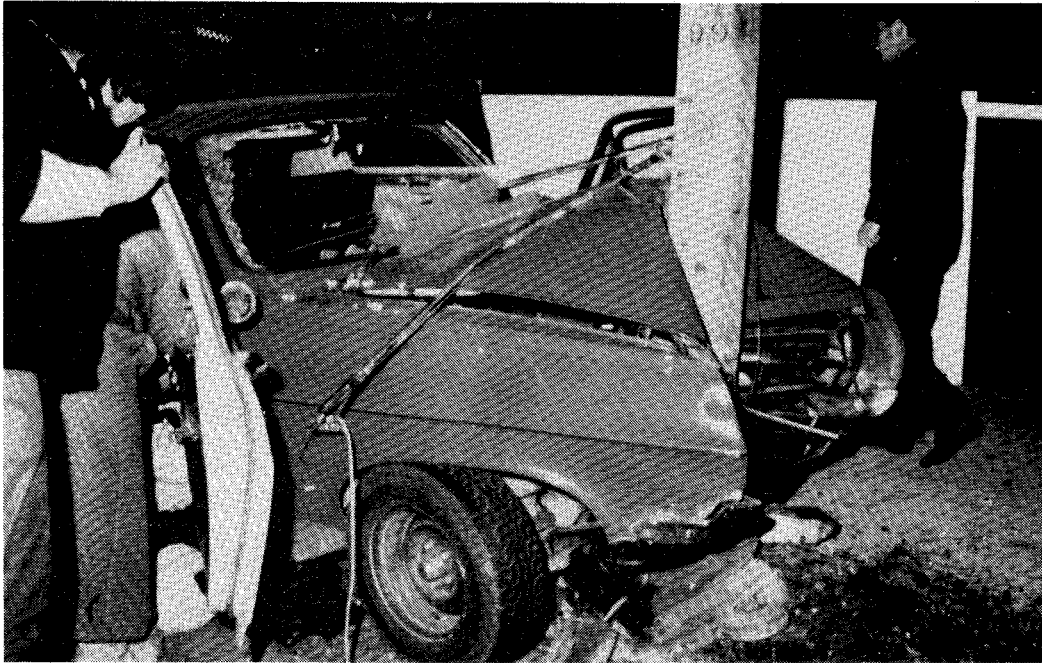
FIGURE 4.46: Damage to Holden panel van following collision with utility pole (Accident 051, See Figure 4.47)

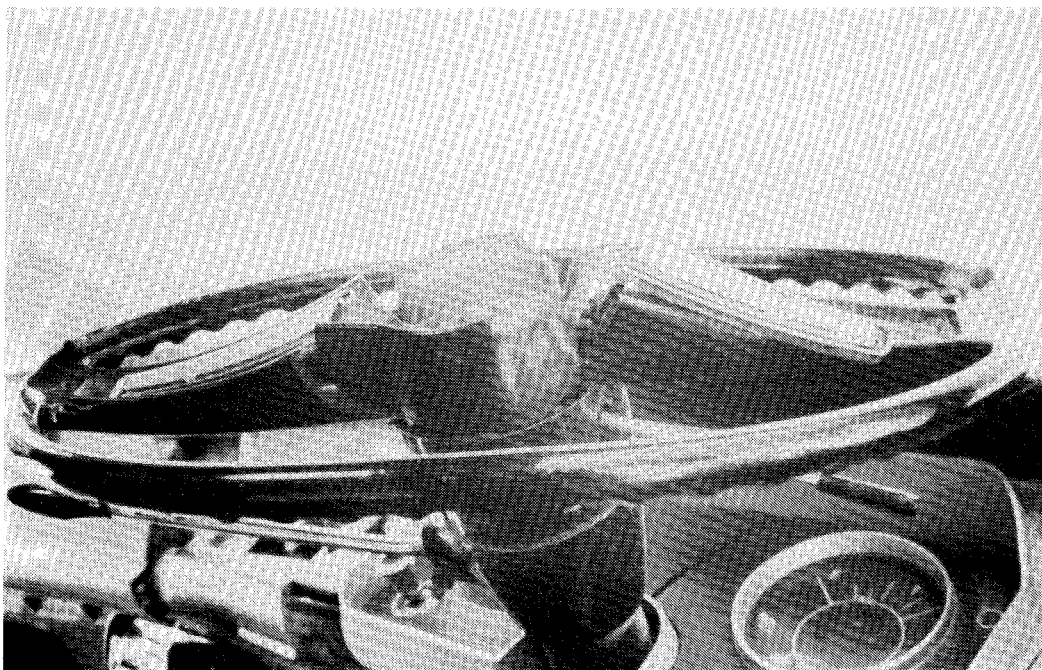
FIGURE 4.47: Damage to steering wheel caused by unrestrained driver being thrown against it (Accident 051, see Figures 4.46 and 4.89)

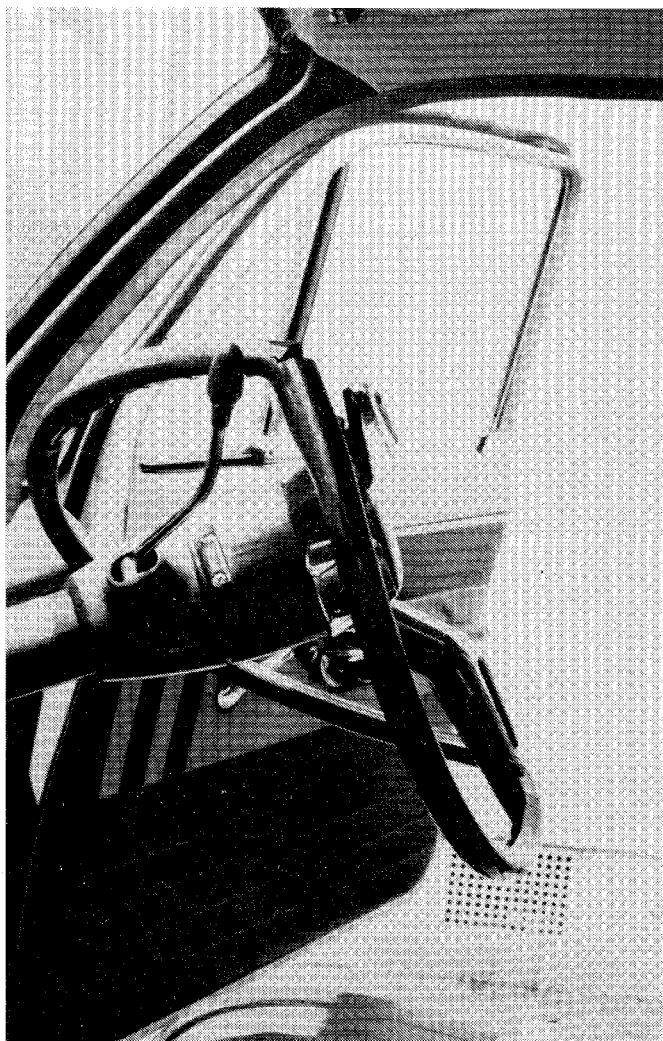
FIGURE 4.49:
Damage to steering wheel
of Holden in Accident 245
(see Figure 4.48)
