ADELAIDE IN-DEPTH ACCIDENT STUDY

1975-1979

PART 6: CAR ACCIDENTS

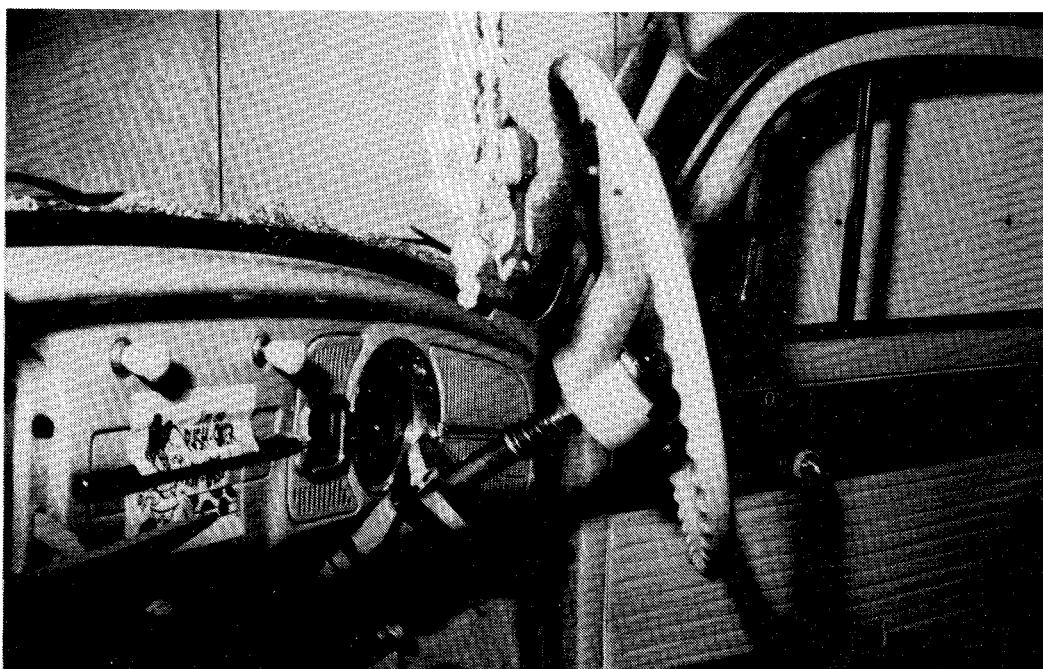
FIGURE 4.51: Unrestrained driver was virtually uninjured despite
damage to steering wheel and penetration of steering
column (See Figure 4.50)

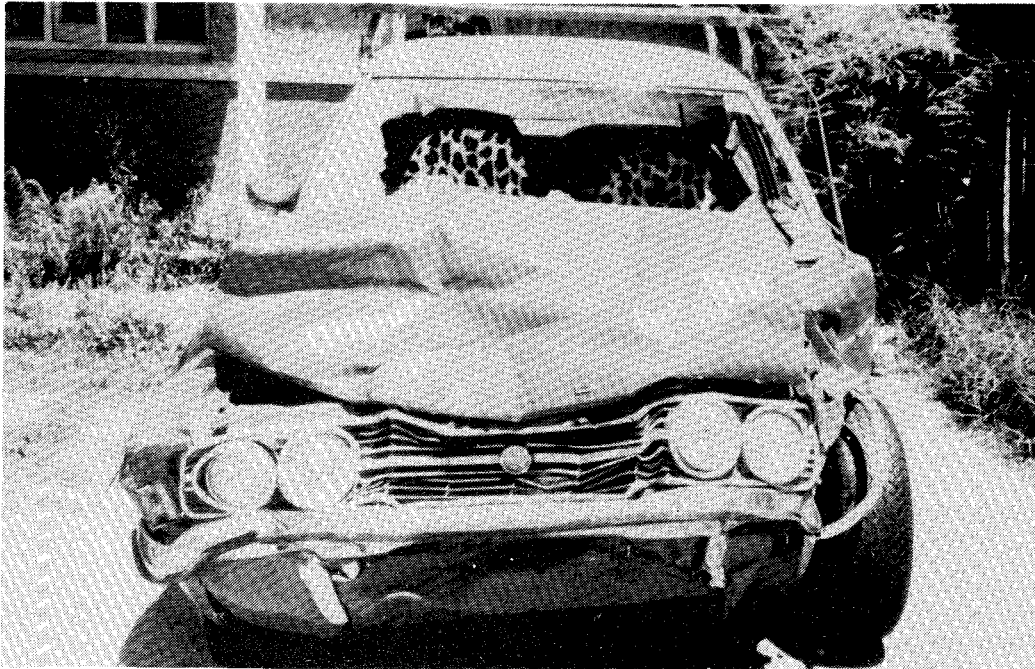
FIGURE 4.52: Damage to a 1973 Ford Cortina TC following an intersection collision (Accident 259, See Figure 4.53, 4.80)

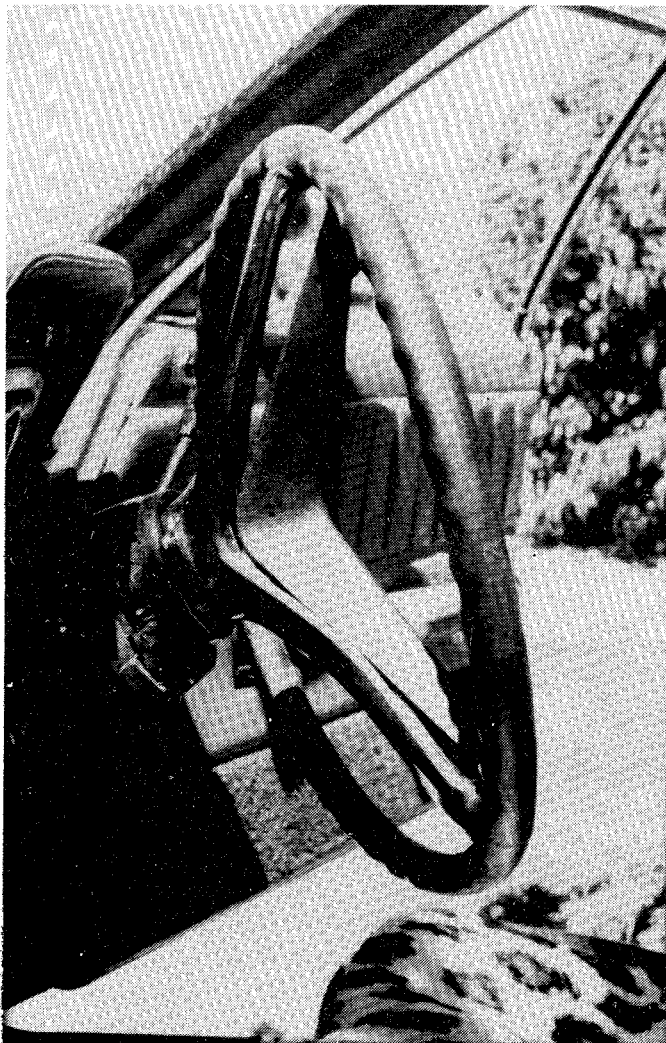
FIGURE 4.53:

Damage to steering wheel of car shown in Figure 4.52.

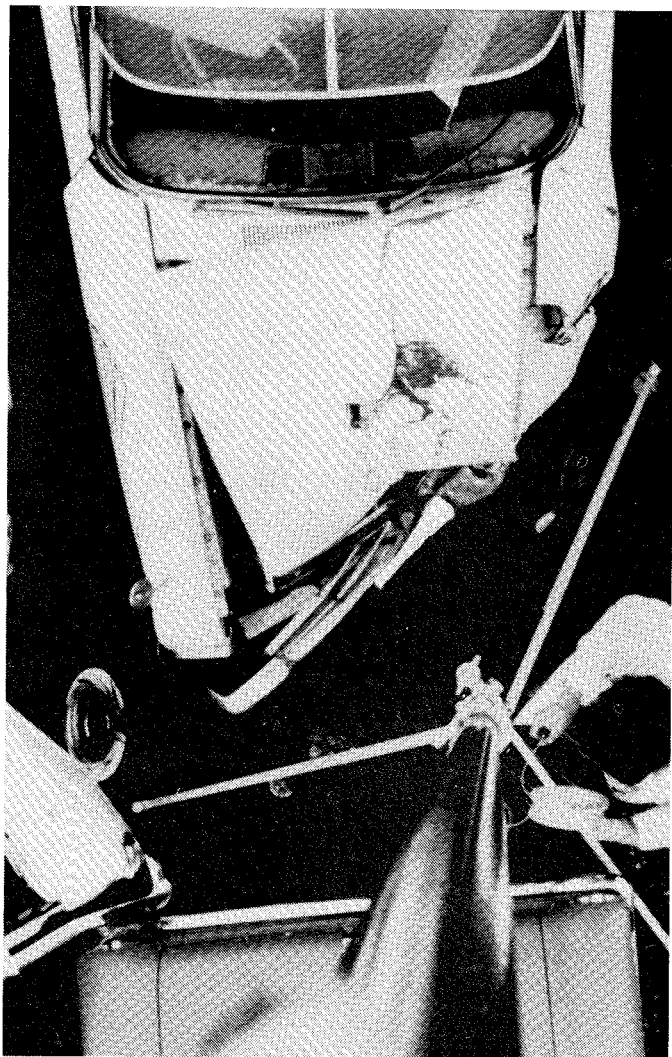
FIGURE 4.54:

Damage to Ford Falcon due to collision with parked car. (Accident 138, See Figure 4.55)

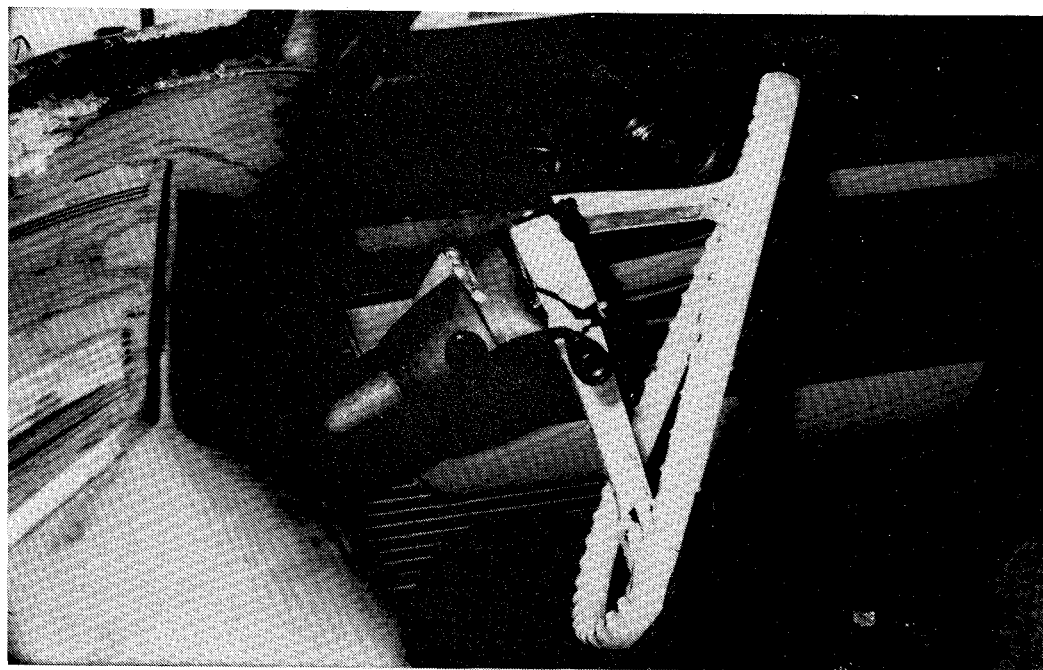
FIGURE 4.55: Damage to steering wheel of car shown in Figure 4.54. Unrestrained driver received a bruised wrist.

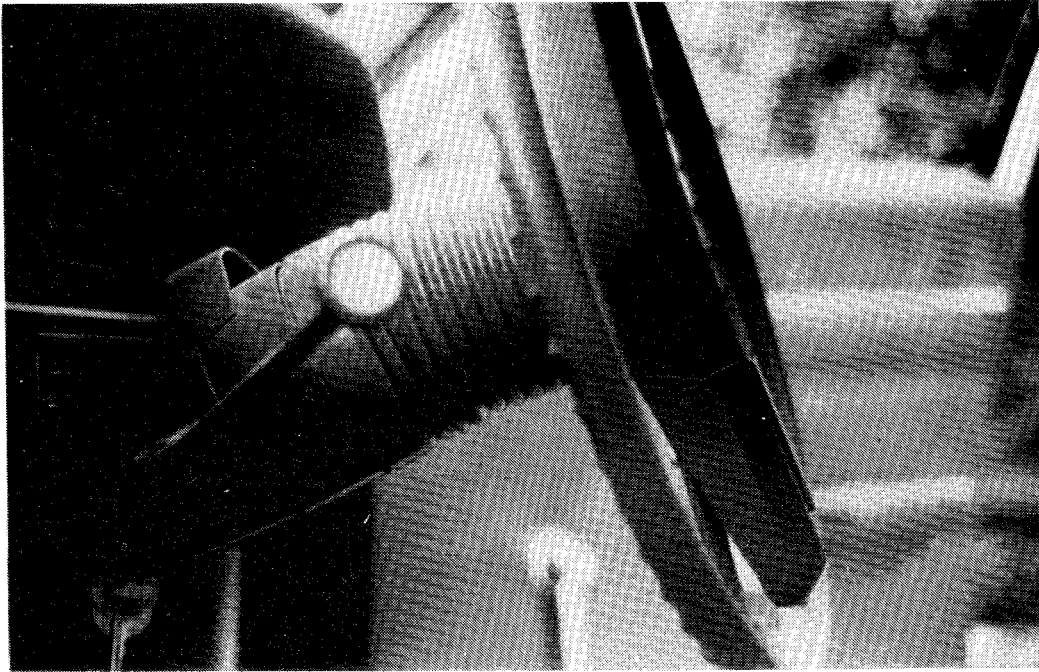
FIGURE 4.60: Deformation of steering wheel and energy-absorbing element following collision with utility pole. (Accident 294, See Figure 4.59)

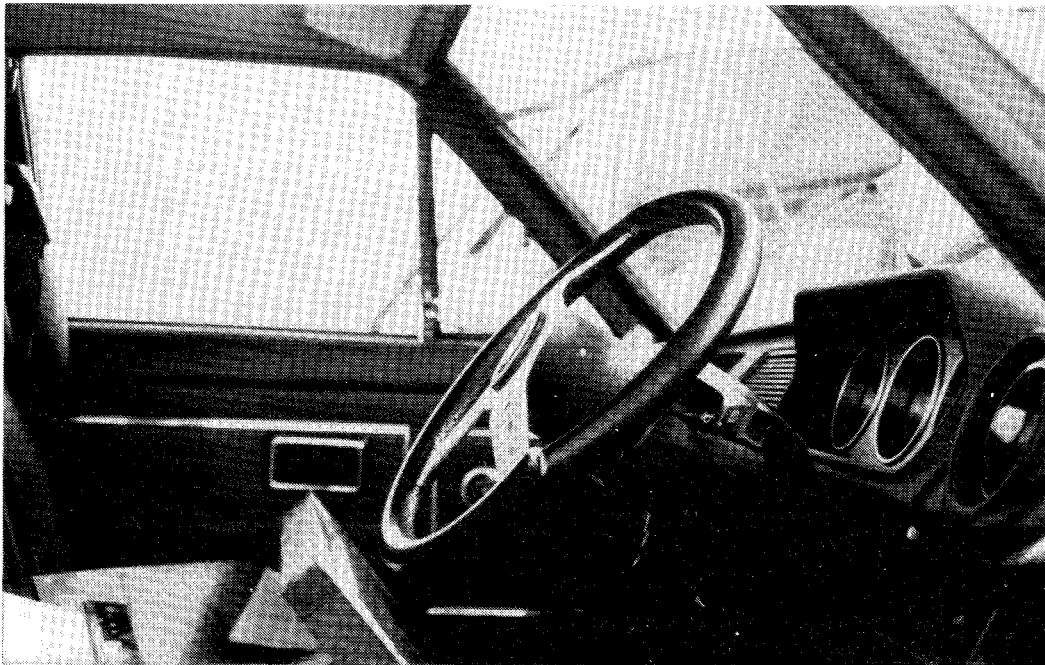
FIGURE 4.61: Steering column hub exposed by bending of spokes of non-standard steering wheel. (Accident 017.)

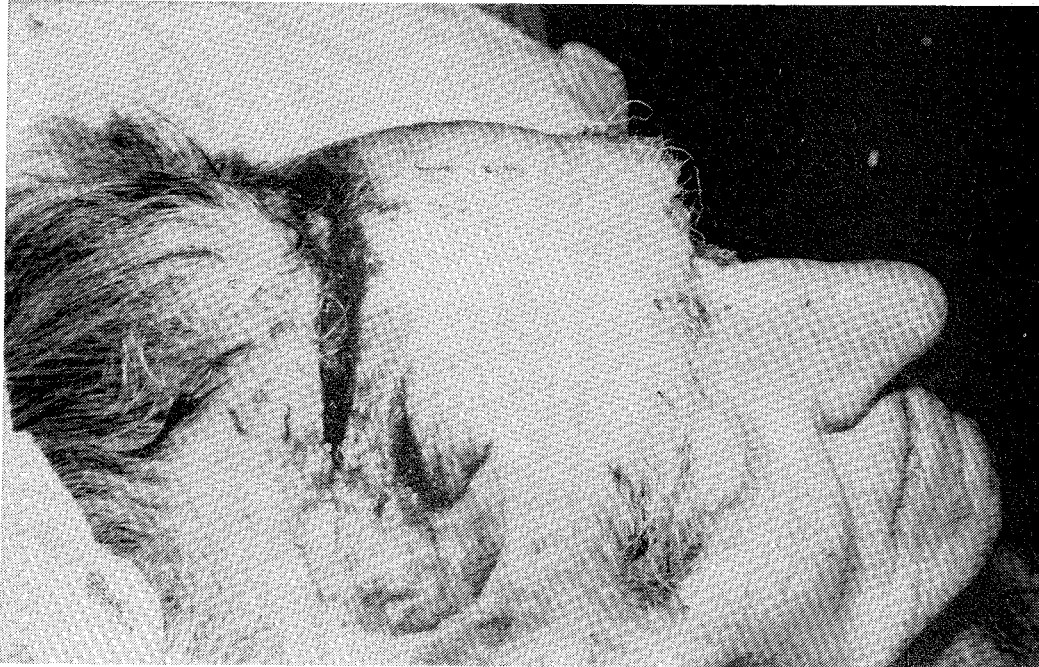
FIGURE 4.70: Lacerations to the forehead caused by the rear vision mirror and the edge of the sheet metal section forming the header area. (Accident 076, See also Figure 4.71)

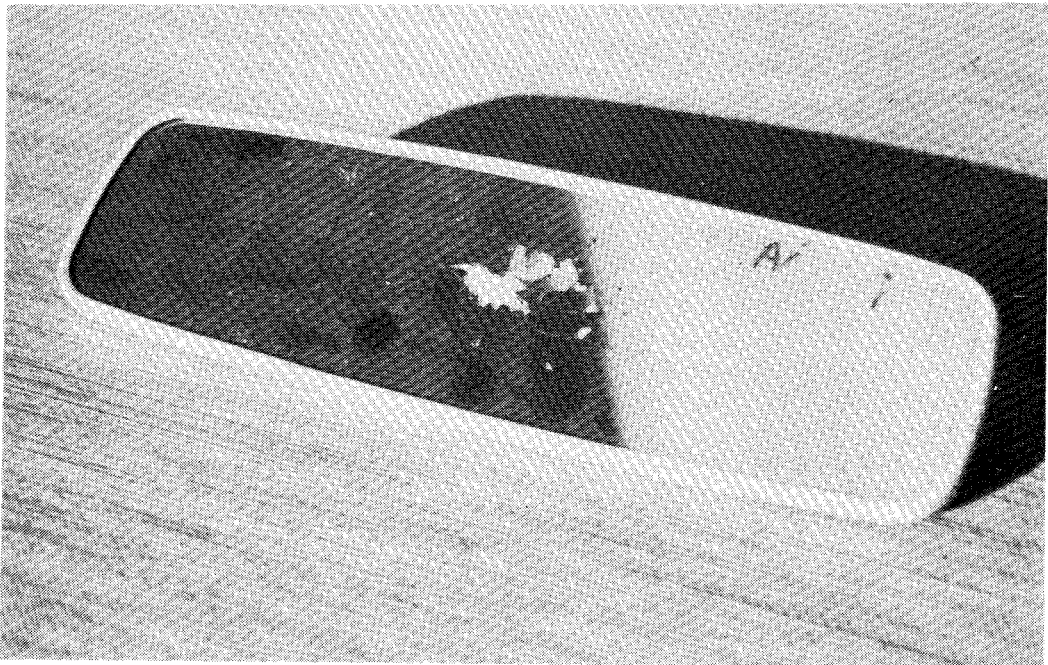
FIGURE 4.73: Damage to rear vision mirror glass (See Figure 4.72)

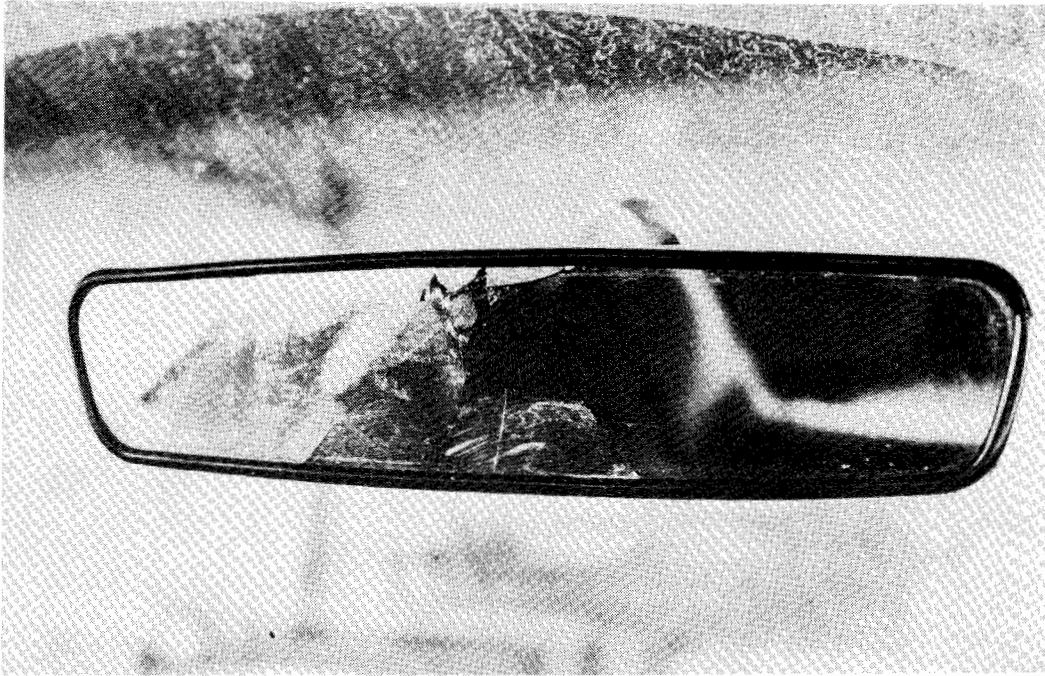
FIGURE 4.74: Damage to mirror due to head contact with rear vision mirror which did not break away (Accident 104)

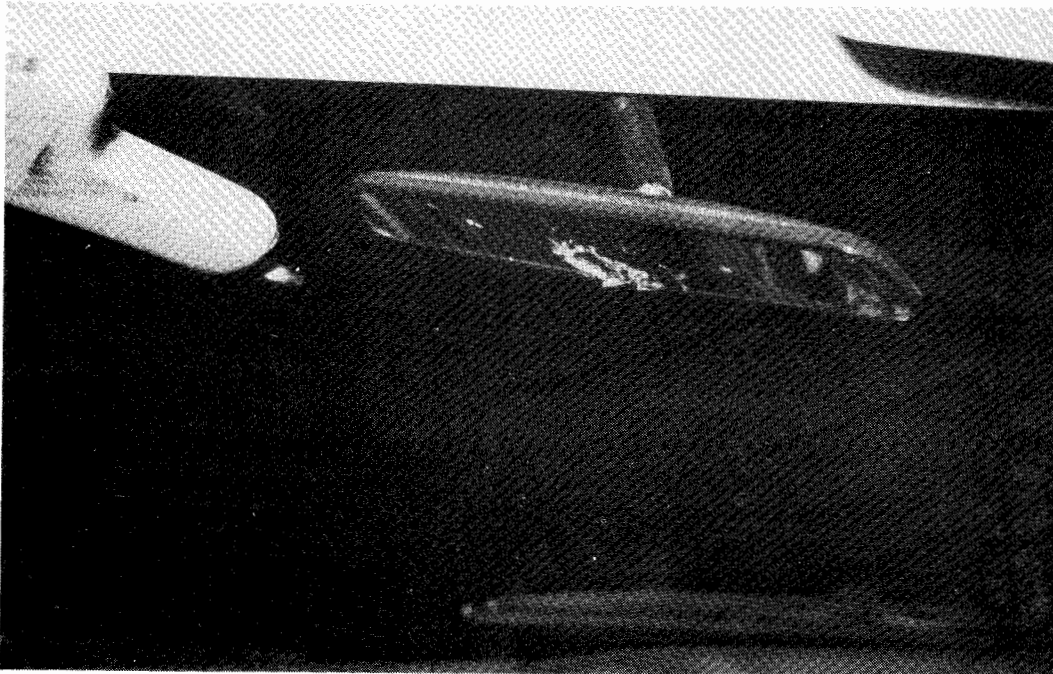
FIGURE 4.75: Damage to rear vision mirror following impact by occupant (Accident 108)

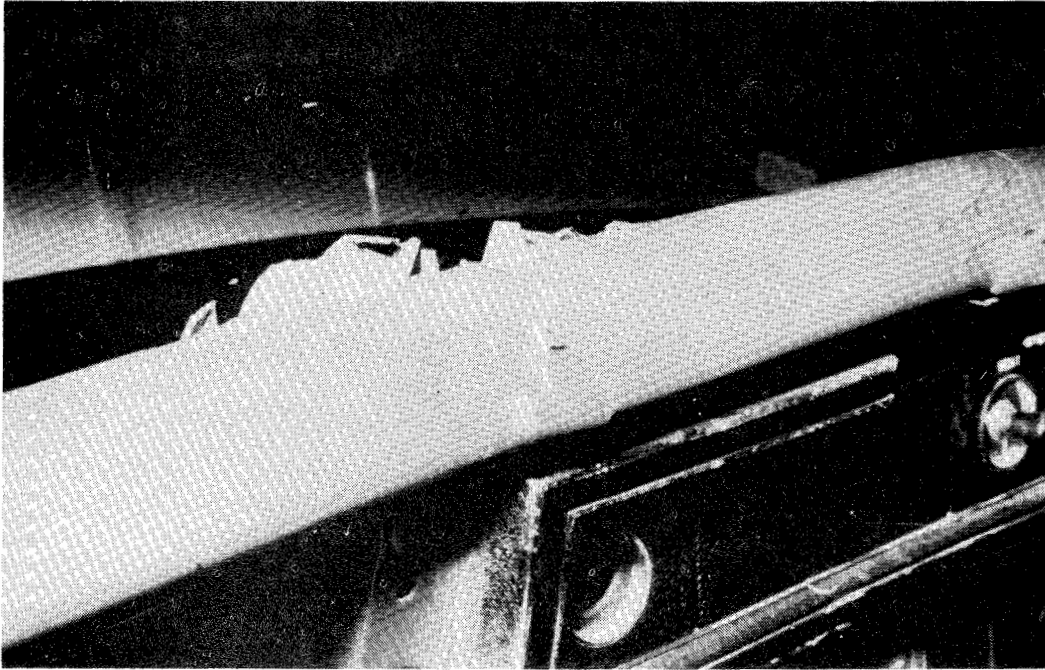
FIGURE 4.76: Damage to padding of instrument panel of a 1969 HT Holden station wagon caused by face of left front passenger (Accident 096, see also Figures 4.27 et seq.)

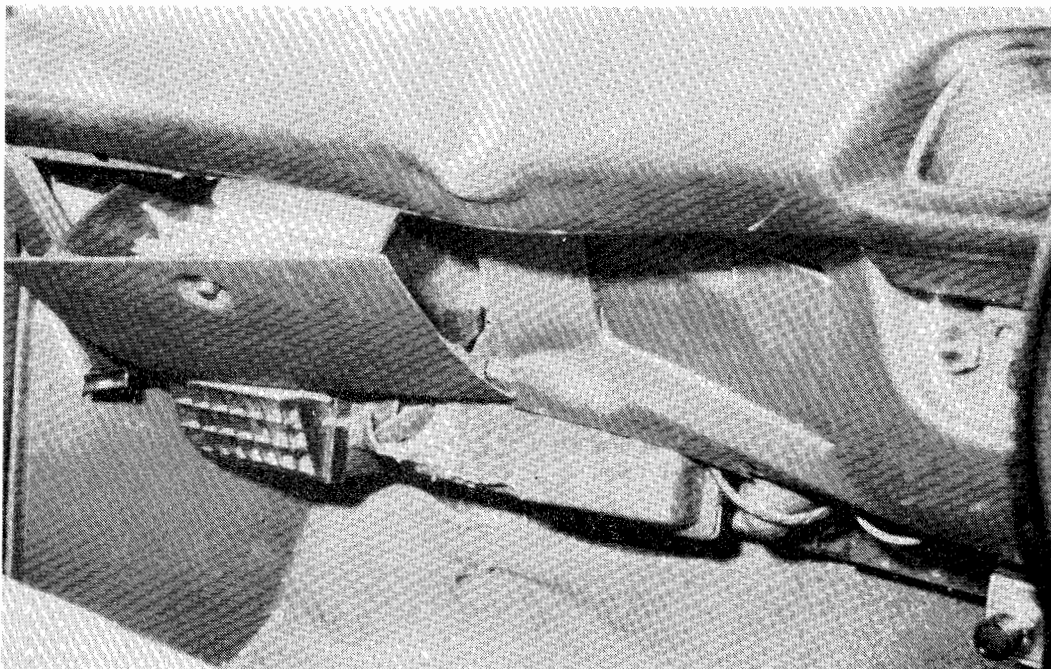
FIGURE 4.77: Damage to instrument panel caused by unrestrained occupant being thrown against it. Door of glove-box has come open. (Accident 232, 1972 Chrysler VH Valiant Charger)

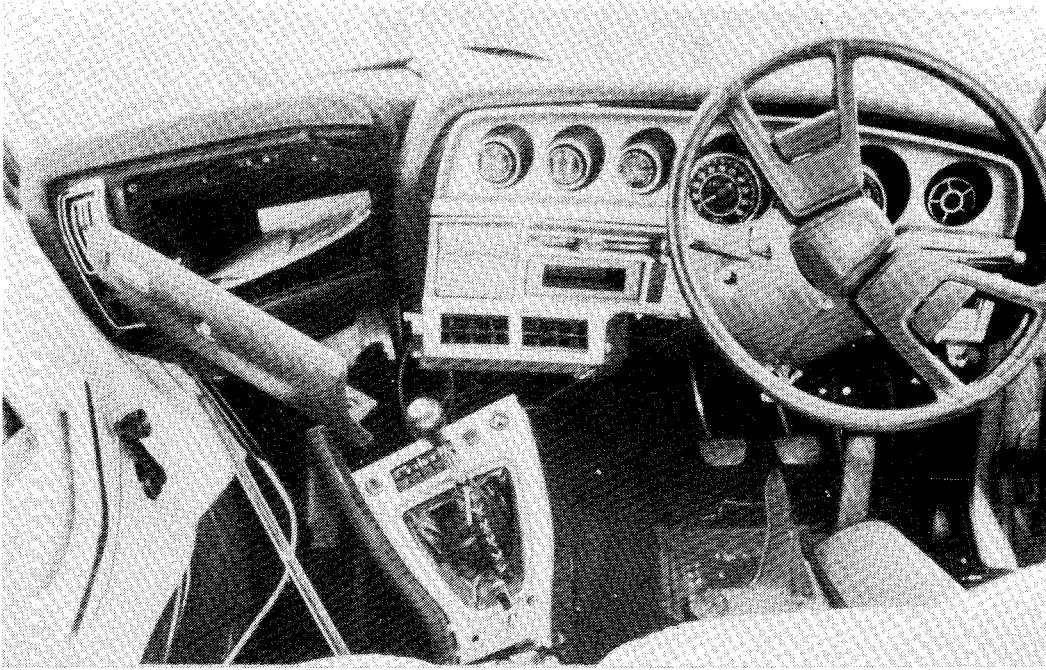
FIGURE 4.78: Door of glovebox hanging open after severe deformation of the instrument panel when car was struck on the left side (Accident 124, 1974 Mazda 929 coupe. See also Figures 4.37 et seq.)

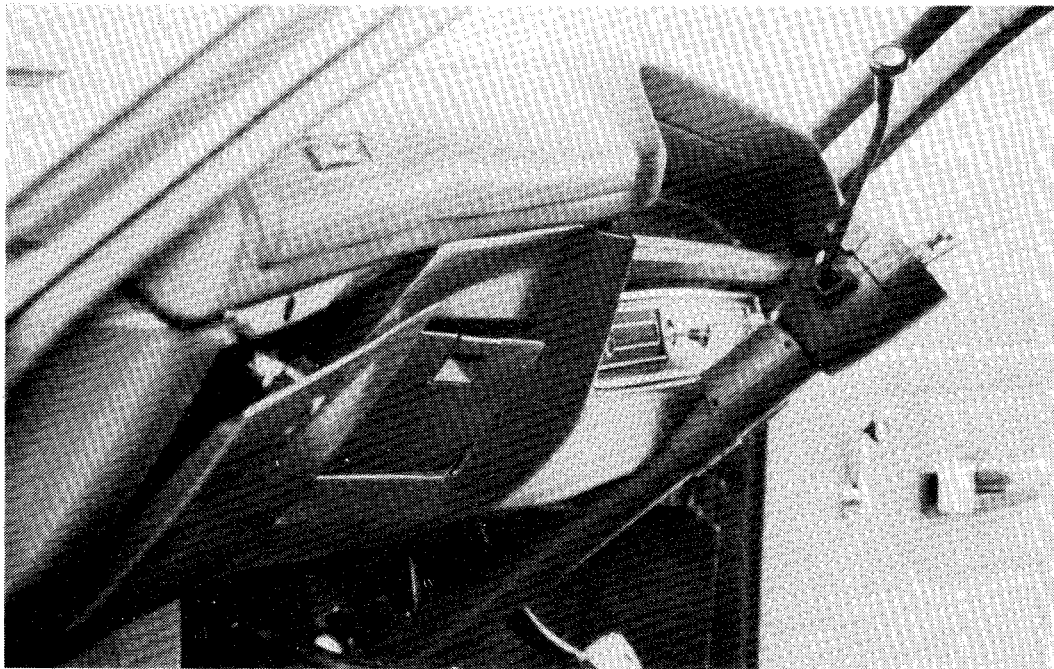
FIGURE 4.79: Damage to instrument panel of a 1975 Chrysler VJ sedan caused by unrestrained occupant, who was not injured. Note opened door of glovebox. (Accident 057, see also Figures 4.56 et seq. and 4.90)

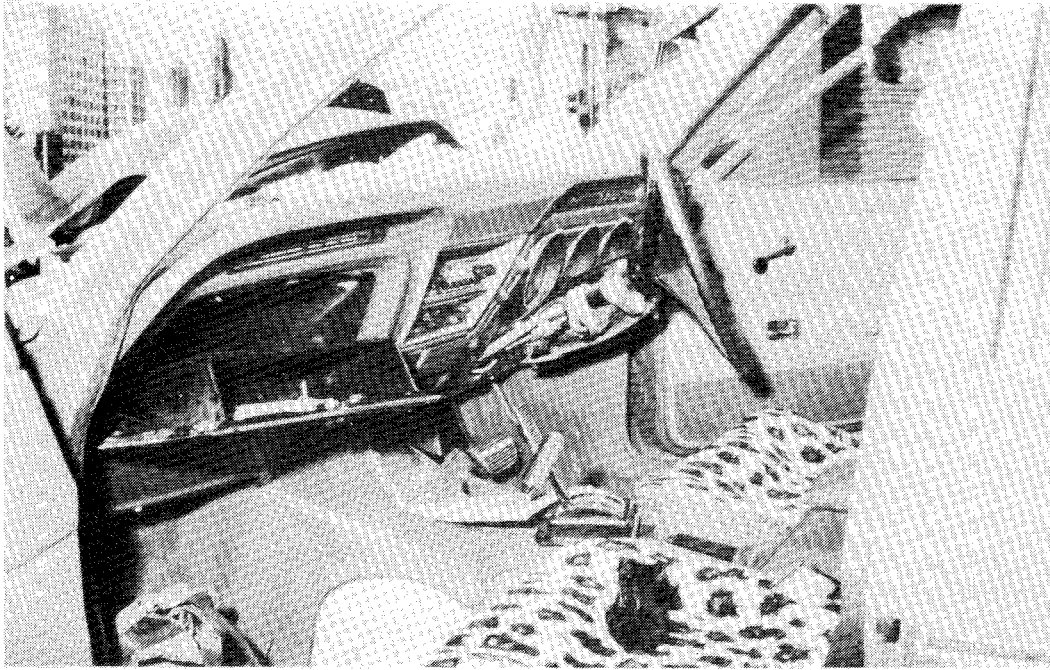
FIGURE 4.80: Glovebox door open following impact by knee of unrestrained front passenger. (Accident 259, 1973 TC Ford Cortina, see Figures 4.83 and 4.52)

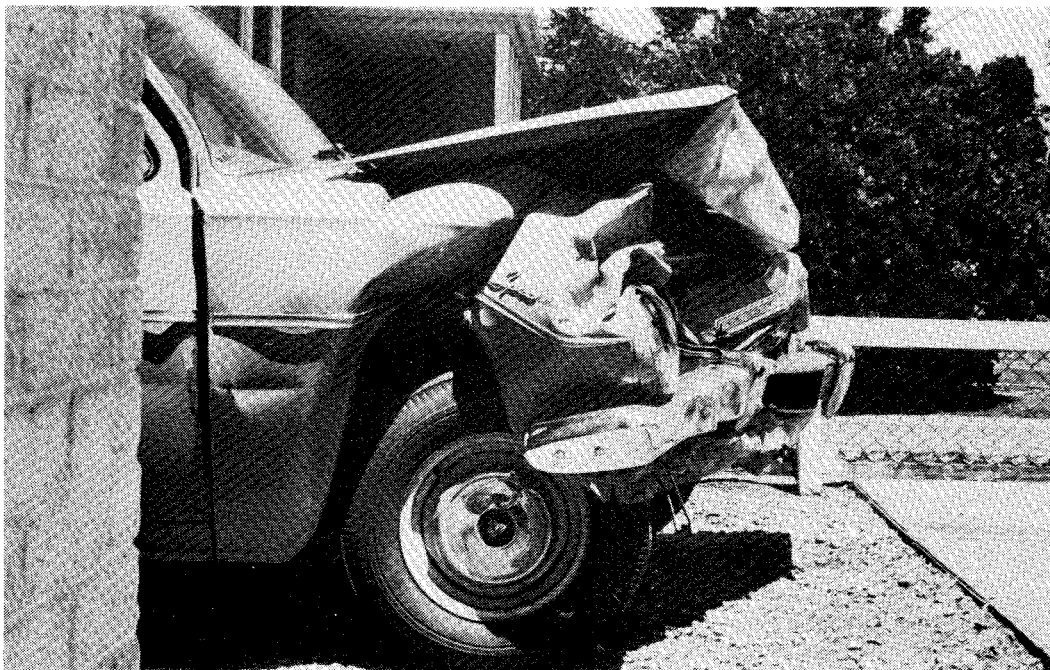
FIGURE 4.81: Damage resulting from a head-on collision (Accident 245, see Figures 4.82 and 4.48 et seq.)

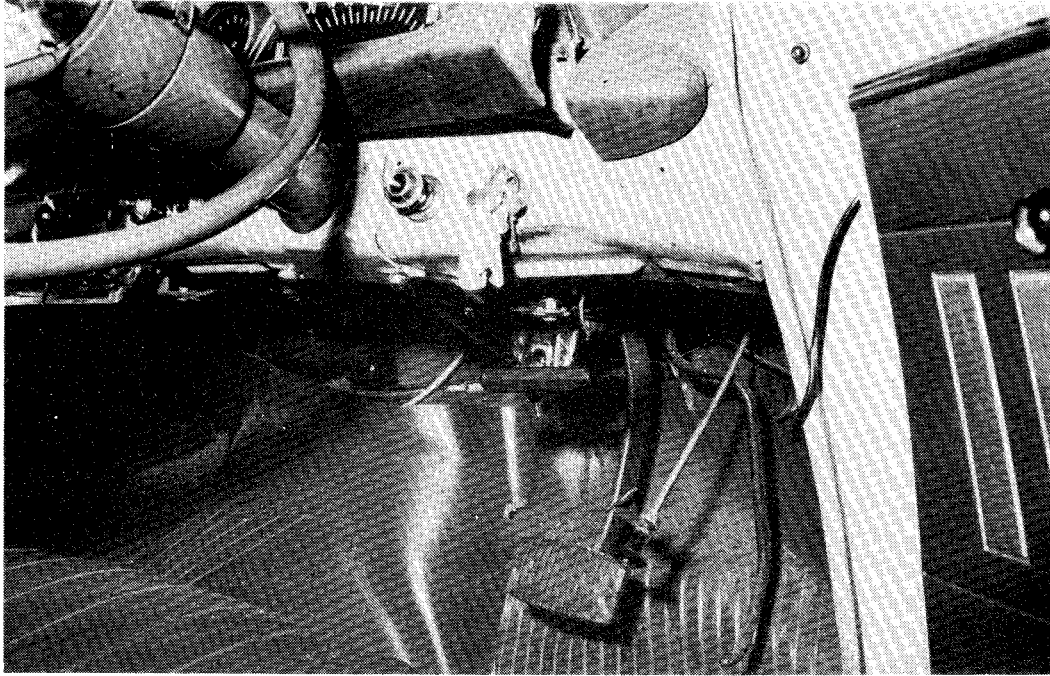
FIGURE 4.82: Dent in instrument panel below ignition key was caused by driver's right knee (Accident 245, see also Figure 4.81)

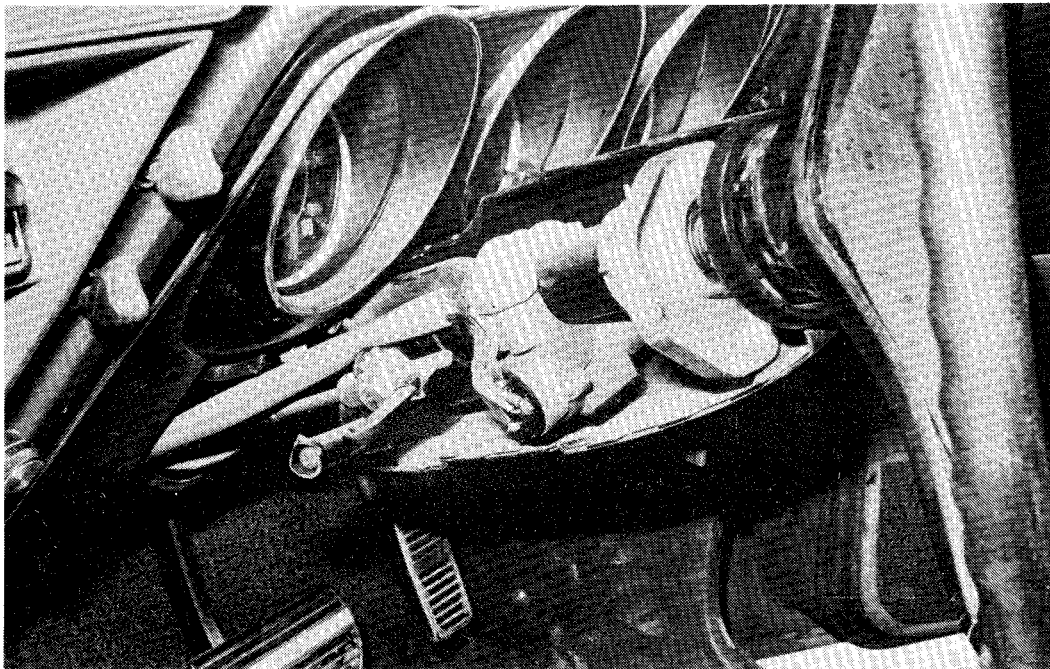
FIGURE 4.83: Plastic housing around steering column shattered by impact by driver's knee. (Accident 259, see also Figure 4.80)

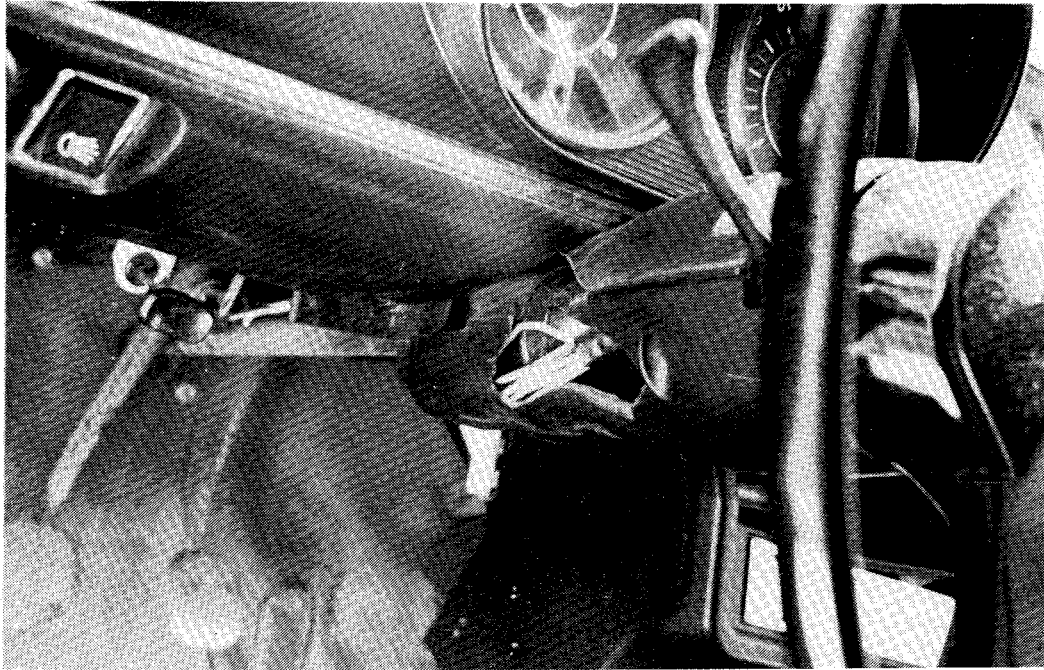
FIGURE 4.84: Damage to plastic housing around steering column from impact by driver's knee. (1970 Fiat 125S sedan, Accident 008)

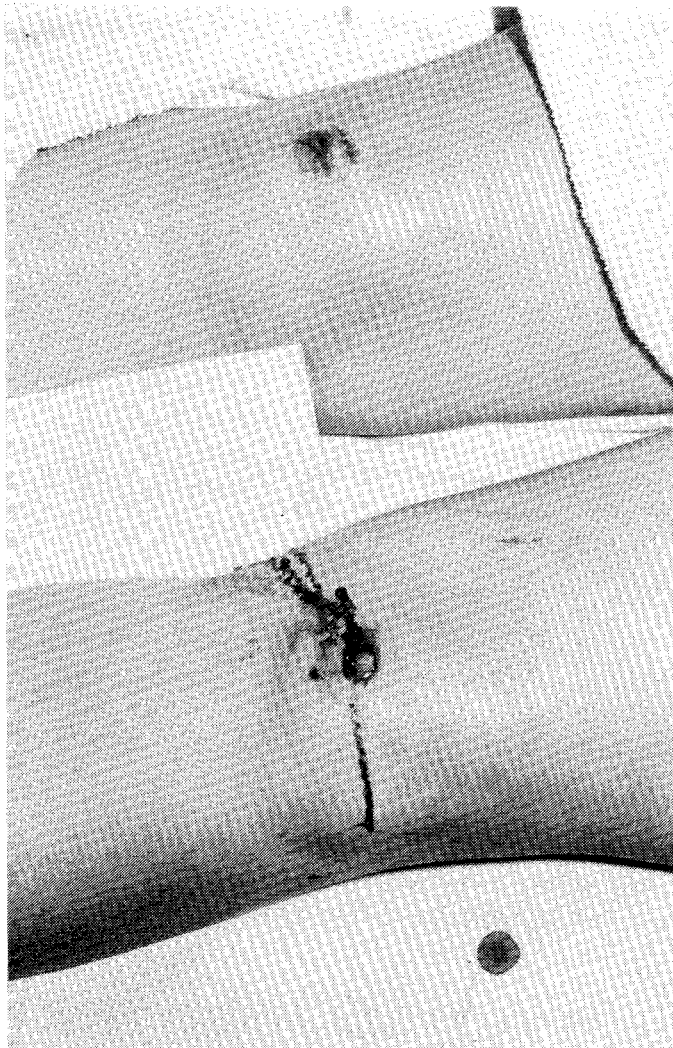
FIGURE 4.85:

Injury to left (lower) knee was caused by contact with the head of the bolt retaining the steering column bracket shown in Figure 4.86. (See also Figure 4.87)

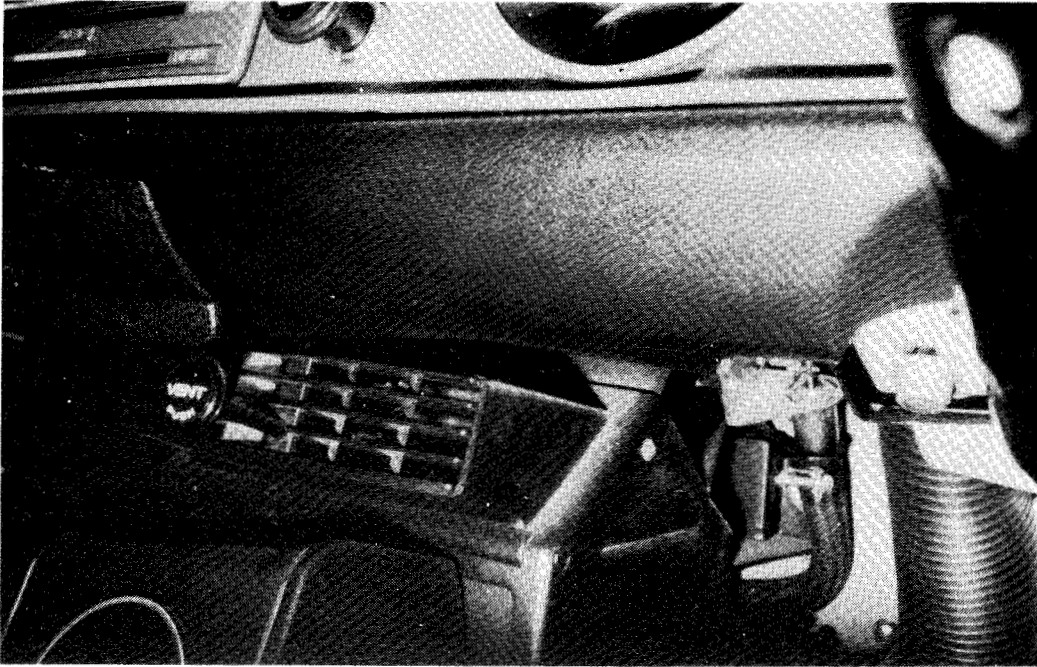
FIGURE 4.86: Steering column bracket retaining bolt (far right) referred to in caption to Figure 4.85. (See also Figure 4.87)

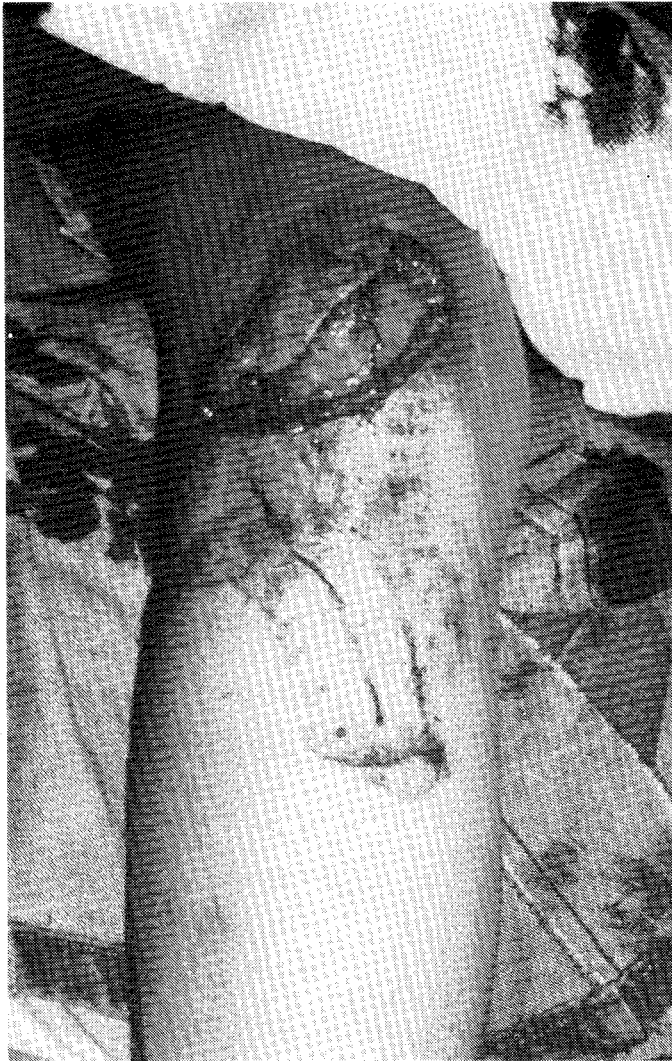
FIGURE 4.88:

Knee laceration
caused by contact
with the accessory
bracket shown in
Figure 4.89.

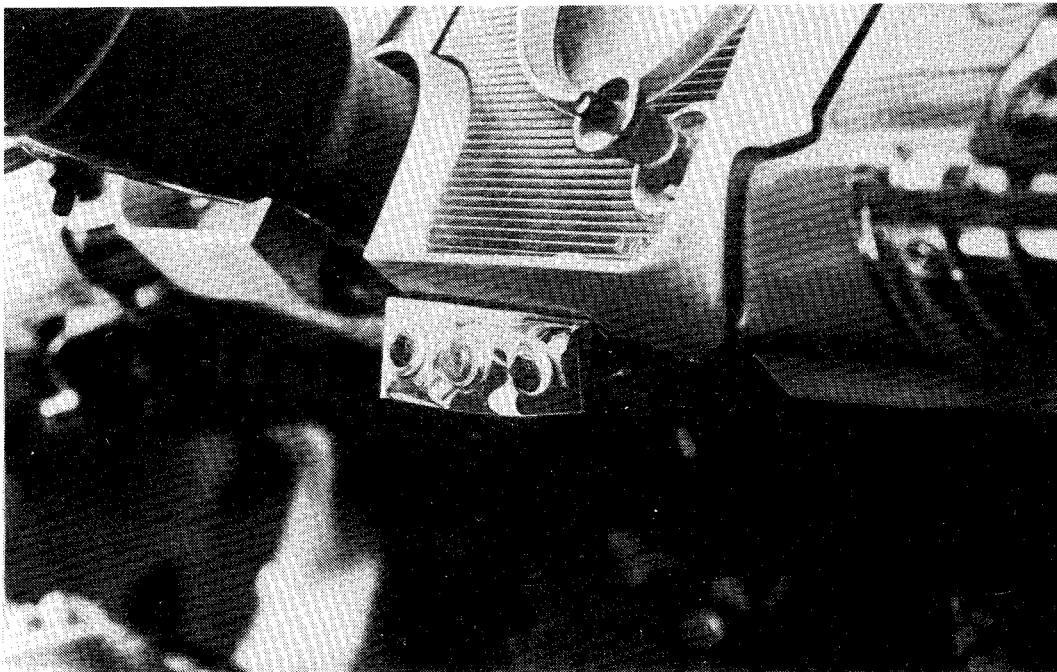
FIGURE 4.89: Accessory bracket fitted below the instrument panel. (Accident 051, See Figures 4.88 and 4.46, 4.47)

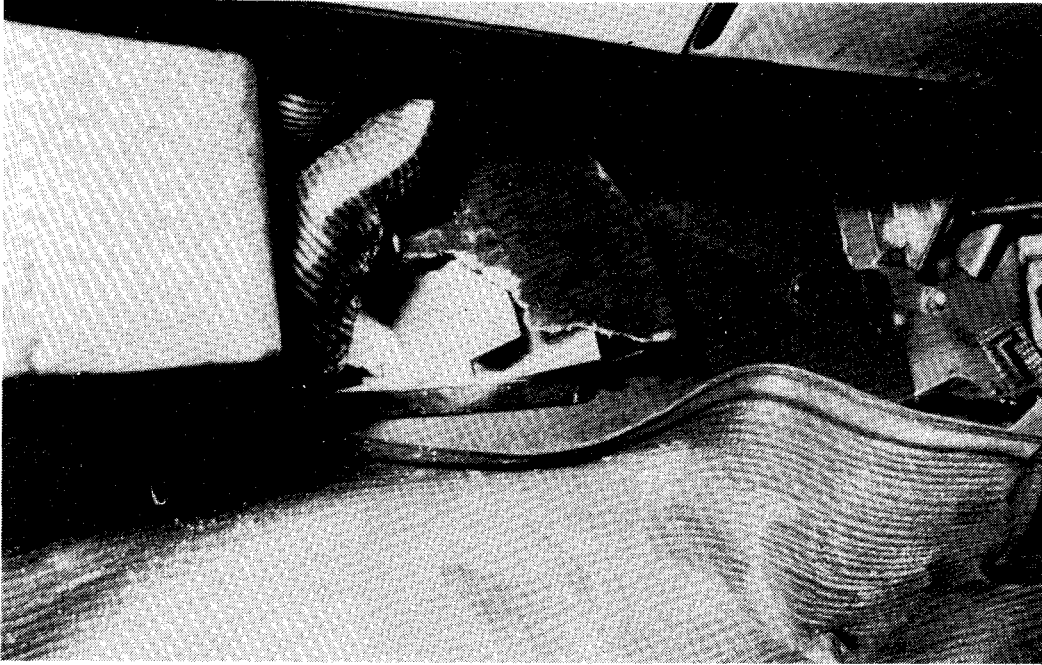
FIGURE 4.90: Failure of housing of heater duct due to occupant contact, exposing sheet metal vanes. (Accident 057, see Figure 4.79)

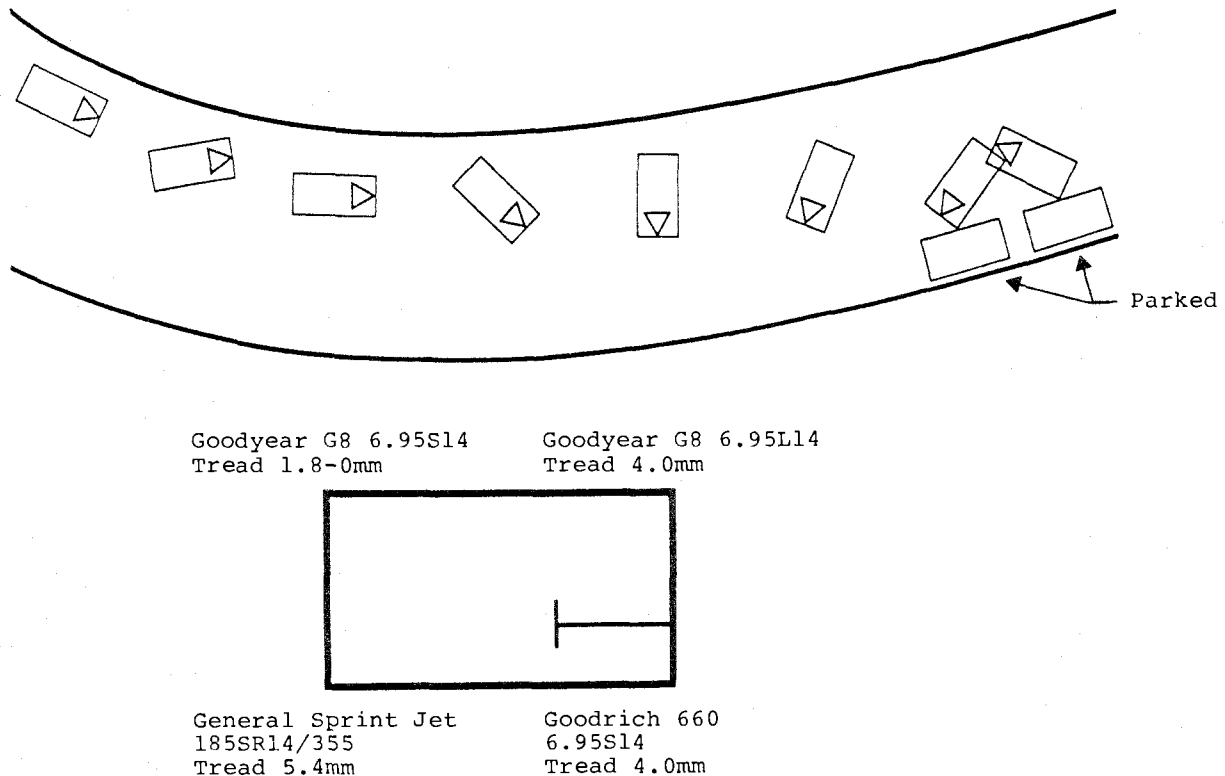
FIGURE A2.2: Accident 132: Vehicle Movements and Tyre Specifications

The loss of control may have been due in part to the inexperience of the young driver, as noted above, but it is clear that the mismatch in carcass construction, tread and sidewall stiffness of the tyres on the rear axle, together with the low coefficient of friction at the bald left hand rear tyre, would have made the vehicle extremely difficult to control under such circumstances.

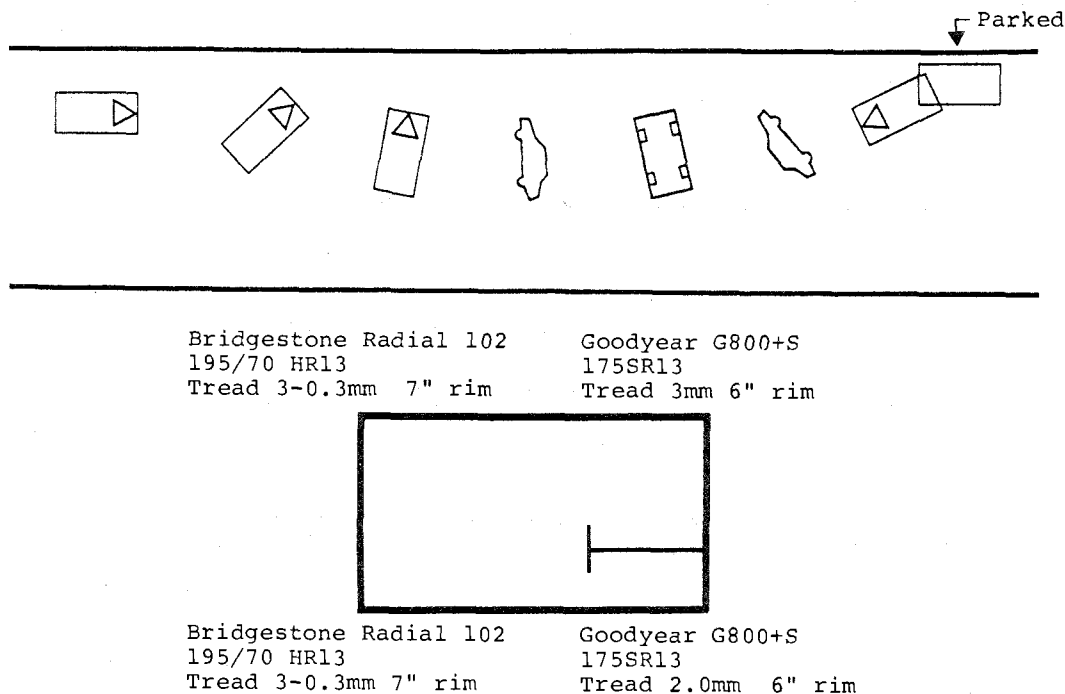
FIGURE A2.3: Accident 291: Vehicle Movements and Tyre Specifications

Other modifications to this car included the fitting of 175SR13 tyres on six inch rims to the front and 195/70HR13 tyres on seven inch rims to the rear, the rear tyres having no tread over 70 per cent of the tread width.

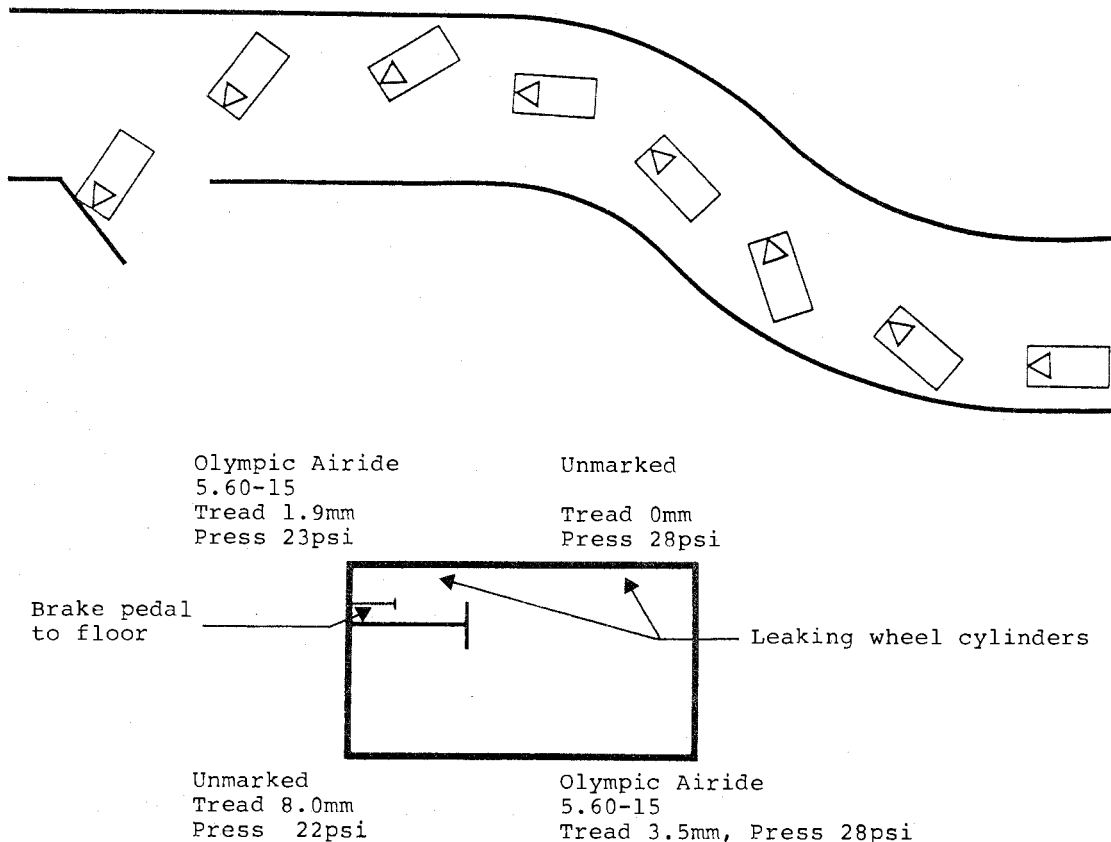
FIGURE A2.11: Accident 168: Vehicle Movements and Defects

A 16 year old male who was operating on a suspended licence and who had had minimal driving experience, attempted to negotiate a downhill right hand, left hand, S-bend in a borrowed 1963 Volkswagen sedan. On entry to the right hand curve, which had a light covering of fine sand, the vehicle yawed in a clockwise direction and then
