IN VIVO AND IN VITRO EVALUATION OF RESIN- BONDED PORCELAIN RESTORATIONS

Department of Dentistry
The University of Adelaide

Submitted as a Partial Requirement for the
Degree of Master of Dental Surgery
in Conservative Dentistry

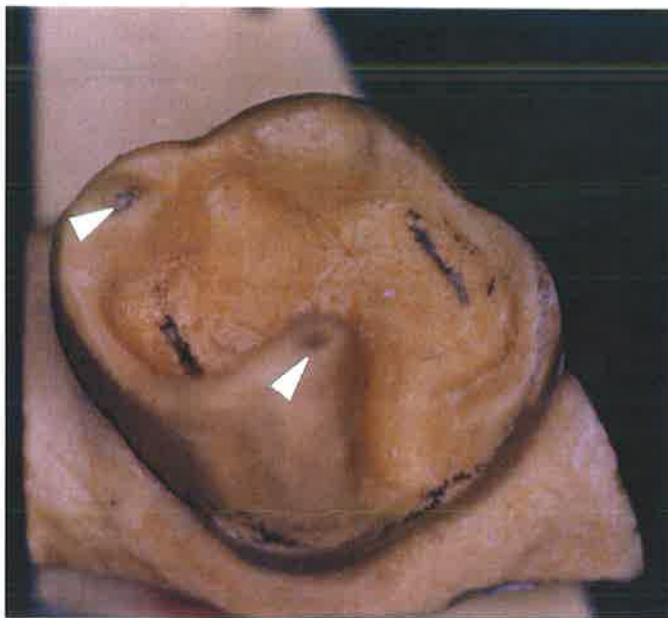
Figure 1 - A representative photograph of a prepared molar tooth showing the cusp tips (arrows) from which the intercusp widths were measured.

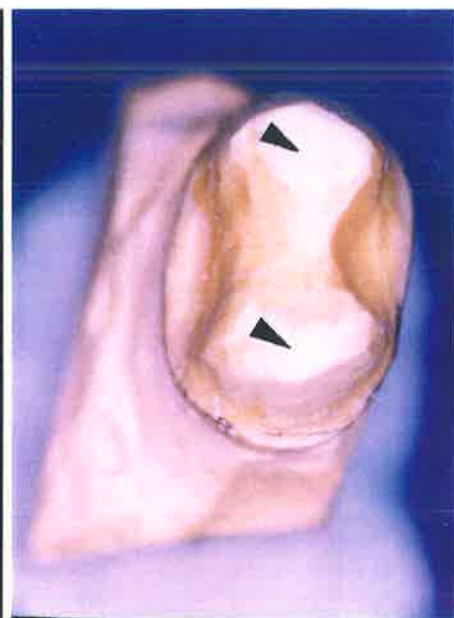
Figure 2 - A representative photograph of a prepared premolar tooth showing the cusp tips (arrows) from which the intercusp width was measured.

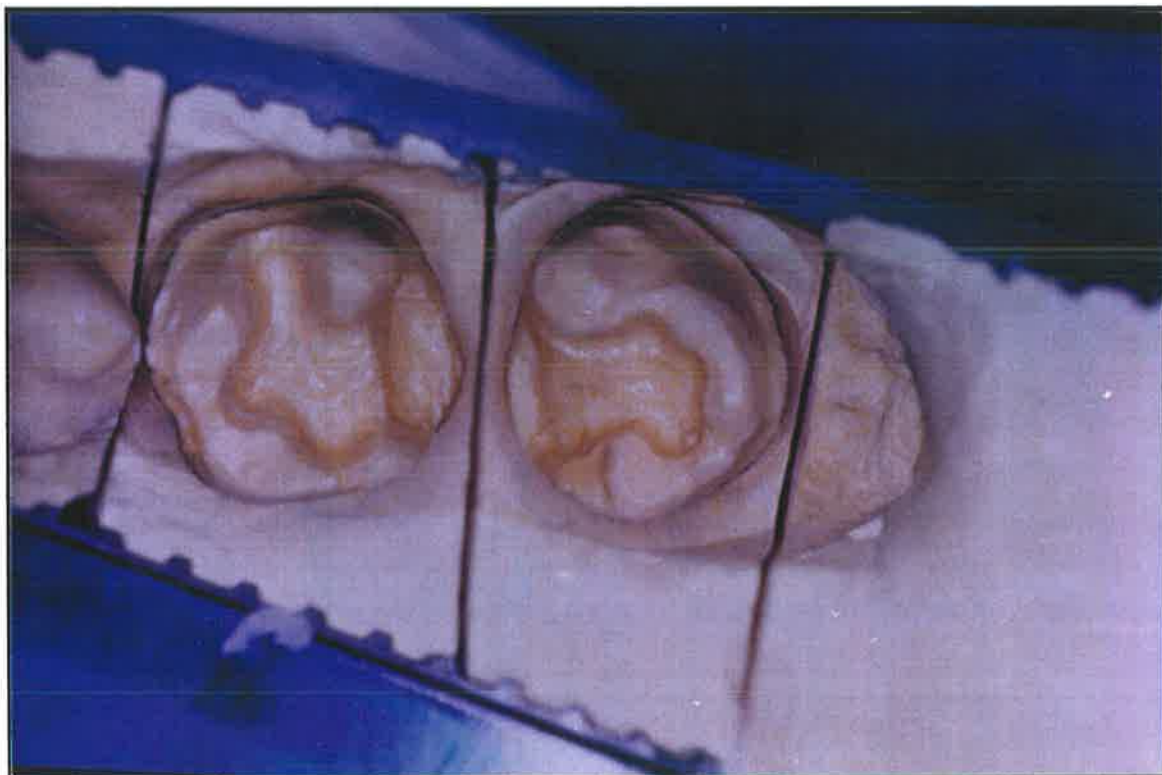
Figure 5 - An occlusal view of two dies inserted in a Mirage tray with shell crown preparations on molar teeth (46 and 47).

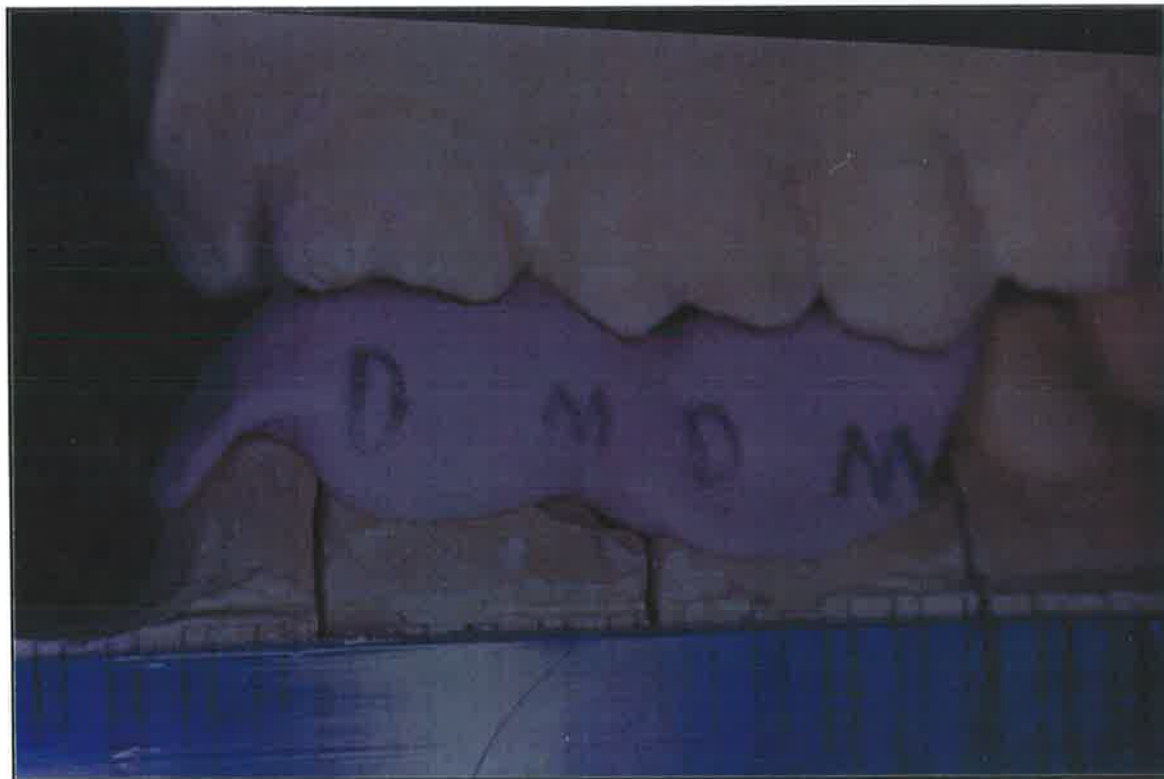
Figure 6 - The same dies in Figure 5 with a putty impression and occluded with the opposing cast.

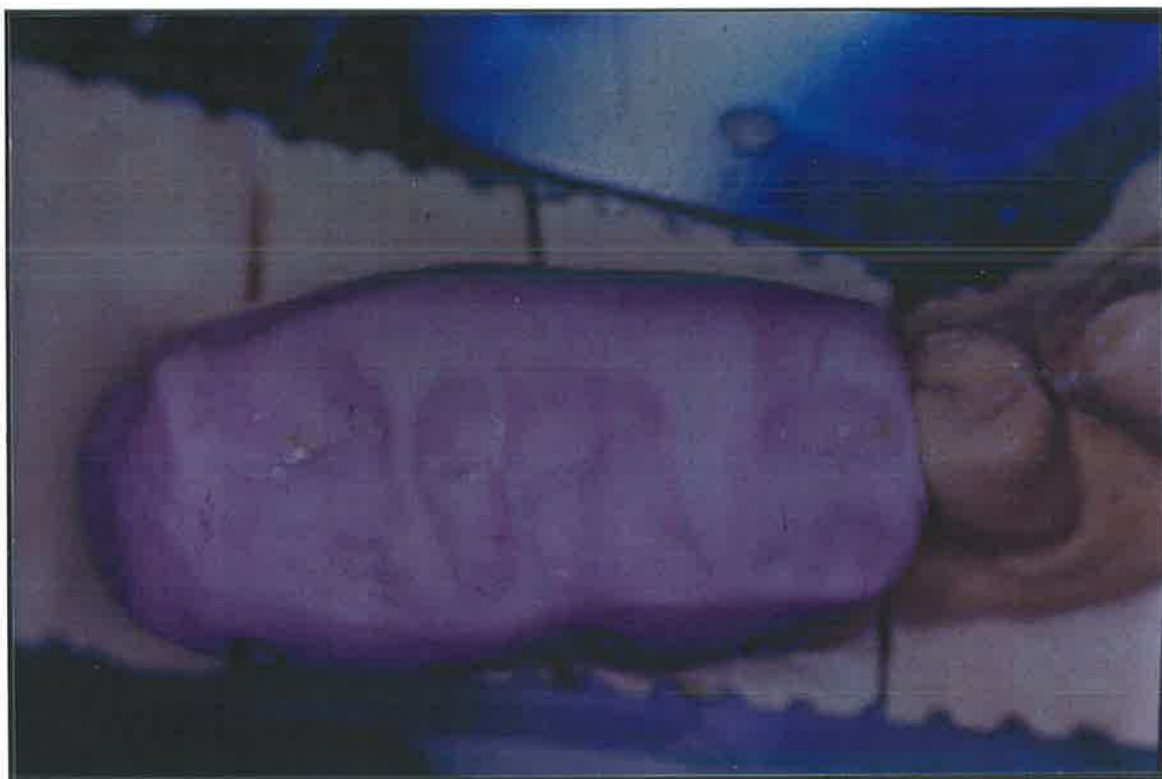
Figure 7- An occlusal view of the same impression in Figure 6 after the putty has set.

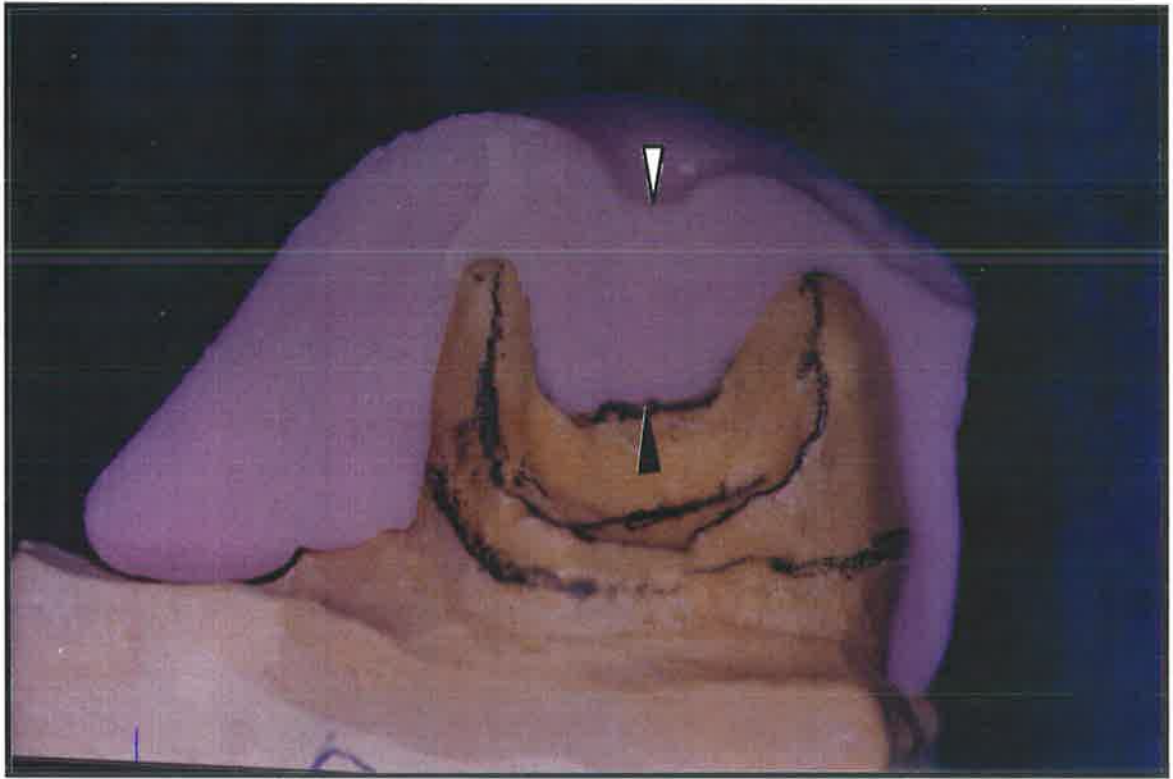
Figure 9 - A photograph showing the distal view of tooth 46 in Figure 5 with sectioned impression. Depth of occlusal floor was measured from the depression between buccal and lingual cusps (white arrow) and pulpal floor (black arrow).

Preparation tapers of restorations with occlusal and proximal boxes were measured indirectly from impressions of the internal walls (Figures 9 and 10 pencilled area). Again, the extensions of the internal buccal and lingual walls were copied onto a piece of paper. The angle between the two lines was measured, as before, with a protractor.

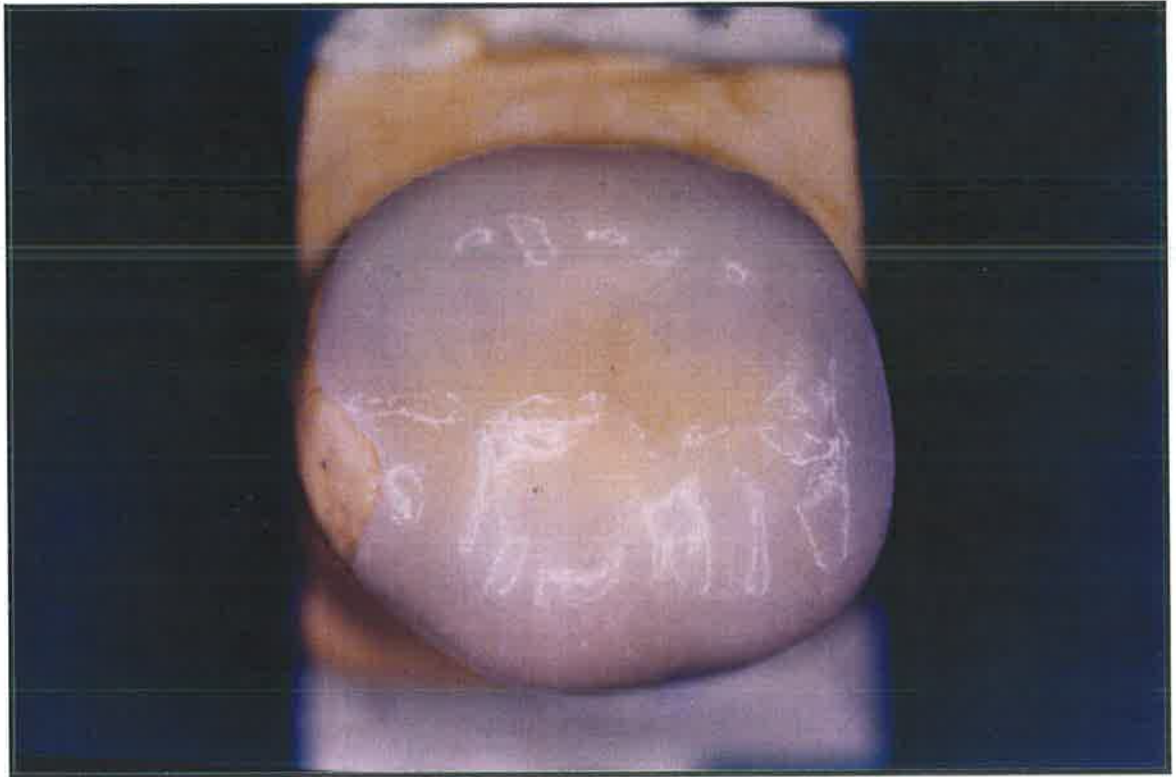
Figure 12 - A metal-reinforced onlay restoration on tooth 46.

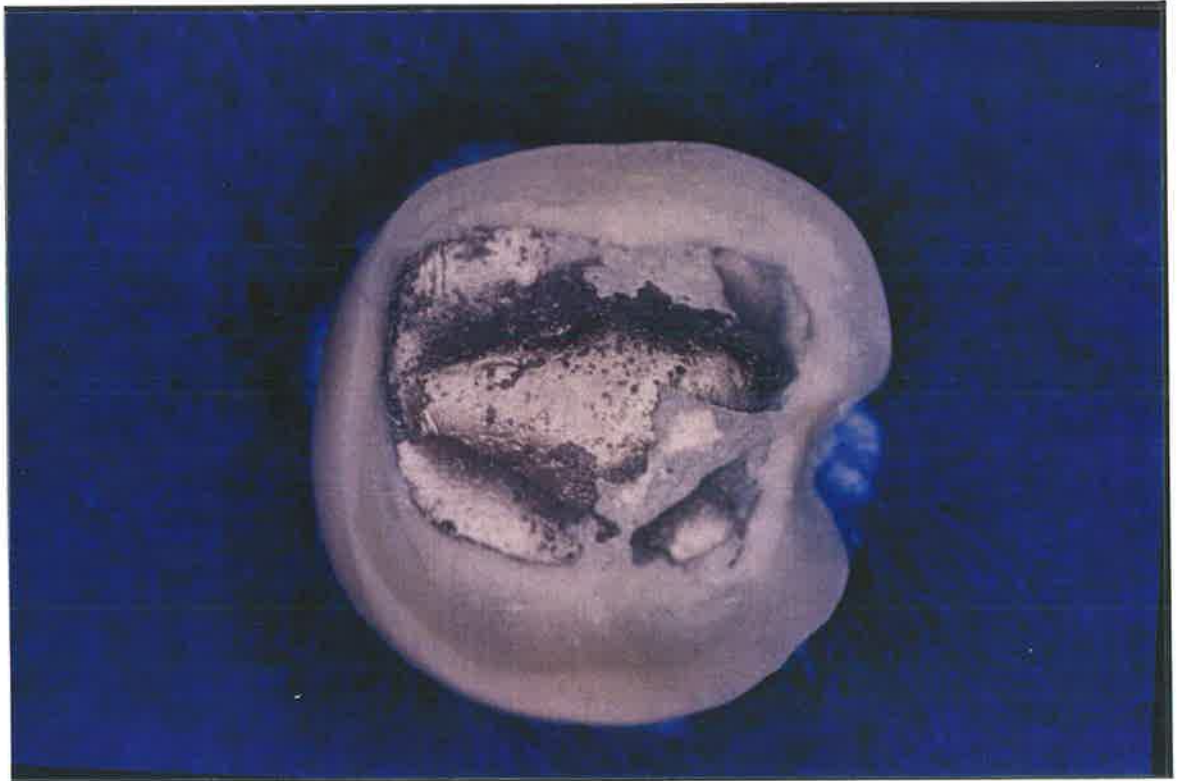
Figure 13 - The fitting surface of the same restoration in Figure 12.

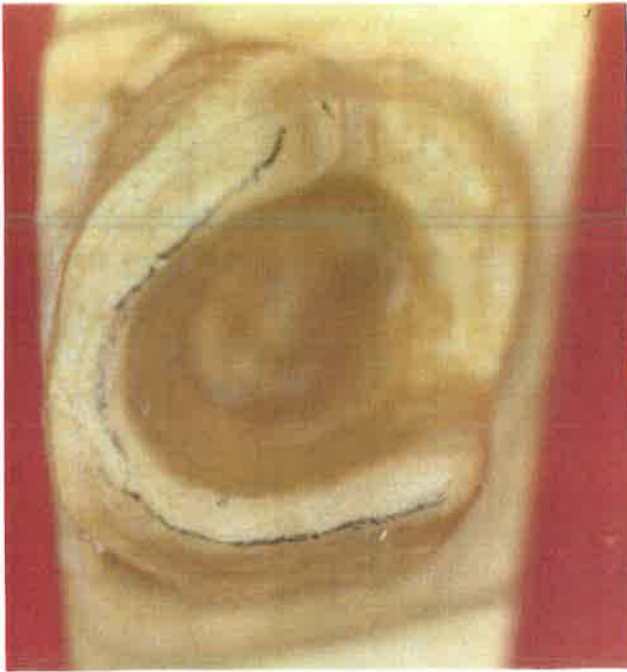
Figure 1- Depth of occlusal floor from central fissure in an onlay design without metal reinforcement prepared on a root canal filled tooth (16).

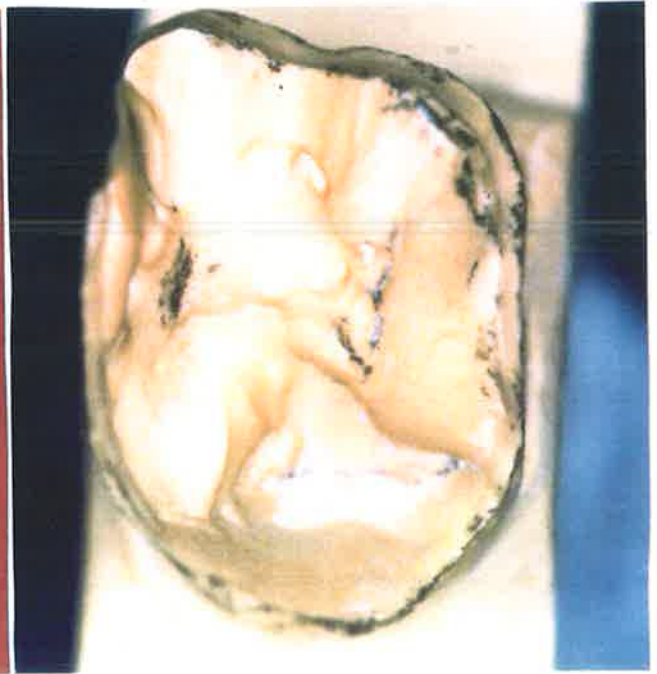
Figure 2 - Retention slots in an onlay preparation of a molar tooth (26).

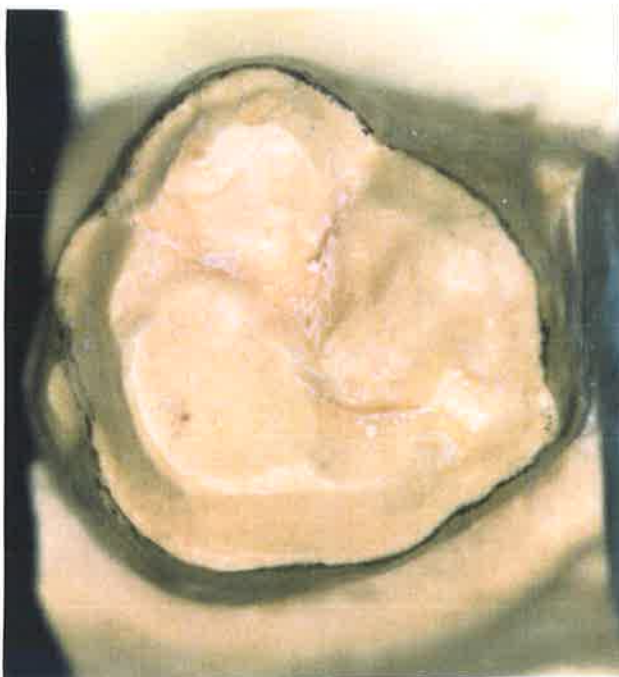
Figure 3- Large external preparation taper ($>40^\circ$) in an onlay design without metal reinforcement of a molar tooth (17).

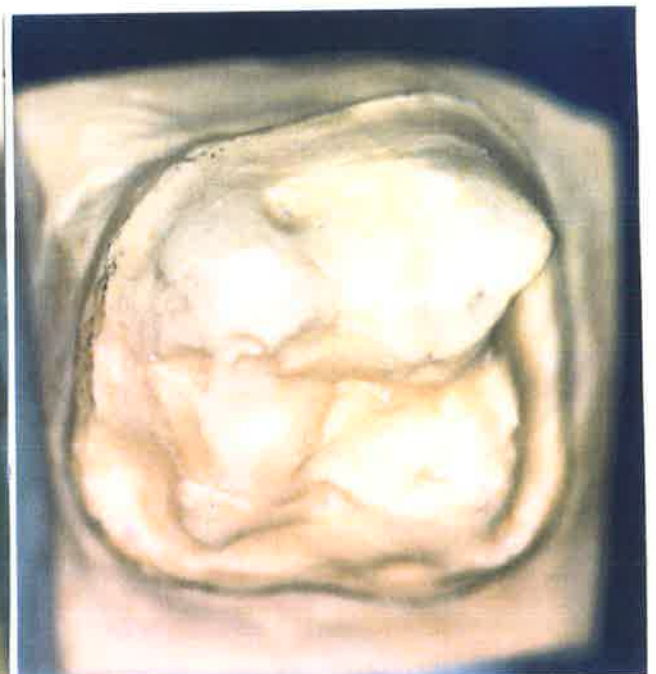
Figure 4 - Large external preparation taper ($>40^\circ$) in a shell crown design without metal reinforcement of a molar tooth (36).

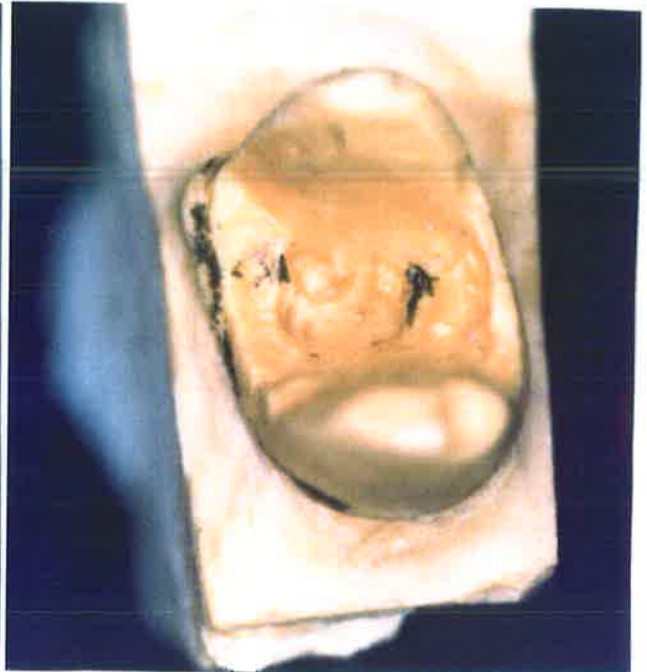
Figure 6 - Internal preparation taper ($<20^\circ$) in a shell crown design without metal reinforcement of a premolar tooth (25).

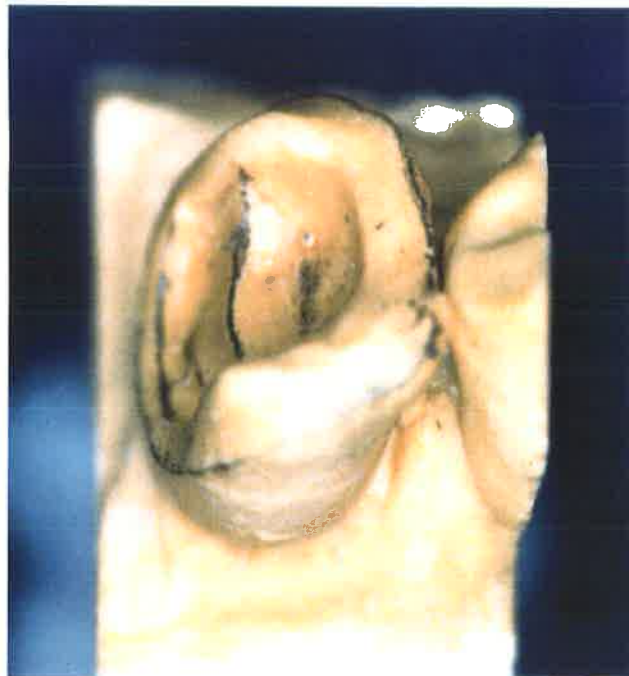
Figure 7- Internal preparation taper ($<20^\circ$) in an onlay design of a premolar tooth (25).

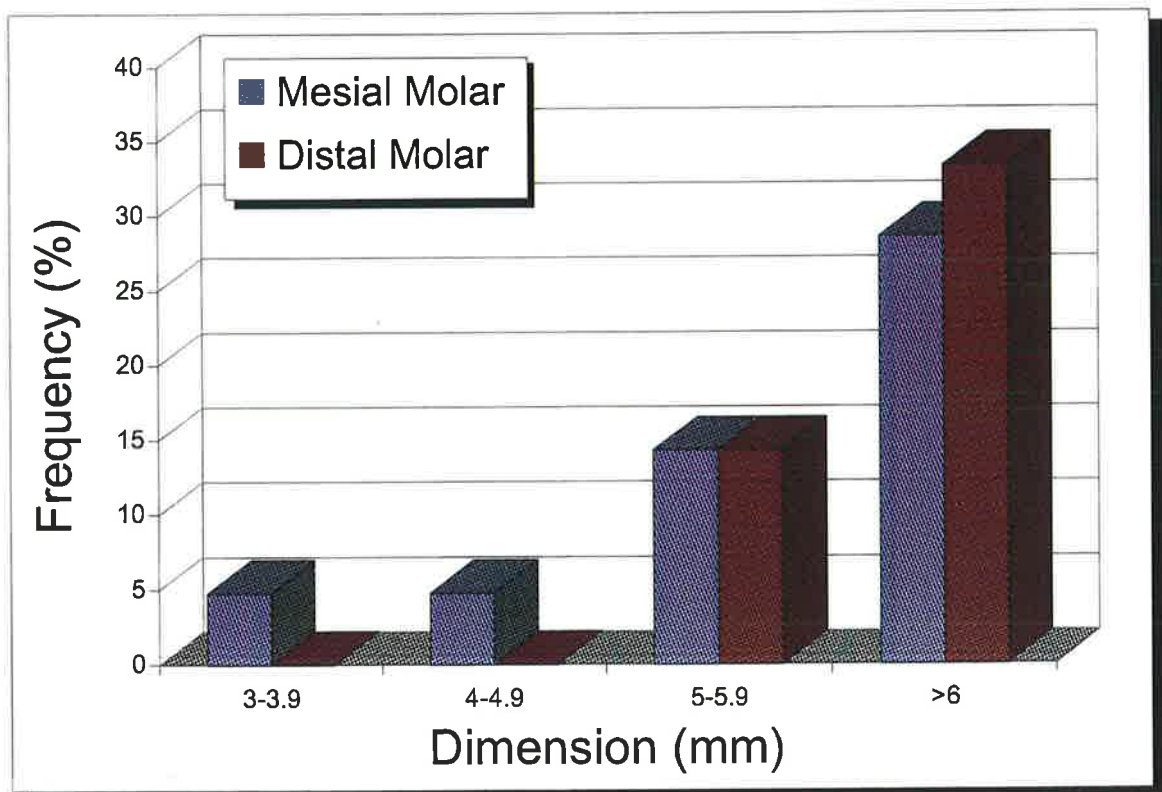
Figure 2b - Intercuspal width in mesial and distal of molar teeth in failed Onlays (N=21).

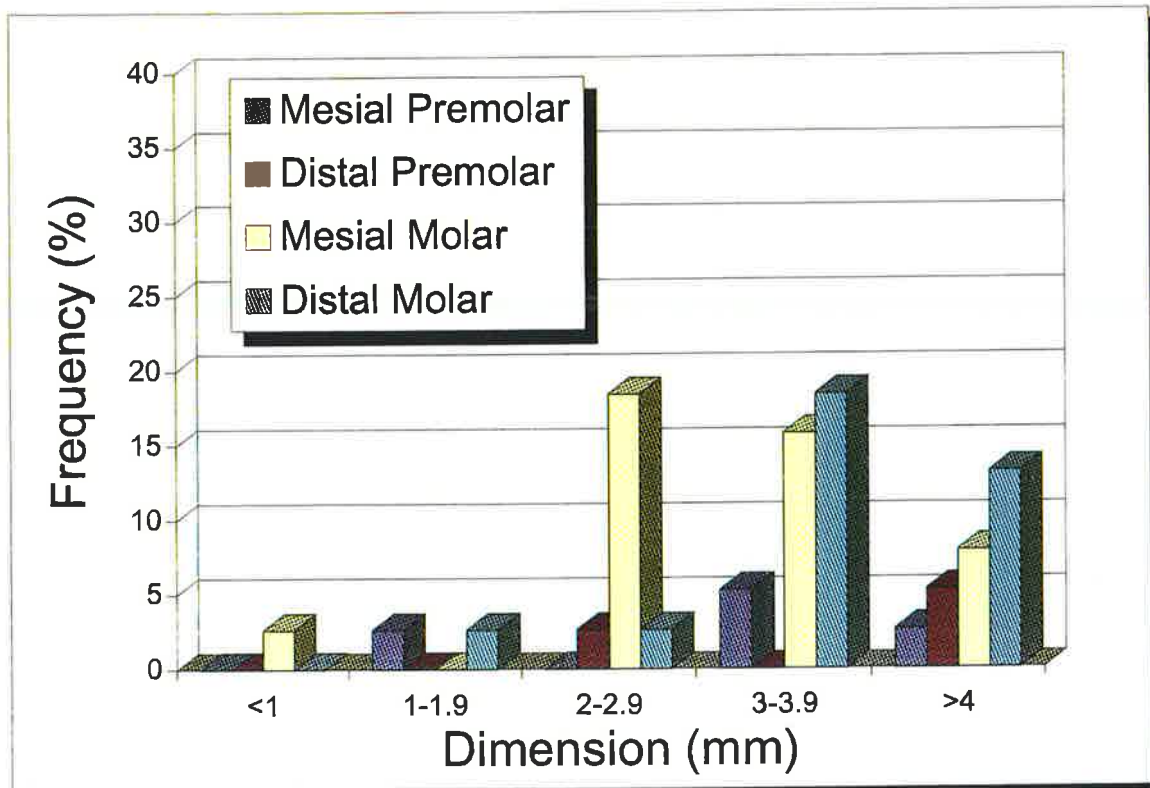
Figure 4a - Isthmus width in mesial and distal of molar and premolar teeth in intact Onlays (N=38).

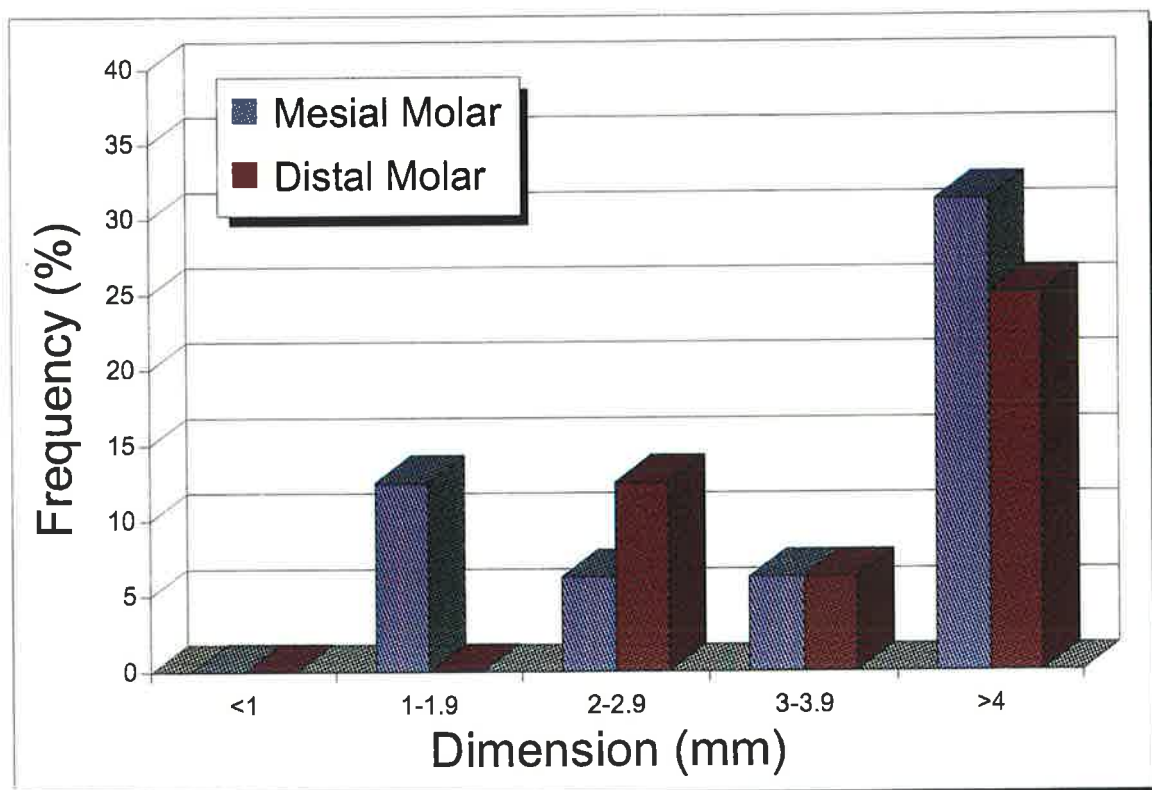
Figure 4b - Isthmus width in mesial and distal of molar teeth in failed Onlays (N=16).

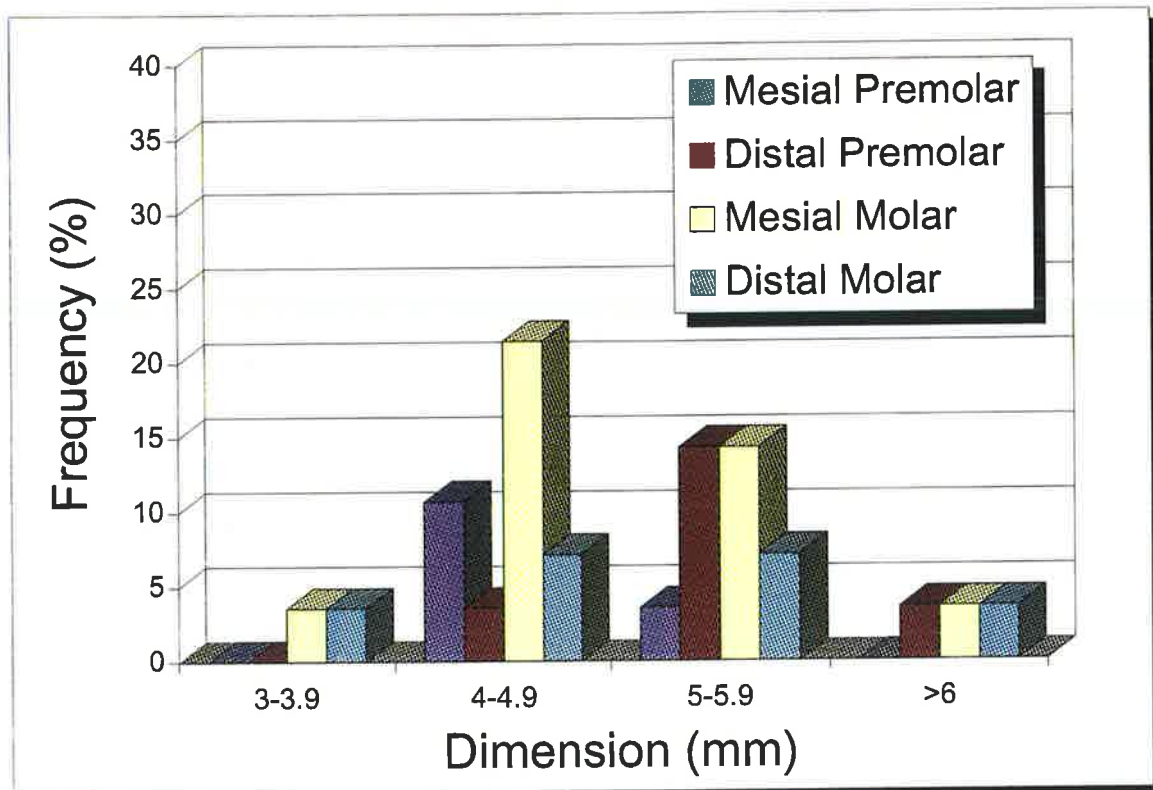
Figure 6a - Proximal width in mesial and distal of molar and premolar teeth in intact Onlays (N=28).

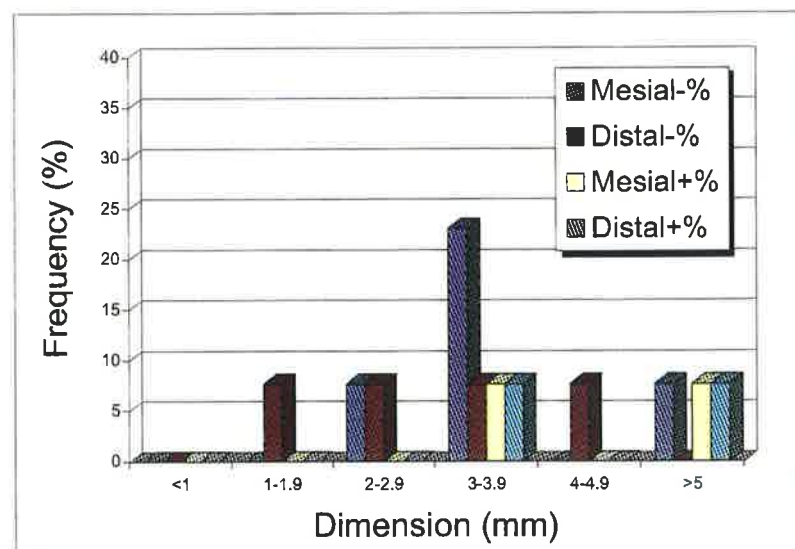
Figure 9c - Depth of occlusal floor from Central fissure in posterior teeth in failed shell Crowns with (N=4) and without (N=9) metal Reinforcement.

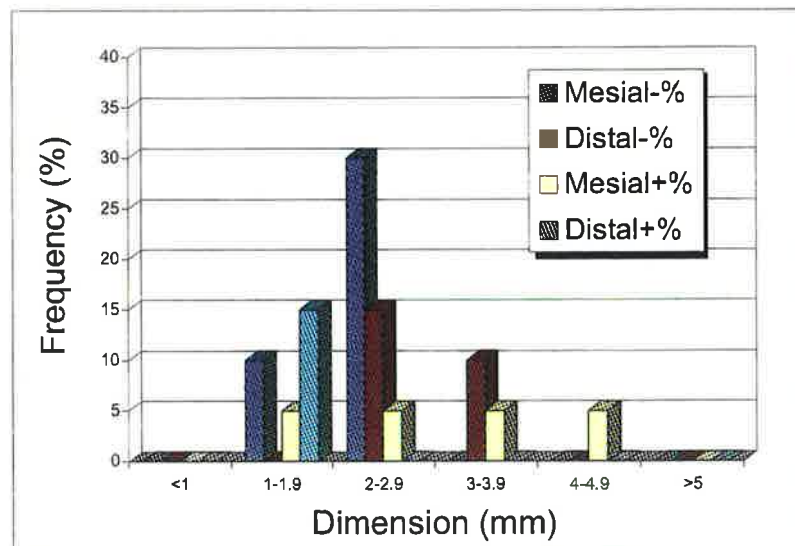
Figure 10c - Depth of occlusal floor from Central fissure in posterior failed Onlays with (N=7) and without (N=13) metal Reinforcement.

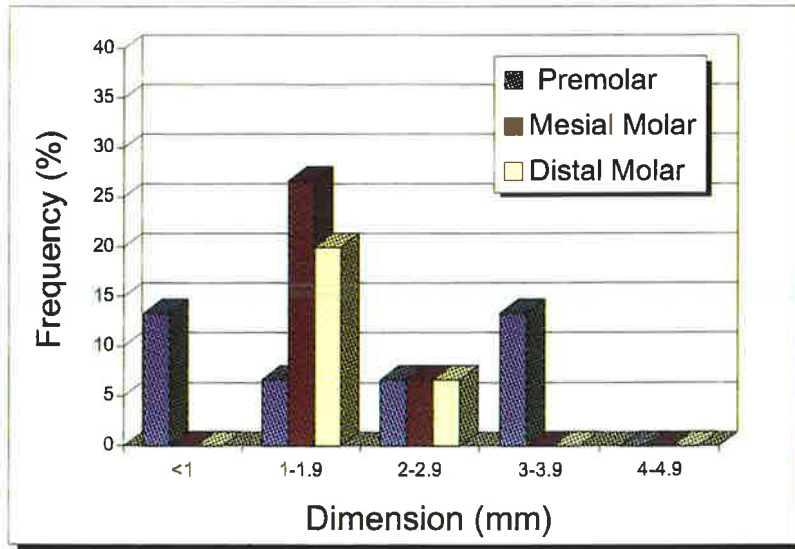
Figure 11a - Cusp reduction in mesial and distal of molar (N=9), and premolar (N=6) teeth in intact Shell Crowns without metal Reinforcement.

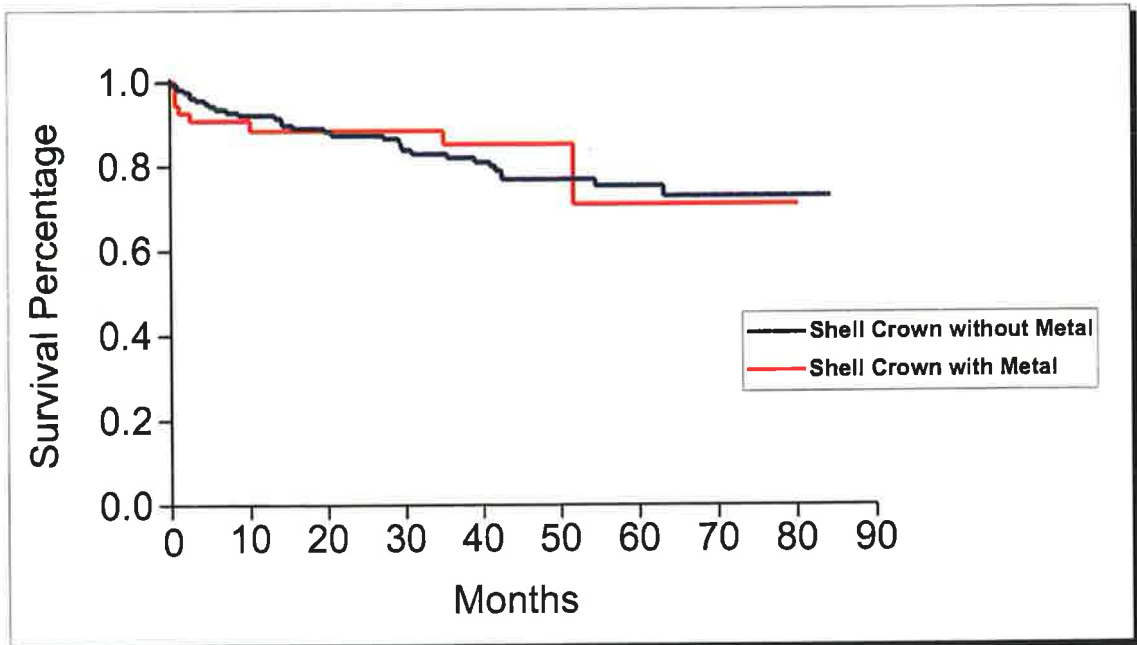
Diagram 4: Survival characteristics of shell crowns with and without metal reinforcement.
