D O M E S T I C   G A R A G E

STRENGTH DETERMINATION BY

PROOF LOADING AND ANALYSIS

A Thesis presented to the Faculty of  
Engineering of the University of  
Adelaide for one third fulfillment  
of the requirements for the Degree  
of Master of Engineering Science

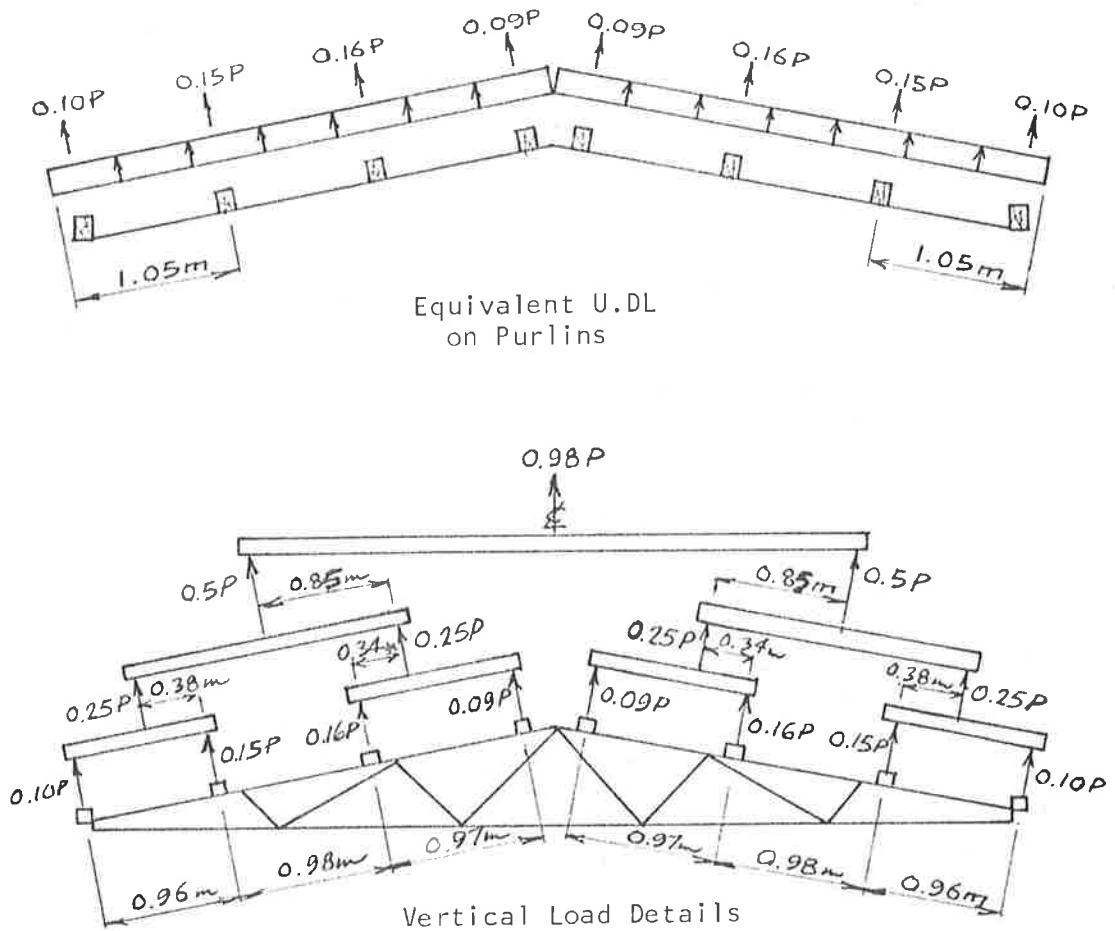
Figure 3.9

Vertical Load Details

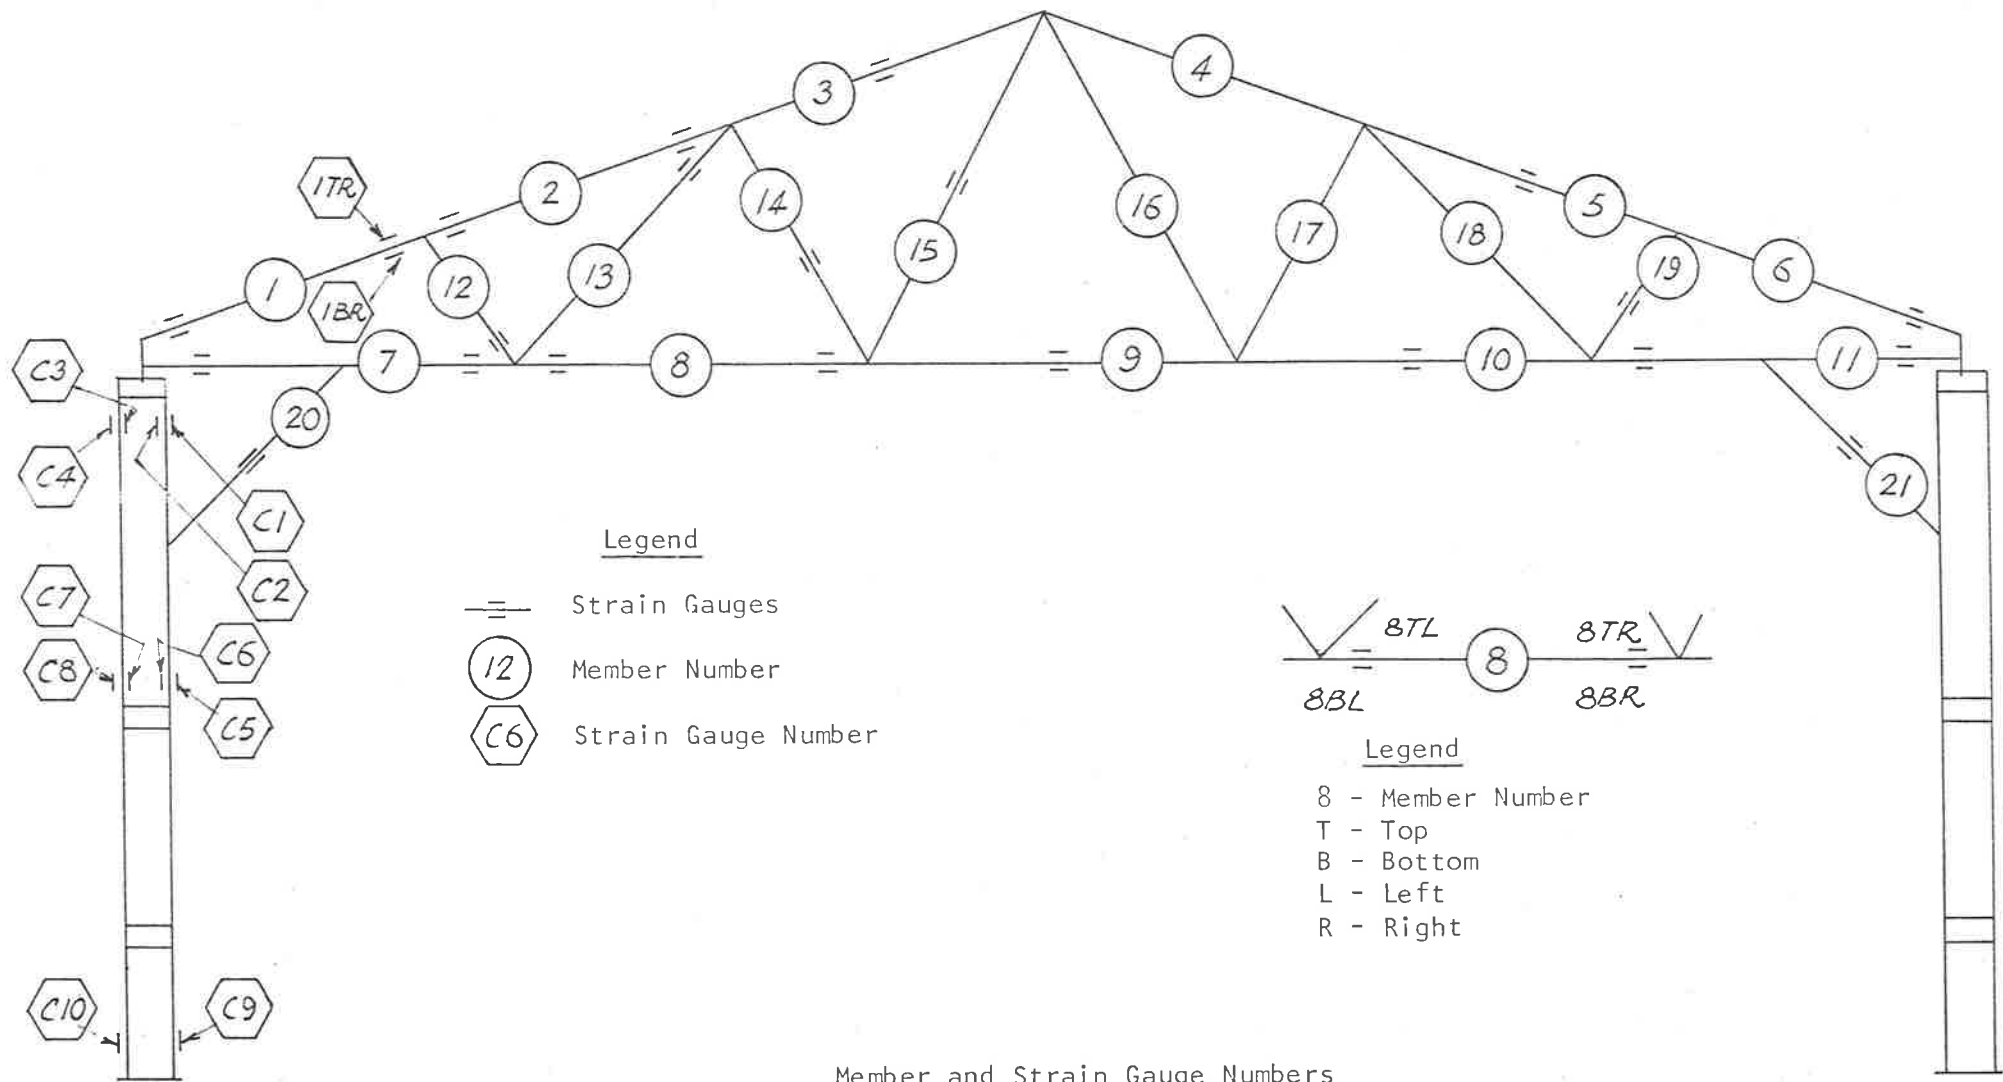
Figure 3.10

Member and Strain Gauge Numbers

Kyowa KFC-5-C1-11, 120 ohm resistance strain gauges were stuck to the frame members on the two opposing faces, top and bottom, on the centreline longitudinal axis.

The strain gauges were concentrated about the truss-column joint, since this was the critical area. Other gauges were placed on the frame in positions which could be used to monitor the general frame behaviour. In total, fifty-four
