**THE RELATIONSHIP BETWEEN
SEDIMENTATION ON ALDINGA REEF,
AND WASHPOOL CREEK
AND SELLICKS CREEK CATCHMENTS,
WILLUNGA BASIN**

Submitted in partial fulfilment of the requirements for the degree of
Bachelor of Arts with Honours in Geography

Department of Geography
University of Adelaide

November 1995

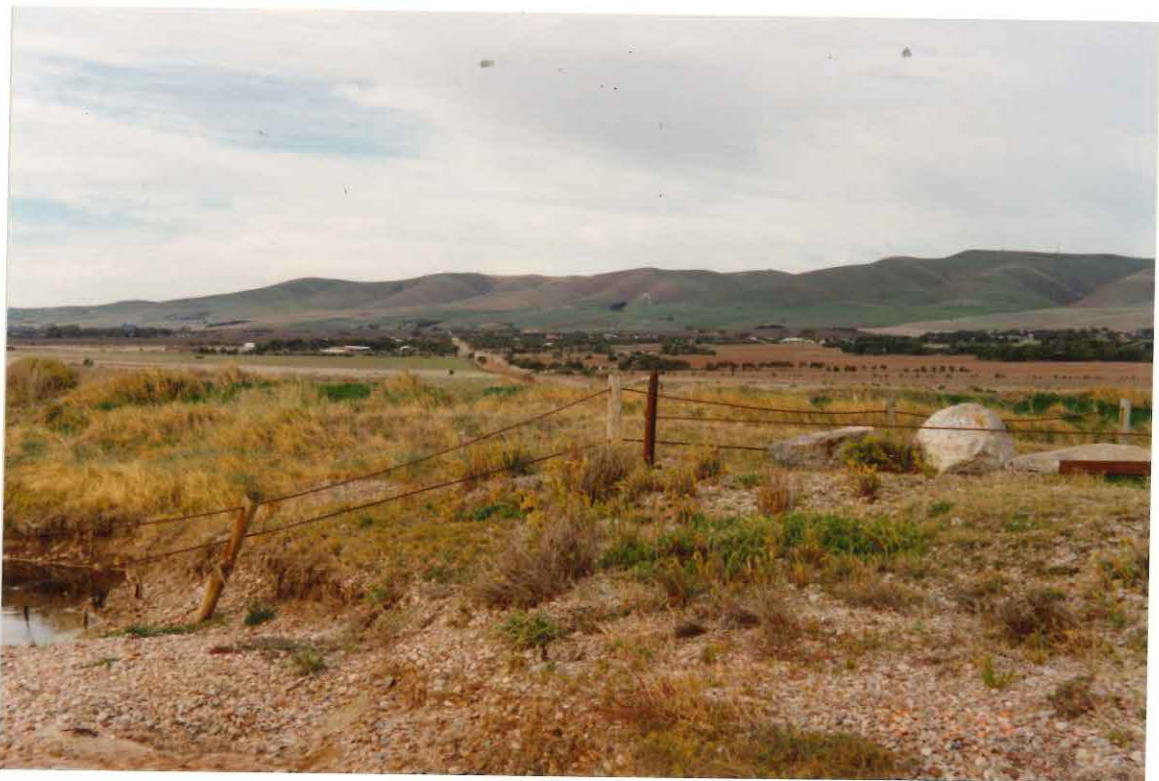
Plate 1: Sellicks Hill Range.

Note the distinct lack of native vegetation, especially trees.

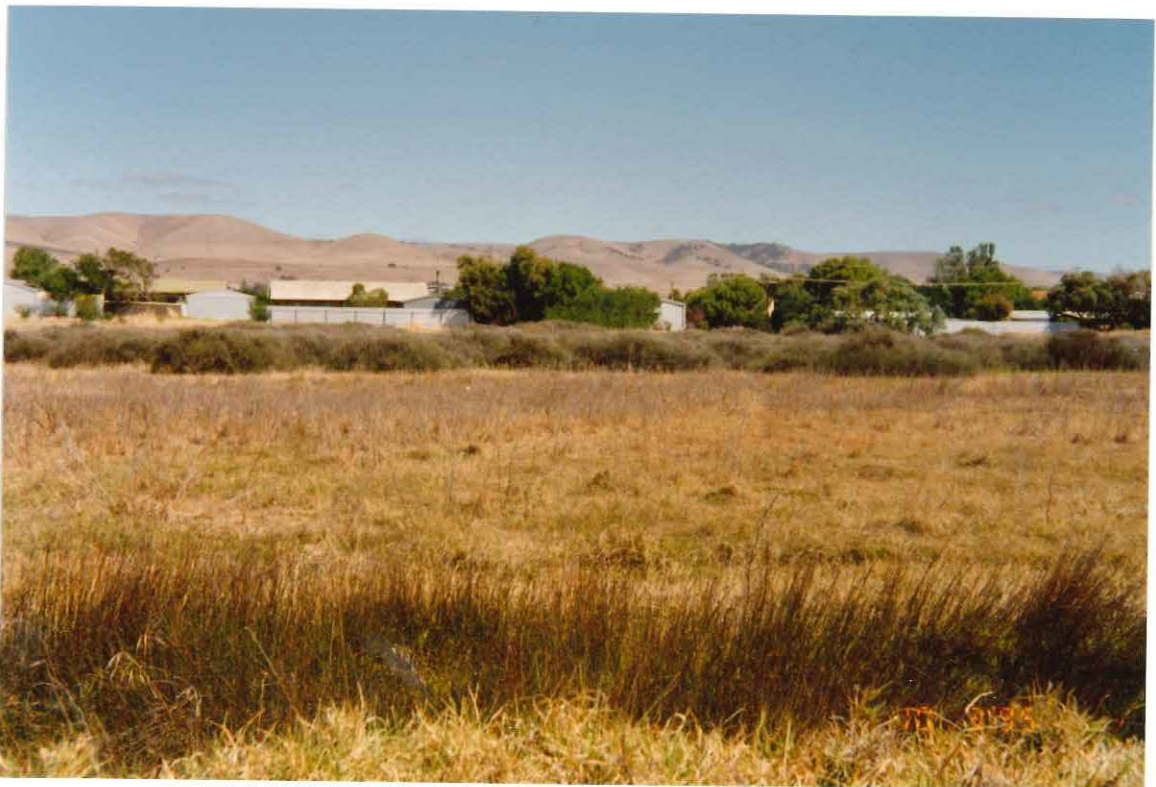
Plate 3: Blue Lagoon.
The patch of Tangled Lignum growing in the centre of the photograph marks the site of Blue Lagoon.
Source: author.

Washpool Creek catchment contains three prominent features which differentiate it from Sellicks Creek catchment. This includes the stand of remnant native vegetation, Aldinga Scrub, and the swampy sites of Washpool Lagoon and Blue Lagoon (Figure 2 and Plates 2, 3 & 4).

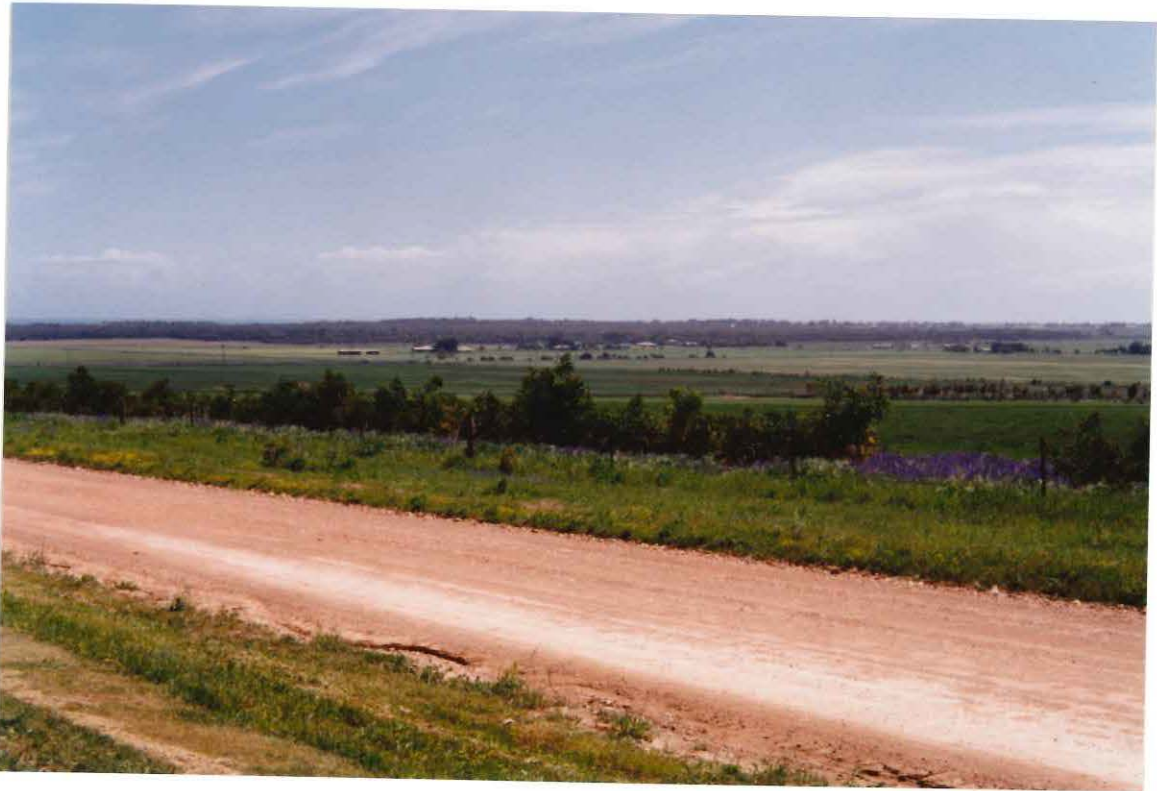
Plate 4: Aldinga Scrub.

From the foothills, Aldinga Scrub is the only patch of remnant native vegetation evident in the study area.

Aldinga Scrub (now preserved as a conservation park), is near the coast south of Aldinga Beach and comprises some 250 hectares (Nurton, 1991: 3). It is an 'ecologically unique area' as it contains the 'last remnant of native coastal scrubland along the greater Adelaide coastline and [is] the only example of coastal scrubland of its type which still exists in the world' (Kinhill Engineers, 1994: 1). The coastal scrubland is also known for its 'boggy nature' (Nurton, 1990: 2). Prior to European settlement, groundwater levels in the Conservation Park were higher 'as the park . . . was subject to inundation in the north eastern, eastern and southern sections for periods of up to six months each year' (Nurton, 1990: 4). As a result the scrub supported a vegetation community common to wetter environments including *Muehlenbeckia cunninghamii* (Tangled Lignum), a species commonly found in the low-lying areas in the Murray-Darling Basin; *Dipodium punctatum* (Hyacinth Orchid); *Ophioglossum lusitanicum* (Adder's Tongue); and *Cladia retipora* (Lacy Coral Lichen), a species rare to South Australia (Nurton, 1990: 6).

While these and other species are still present within the Conservation Park there is evidence that suggests that Aldinga Scrub is drying out. Such evidence includes the dieback of large gums, and increases in salinity levels. In the swamp areas the extent of stands of Bullrush (*Typha domingensis*) and Common Reed (*Phragmites australis*) have apparently declined. Much of this 'drying out' of the scrub is due to changes in groundwater regimes associated with the draining of the catchment and of Washpool and Blue Lagoons in the 1950s, and increases in the number of bores used for agriculture, both of which are having the effect of lowering the watertable (Nurton, 1990: 4). As a consequence, it is not known whether 'the vegetation . . . [is] in transition from one dependent on, or at least supplemented by, high groundwater levels to one suited to drier circumstances' (Nurton, 1990: 3).

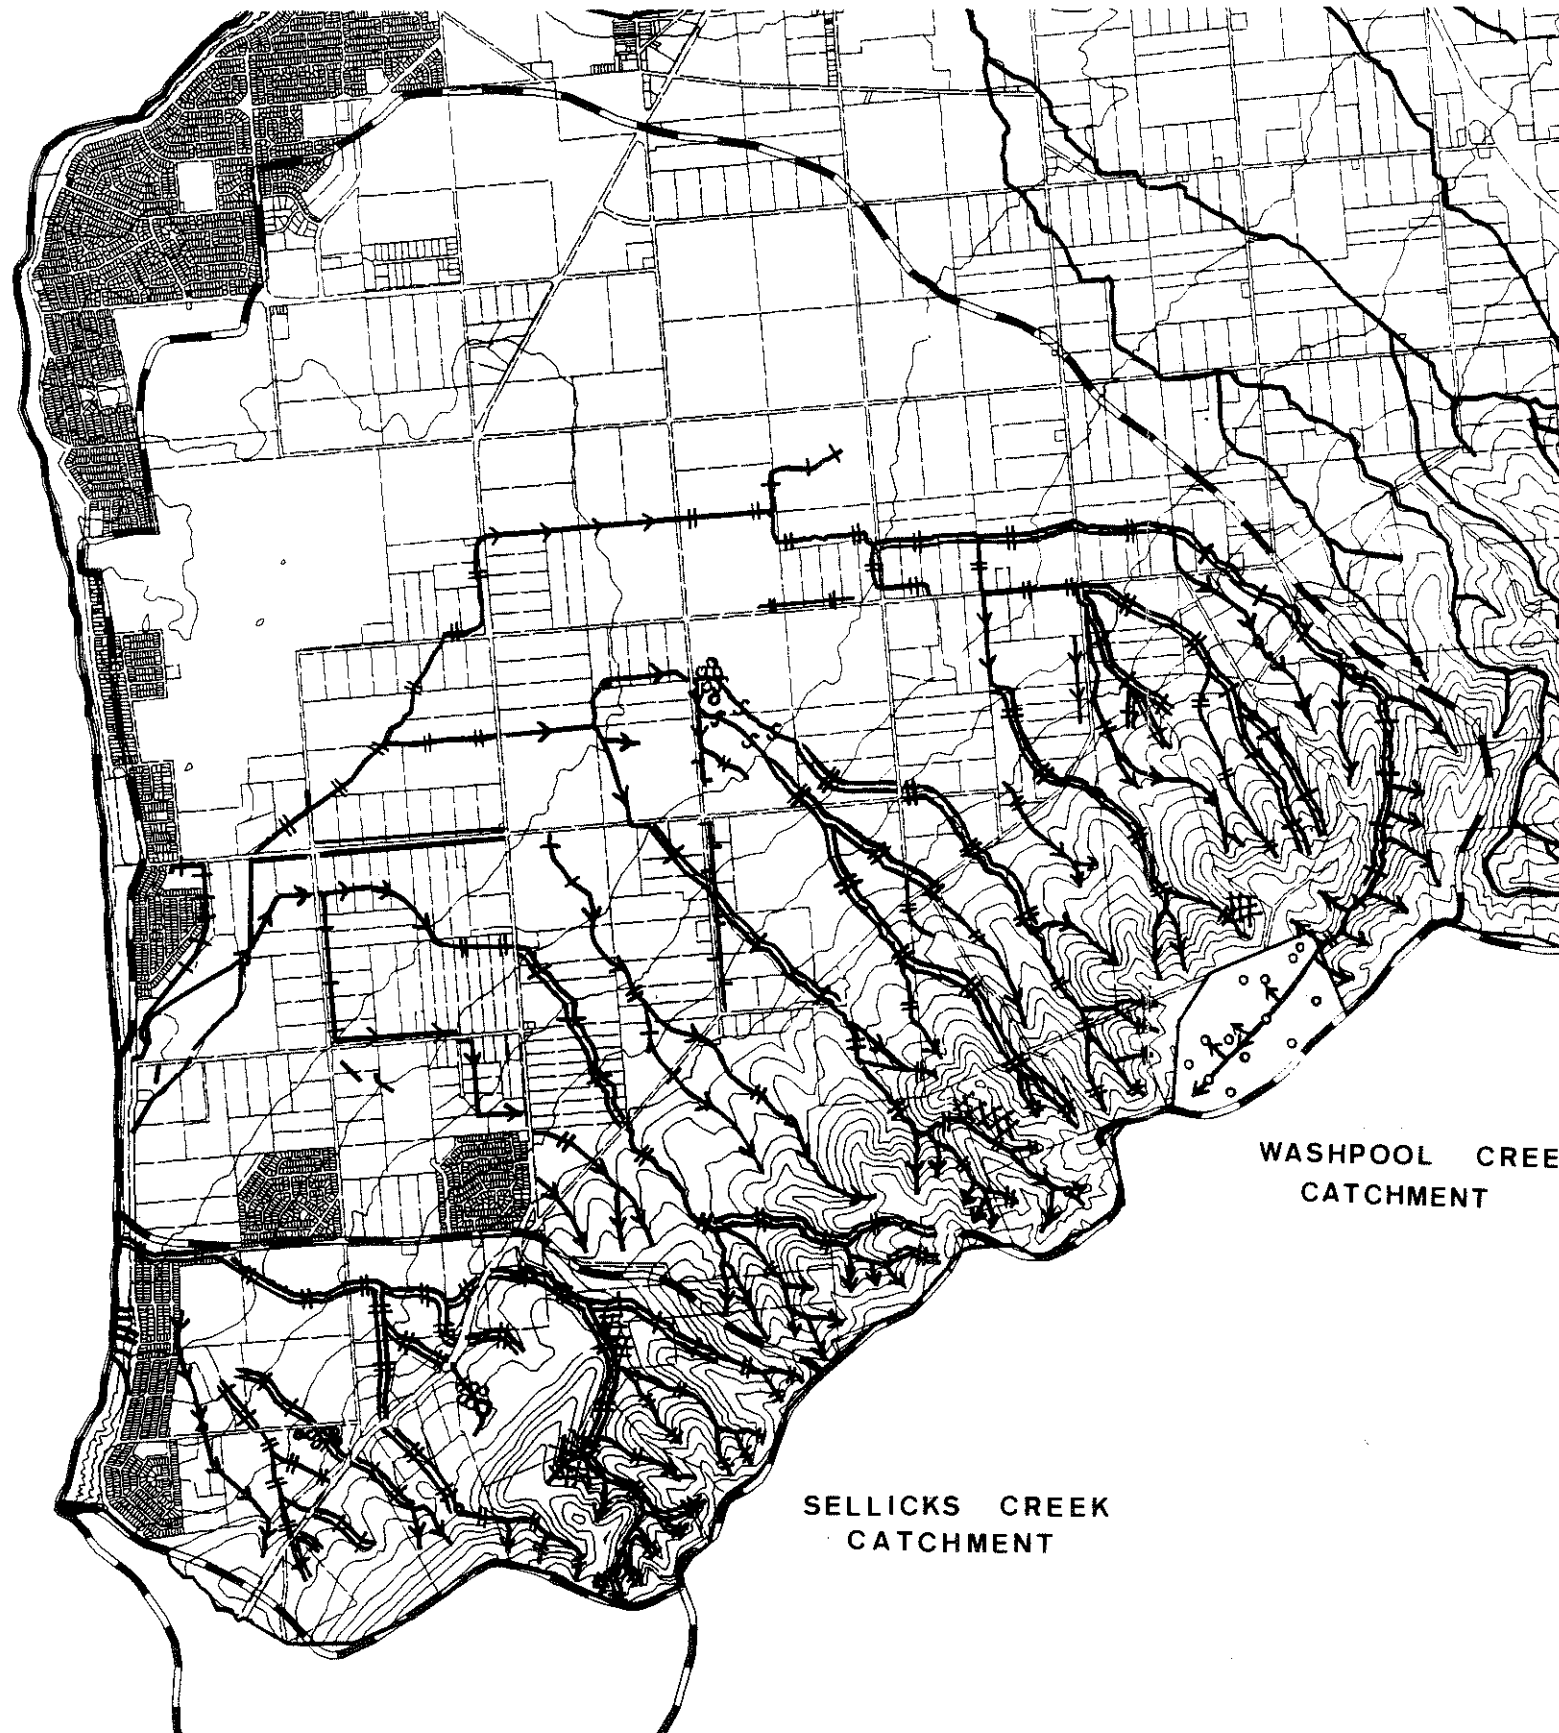
**Figure 8: Drainage in Washpool
Creek and Sellicks Creek
catchments.**
Source: author.

Drainage in Sellicks Creek catchment is centred mainly around Sellicks Creek gully (Figure 8). There are very few shallow watercourses in this catchment, least of all in the lower elevations close to the Gulf. Tunnel erosion is a feature of this catchment which helps explain the deeply incised watercourses at their origin (Plate 10). Such erosion originates in the steep slopes of Sellicks Hill Range.

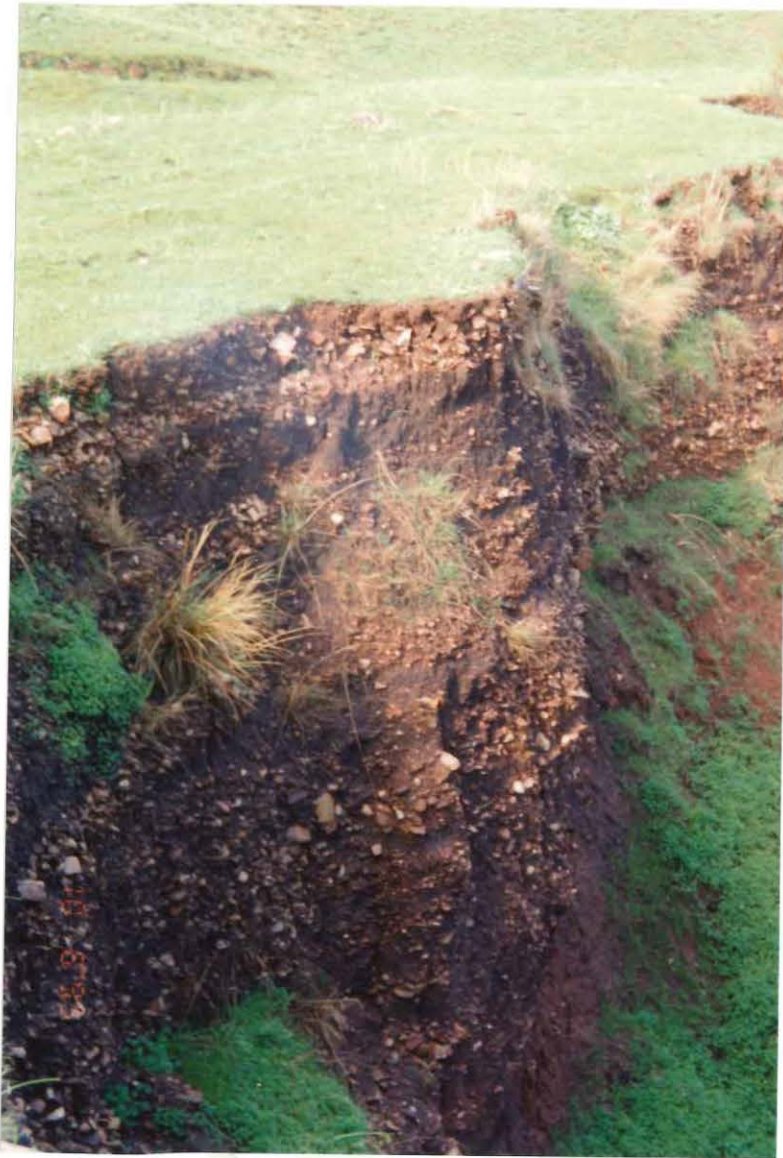
Plate 6a: Soil profile of the gully at Site A.

The presence of stones in the soil profile is an indicator of the soil's unconsolidated nature.

the soil structure, making the gully at this location more susceptible to soil erosion (Plates 6a, 6b & 6c).

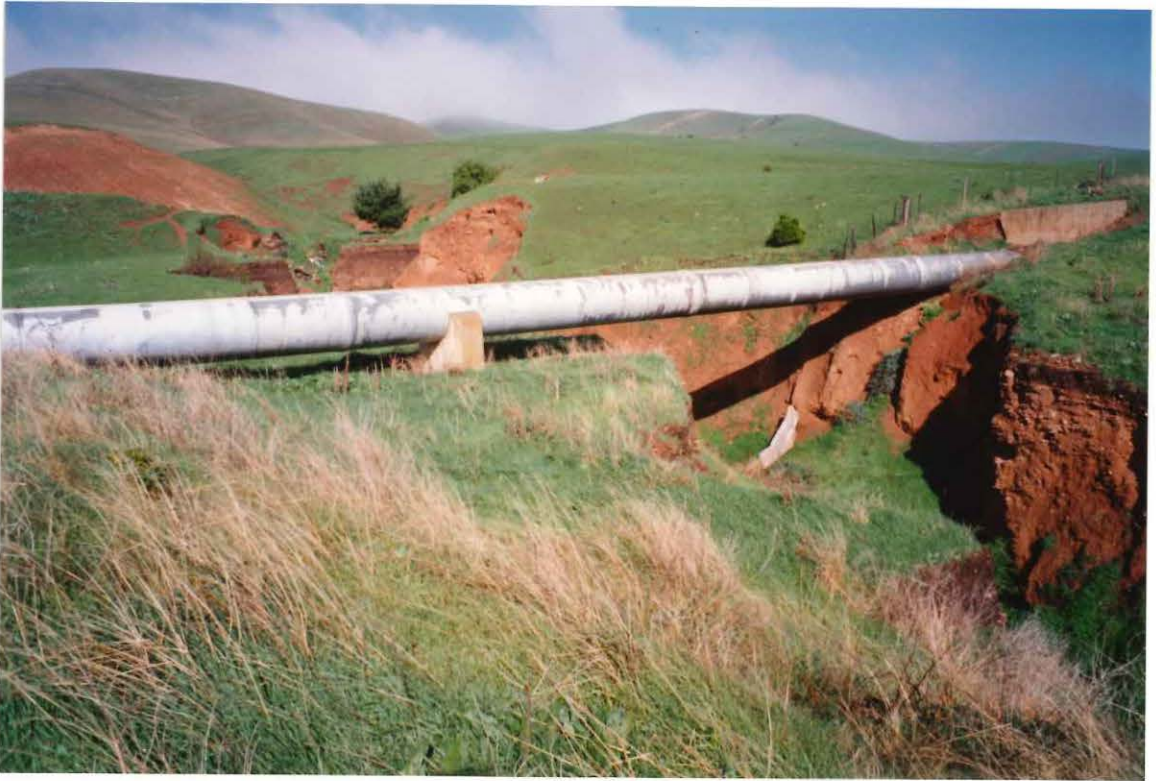
Plate 6b: The Myponga-Adelaide pipeline at Site A.
Source: author.

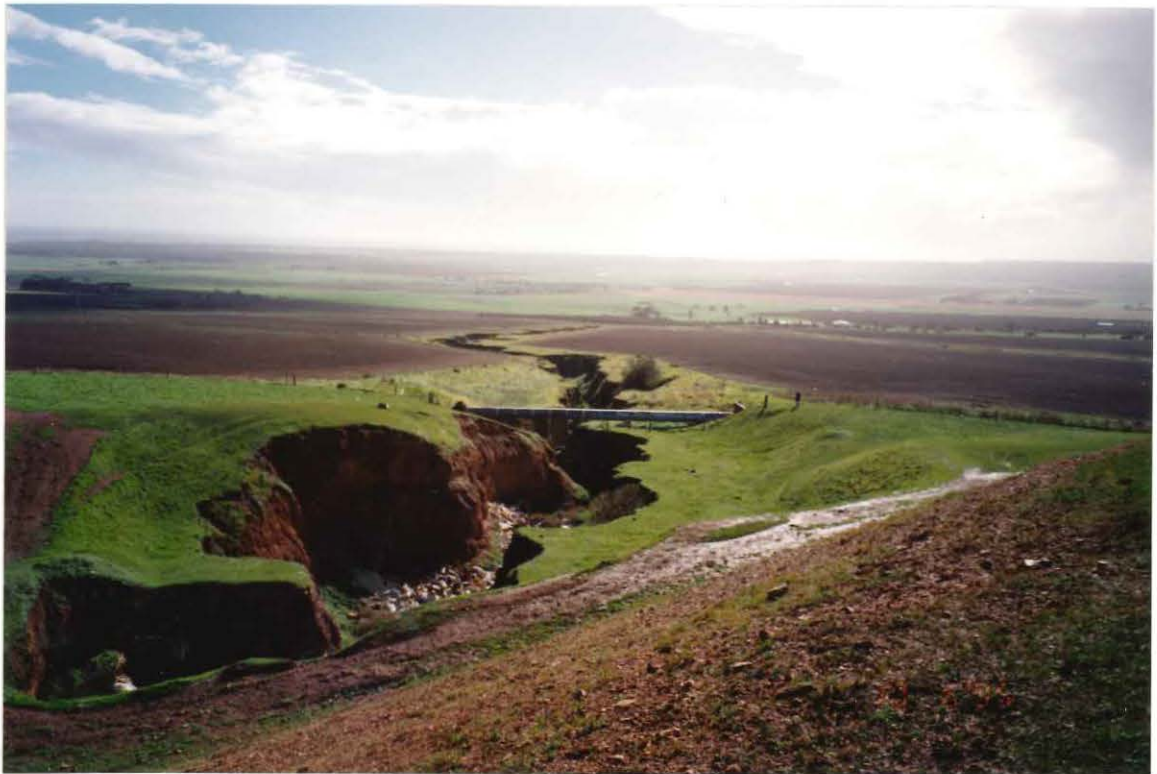
Plate 6c: The Site A gully in Washpool Creek catchment.
Note dumping of rubbish in the base of the gully.
Source: author.

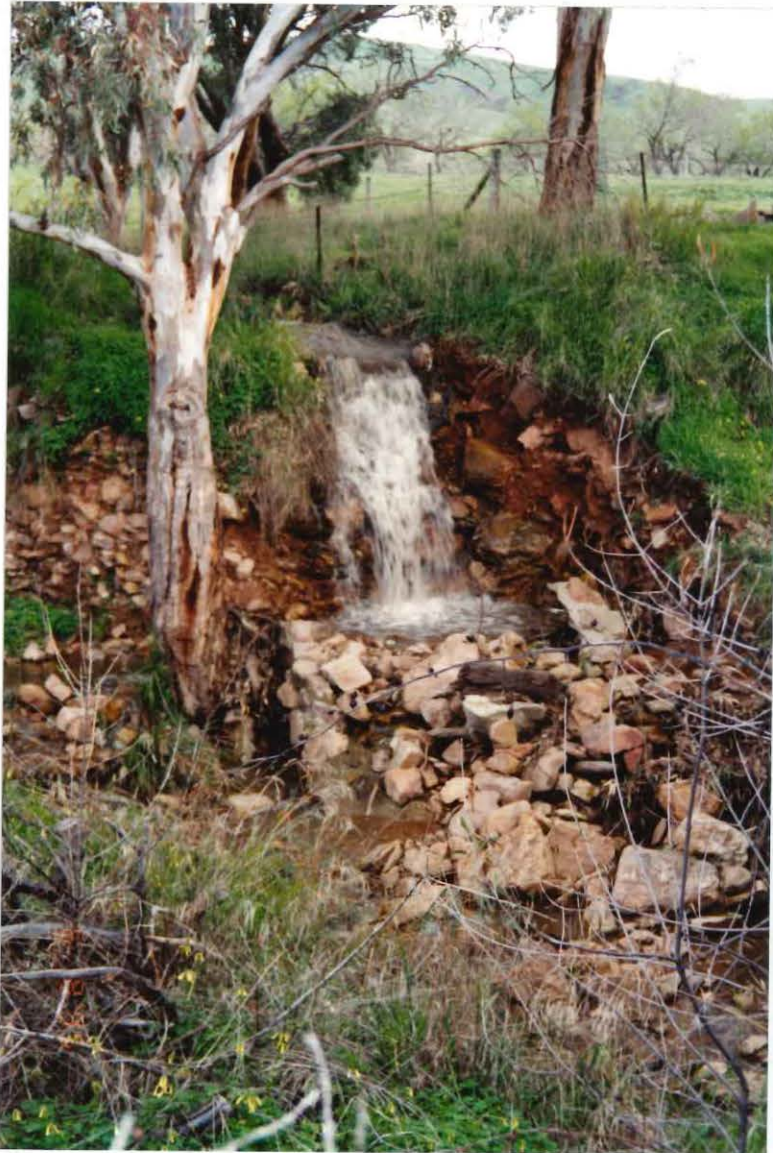
Plate 7a: The waterfall and plunge pool of the northern most drain at Site B(ii).
Source: author.

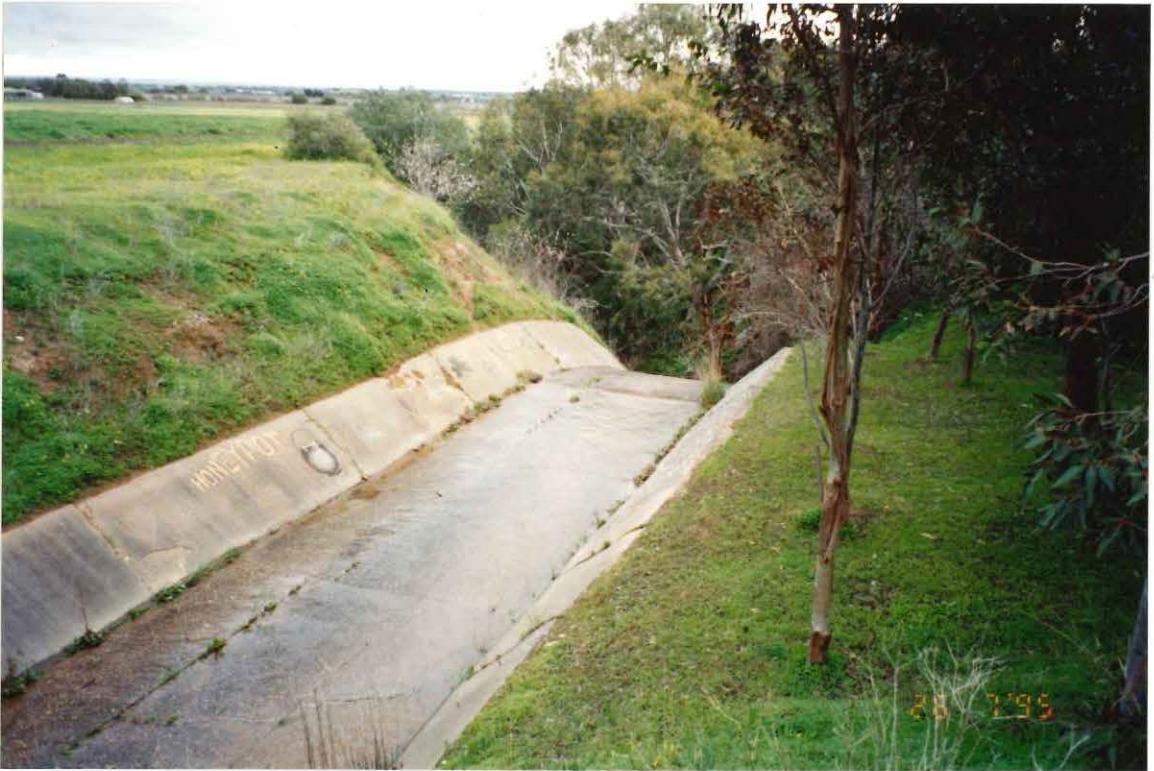
Plate 7b: A large culvert intersected by Ryan Road at Site B(iii), Washpool Creek catchment.

This culvert is an indication of the width and depth of drains found in this catchment.
Source: author.

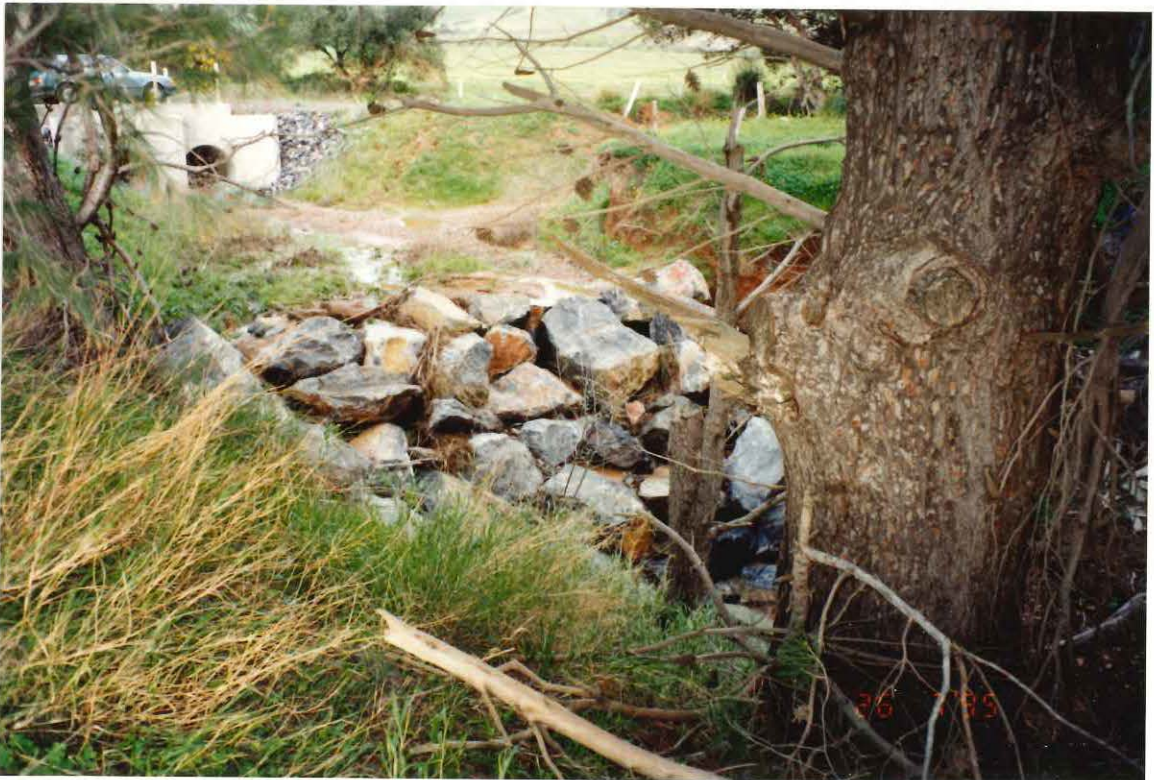
Plate 8: The Hahn Road gully, Site C.

The majority of water in this gully flows through the culvert in the top left of the photo. At the centre right another gully coming from the south joins the main gully. Past the point of the rocks the gully evolves into a narrower, yet still a very deep gully.

The drain immediately to the south of this, which runs along Hahn Road, can also carry considerable volumes of water. The drain displays gully features and at Site C (Figure 9), a large culvert and junction further illustrate past high discharge events (Plate 8). Large rocks have been placed at the nickpoint of this site in an attempt to reduce further headward cutting of the gully.

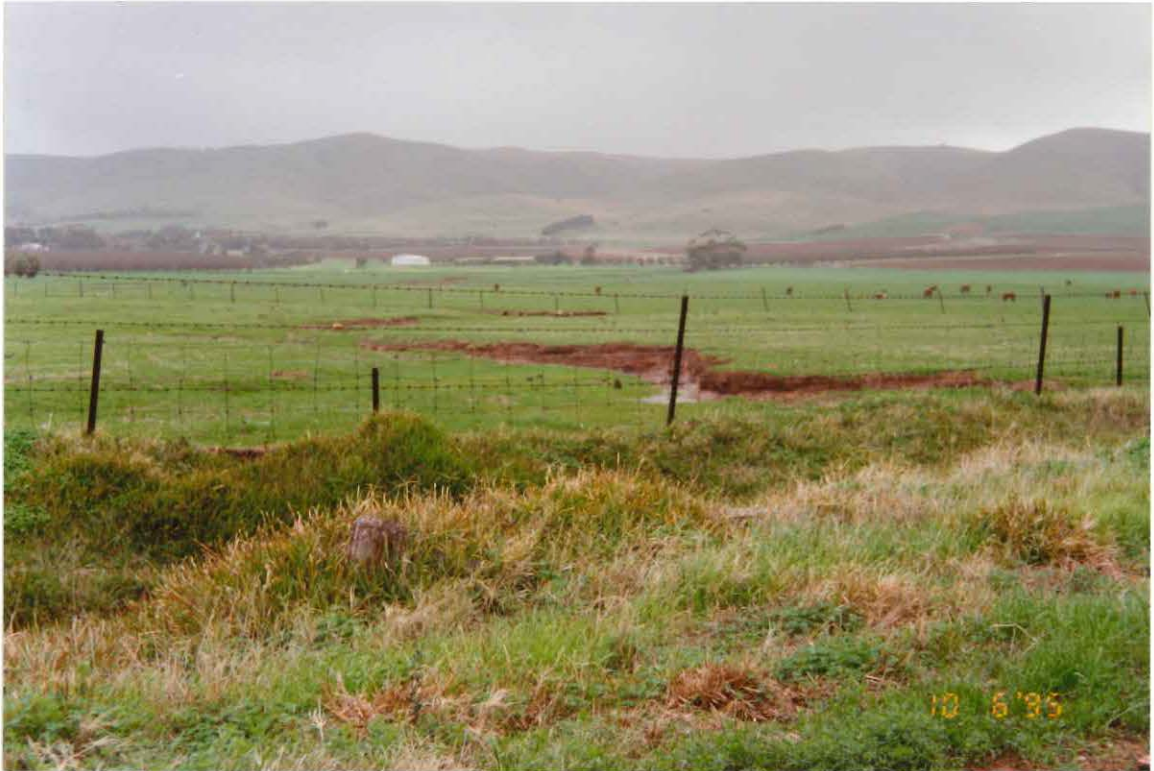
Plate 9: A possible fluvial flood channel along Plains Road, Site D.

The meandering and shallow nature of the channel is characteristic of water flow when it reaches gentler slopes which reduce the velocity of the flow.

These examples provide an indication of the velocity of streamflow and the erosive powers of water flowing down these streams. While these examples are of more active forces of erosion, there are other examples in the catchment of lower energy processes of sedimentation, such as the flood channel along Plains Road at Site D on Figure 8 (Plate 9).

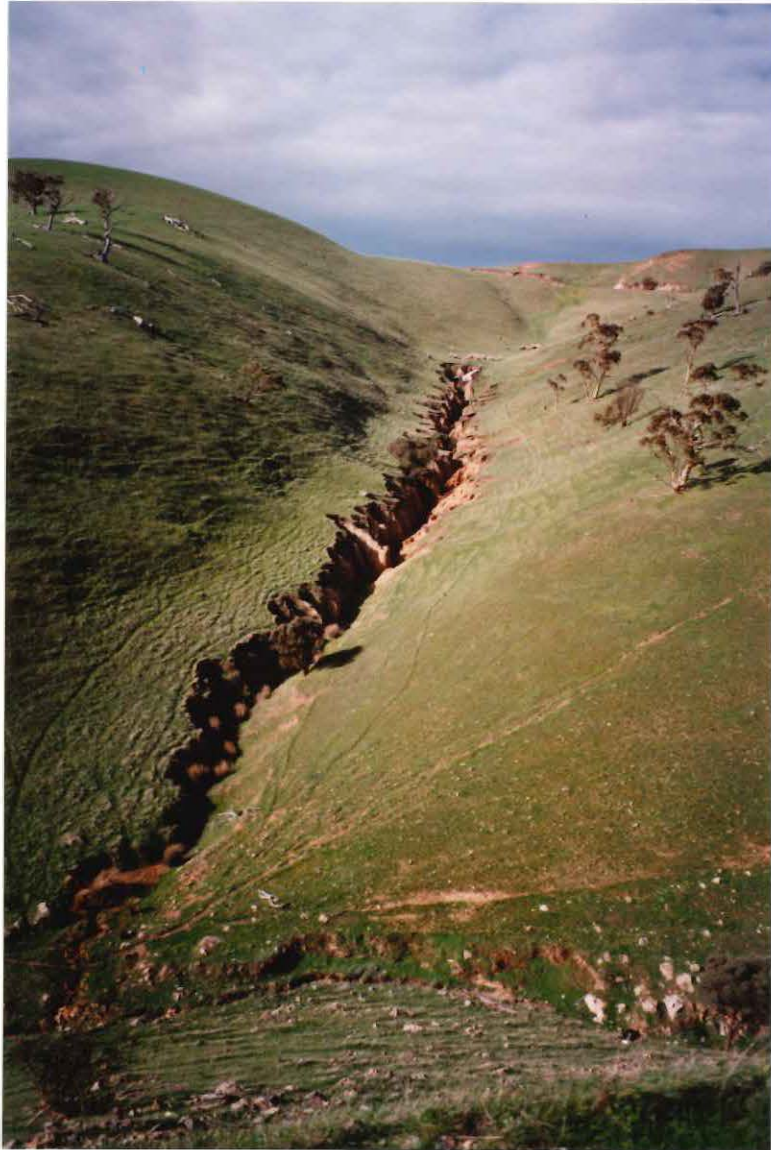
Plate 10: A deeply incised channel common in Sellicks Hill Range
Source: author.

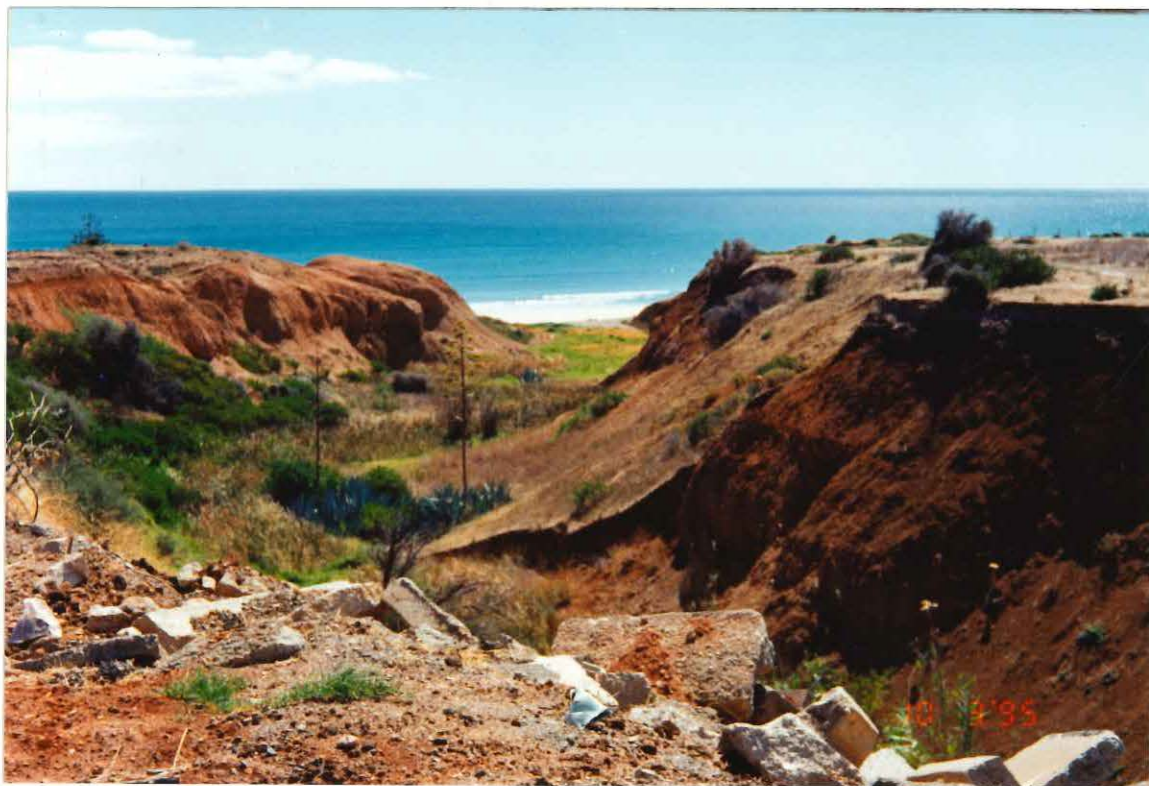
Plate 11a: Sellicks Creek Gully at its mouth.

It is a very large and dynamic feature which has evolved from severe environmental degradation.

Sellicks Creek gully is a very prominent feature in both catchments, and is visually intrusive. It is the longest drain in the catchment and transports the greatest volumes of water of any of the other drains. At its mouth, where it empties into the Gulf of St. Vincent, it measures approximately fifteen metres across and fifteen metres deep (Plate 11a). In the section of the gully between the coast and Justs Road, it has deep vertical walls. A cross-section of the gully walls at Site E (Figure 9) displays the soil layers which may reveal the sedimentary history of this catchment (Plate 11b).

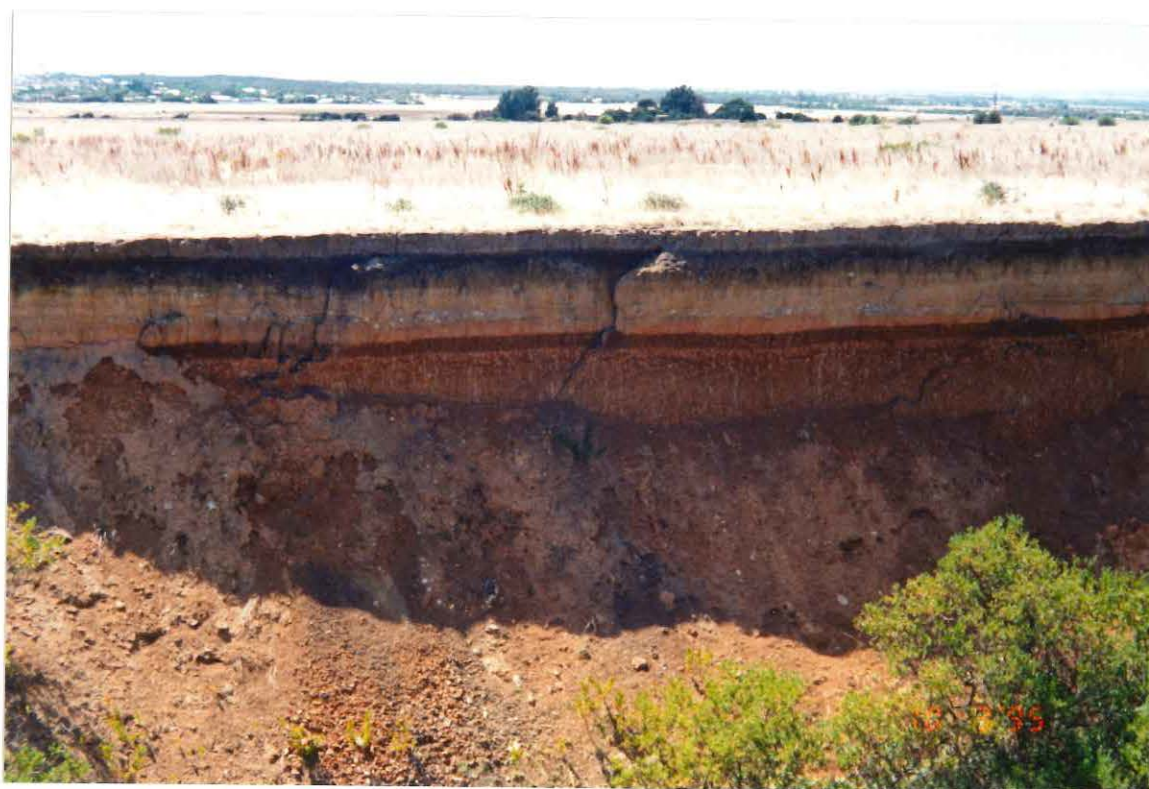
Plate 11b: The soil profile of Sellicks Creek Gully at Site E.

Distinct soil horizons are evident from the photograph.

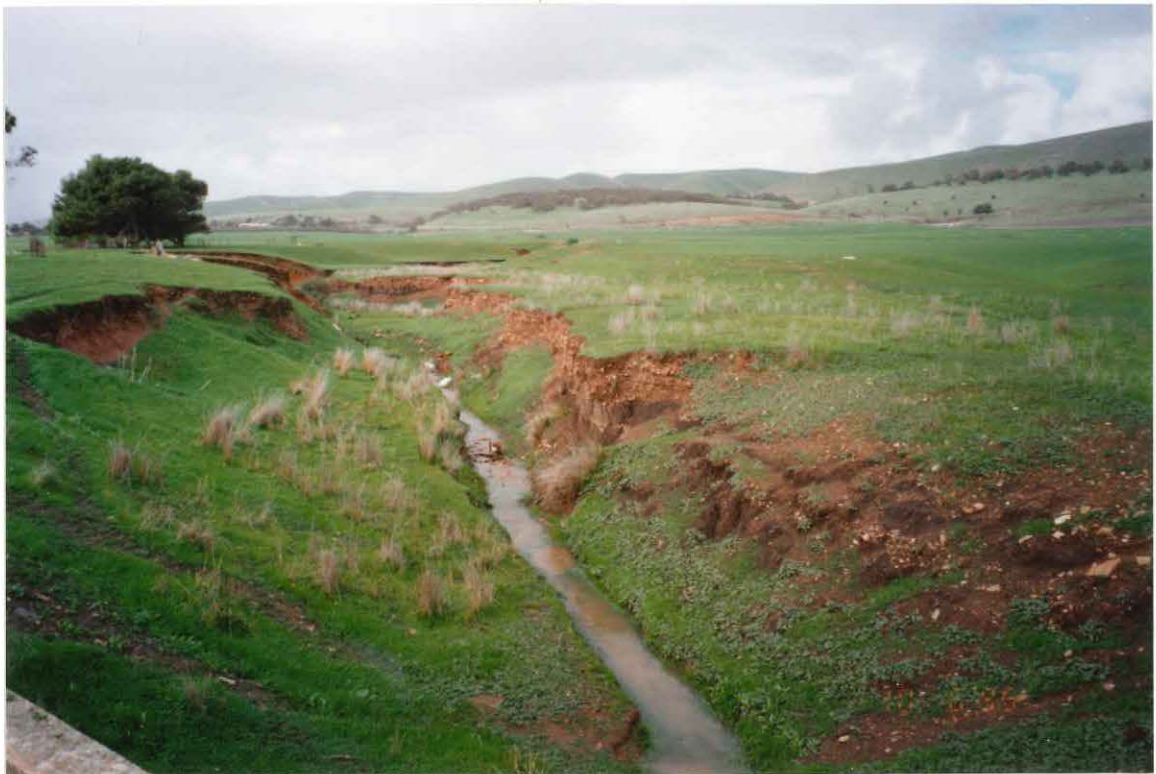
Plate 12a: Sellicks Creek Gully upstream of Justs Road at Site F.
Source: author.

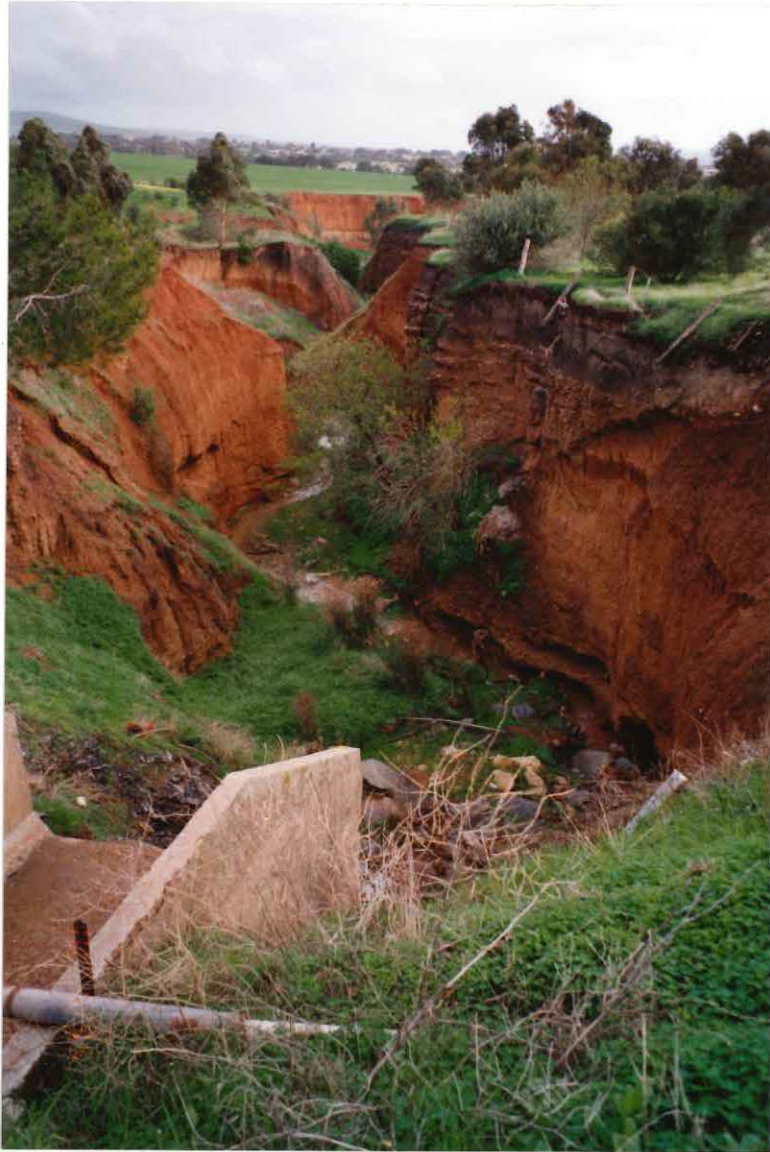
Plate 12b: Sellicks Creek Gully downstream of Justs Road at Site F.

There is a dramatic contrast on either side of Justs Road. Note the fence line in the top right: severe erosion of this gully has occurred during the time of European occupation. Rocks and other rubbish have been dumped at the base of the gully in an attempt to slow down erosion; possibly a futile attempt.

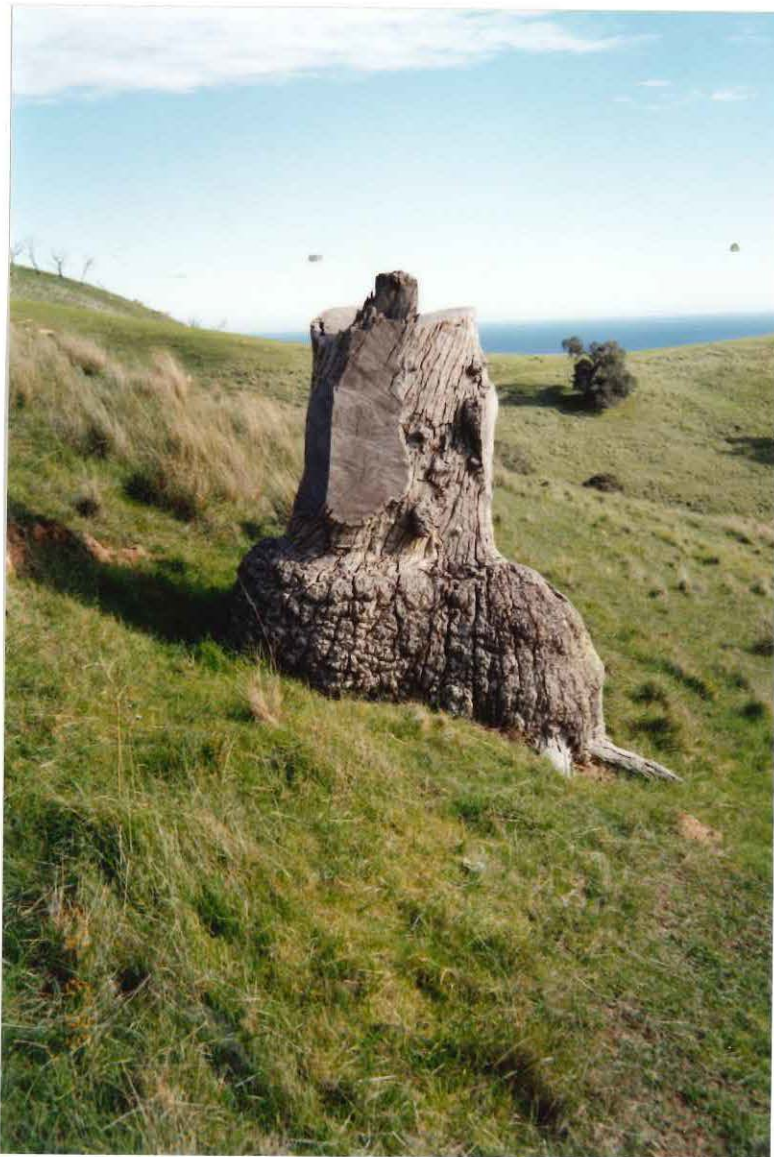
Plate 13: Tree stump on Sellicks Hill Range at Site G.

Note the amount of soil which has eroded away from the crown of the stump.

A number of features in this catchment, such as Sites G and H (Figure 9), have been recognised as useful indicators of sediment erosion and deposition. At Site G an exposed crown of a tree stump found on Sellicks Hill Range along Old Sellicks Hill Road illustrates how much sediment has been eroded from the hillslope in the lifetime of the tree but more so after it was chopped (Plate 13). While the life of the tree and the time at which erosion began could not be established, it is evident that some 30 cm of soil has been eroded from this

hillslope, at this particular location. Site H is representative of sediment deposition, occurring in the gentler slopes of the catchment where streamflow velocity has slowed (Plate 14). At this site a new fence replaces one which has been buried by sediment. Up to 30 cm of the old fence still shows, however, another one metre of the fence is buried. This buried fence, which has only been constructed since European occupation of the region, is indicative of how much sediment has been deposited at this site in a given time. The road which crosses this watercourse acts as an obstruction to the flow of sediment, contributing to the build up of sediment on the upstream side, and the erosion of sediment below it.

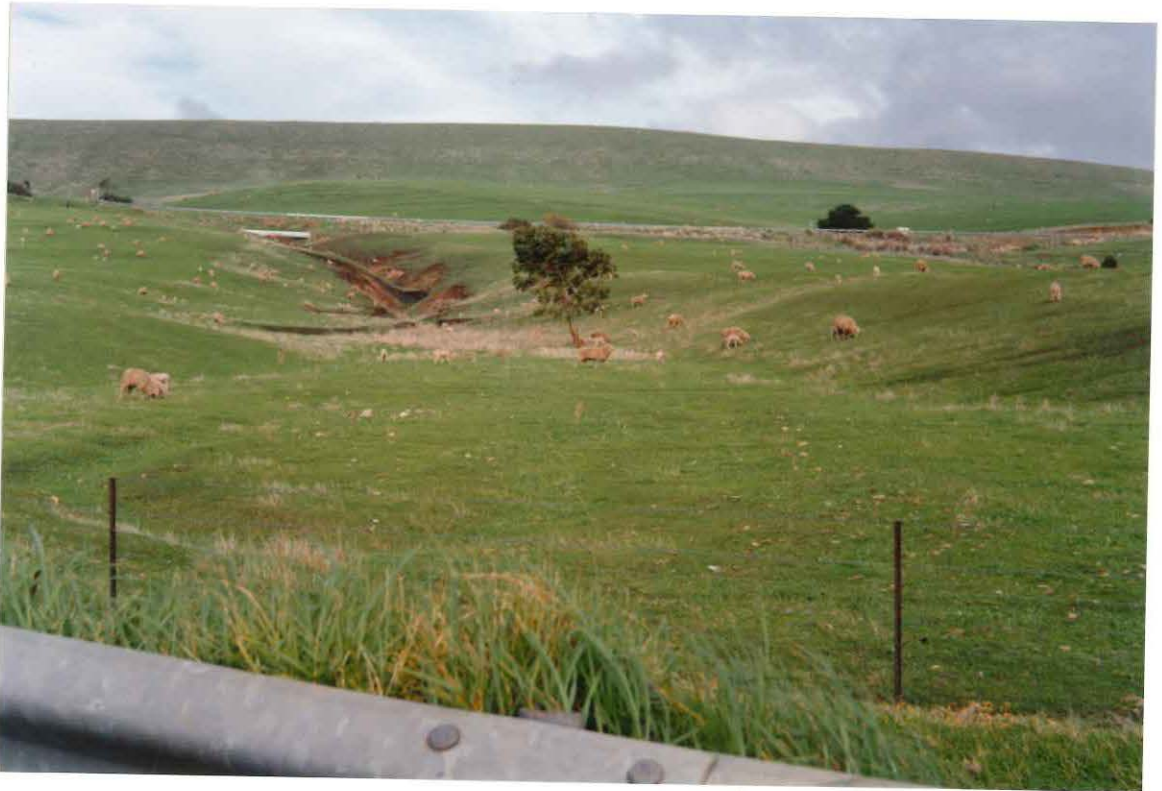
Plate 14: Sediment aggradation in Sellicks Creek catchment at Site H.

While not shown in this photograph, an old fence line was buried at this site due to the aggradation of sediment.

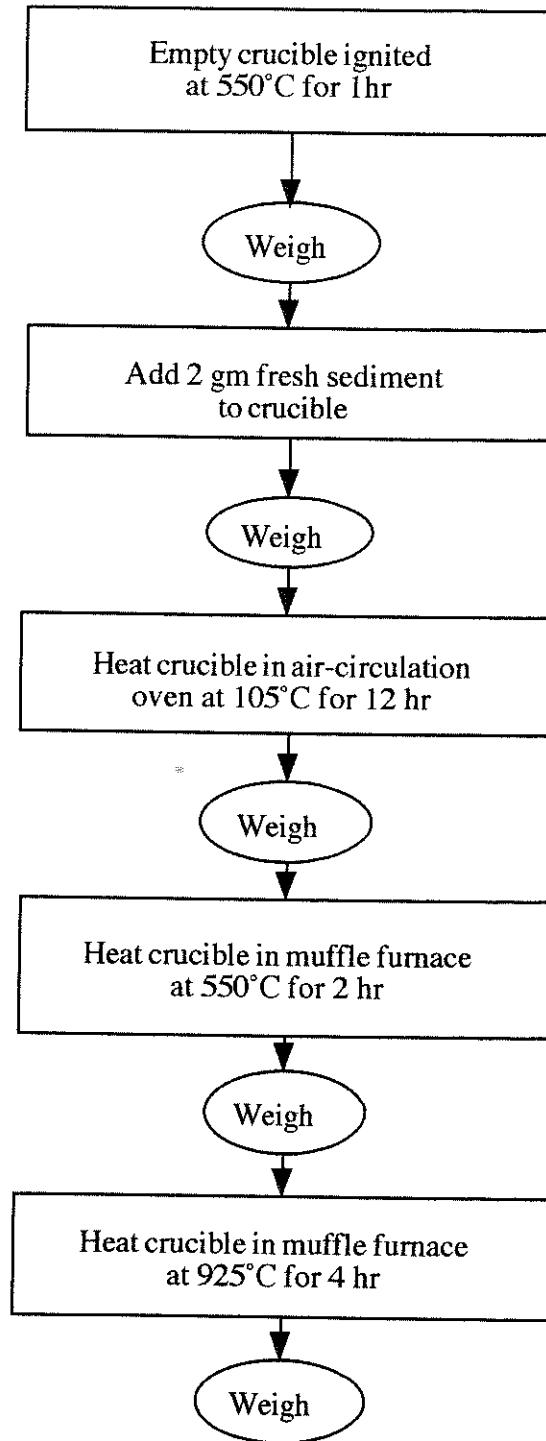
Figure 10: Procedures followed for preparation of samples for dry weight, loss on ignition and carbonate analysis.

A total of 34 samples were extracted from the core to determine the moisture, organic and carbonate contents. Samples were taken from the core at every half centimetre for the first ten centimetres, and every one centimetre thereafter. Dry weight, loss on ignition (LOI) and carbonate content were determined following the methods and calculations described by Bengtsson and Enell (1986: 425-428) (Figure 10).

Porcelain crucibles of a known weight were placed in a muffle furnace heated to 550°C for 1 hour to dry, after which they were cooled to room temperature. Fresh samples of approximately 2 gm were added to the crucibles and weighed. The crucibles were placed in an air-circulation oven at 105°C and dried for about 12 hours. After cooling the samples and crucibles in a desiccator, the weight of the dry sample and crucible was determined. From the dry weight of each sample, moisture content could then be calculated for the length of the core.

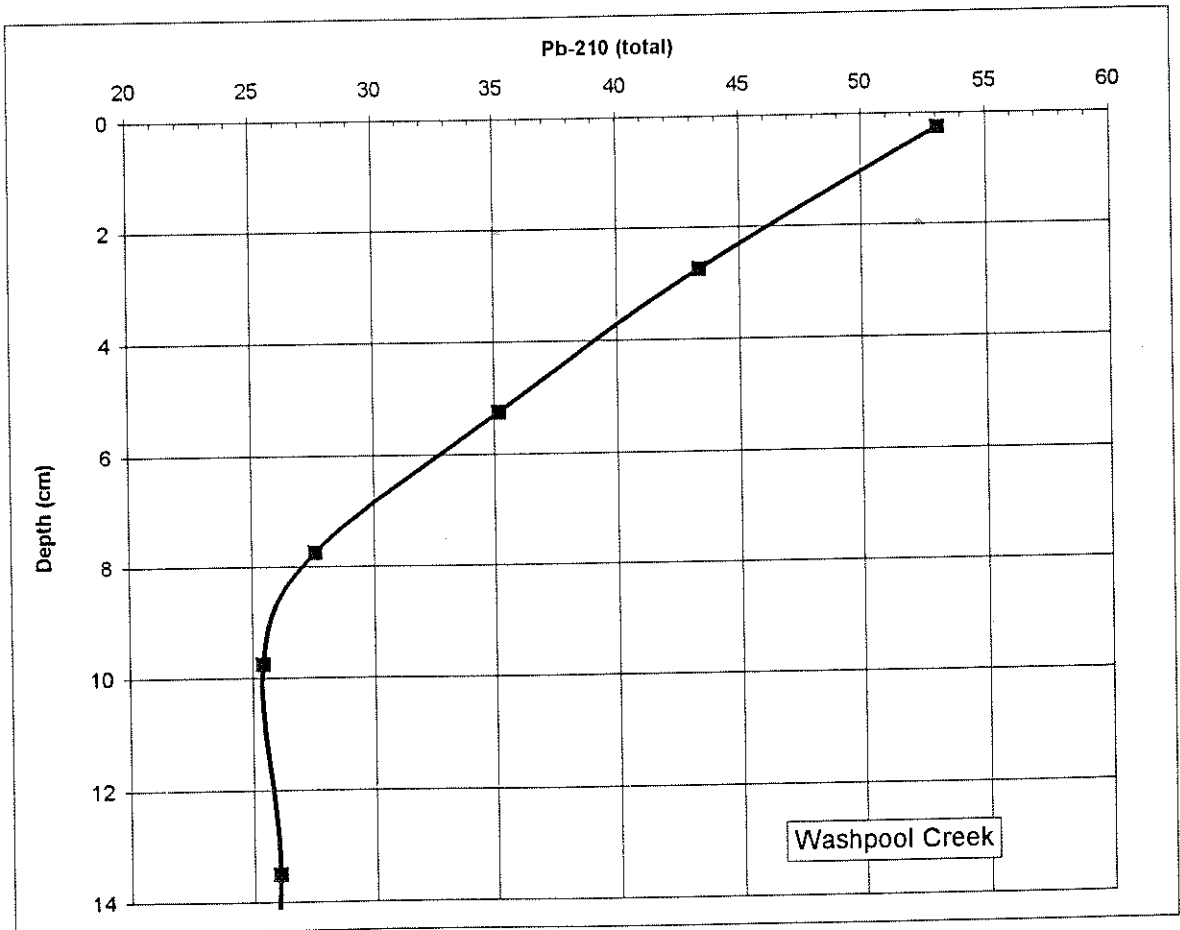
Figure 15: Age accumulation curve of Washpool Lagoon sediment core.

Note: the ages are calculated using interpolations and the Constant Rate of Supply model. Do not push them too far.

years. Inventory and ages for the curve were calculated using the constant rate of supply model (CRS) and was interpolated at 0.5 cm.
