ENVIRONMENTAL HISTORY OF
THE WILLUNGA BASIN
1830s to 1990s

Submitted in partial fulfilment of the requirements
for the degree of Bachelor of Arts in Honours Geography

Department of Geography
University of Adelaide
November 1994

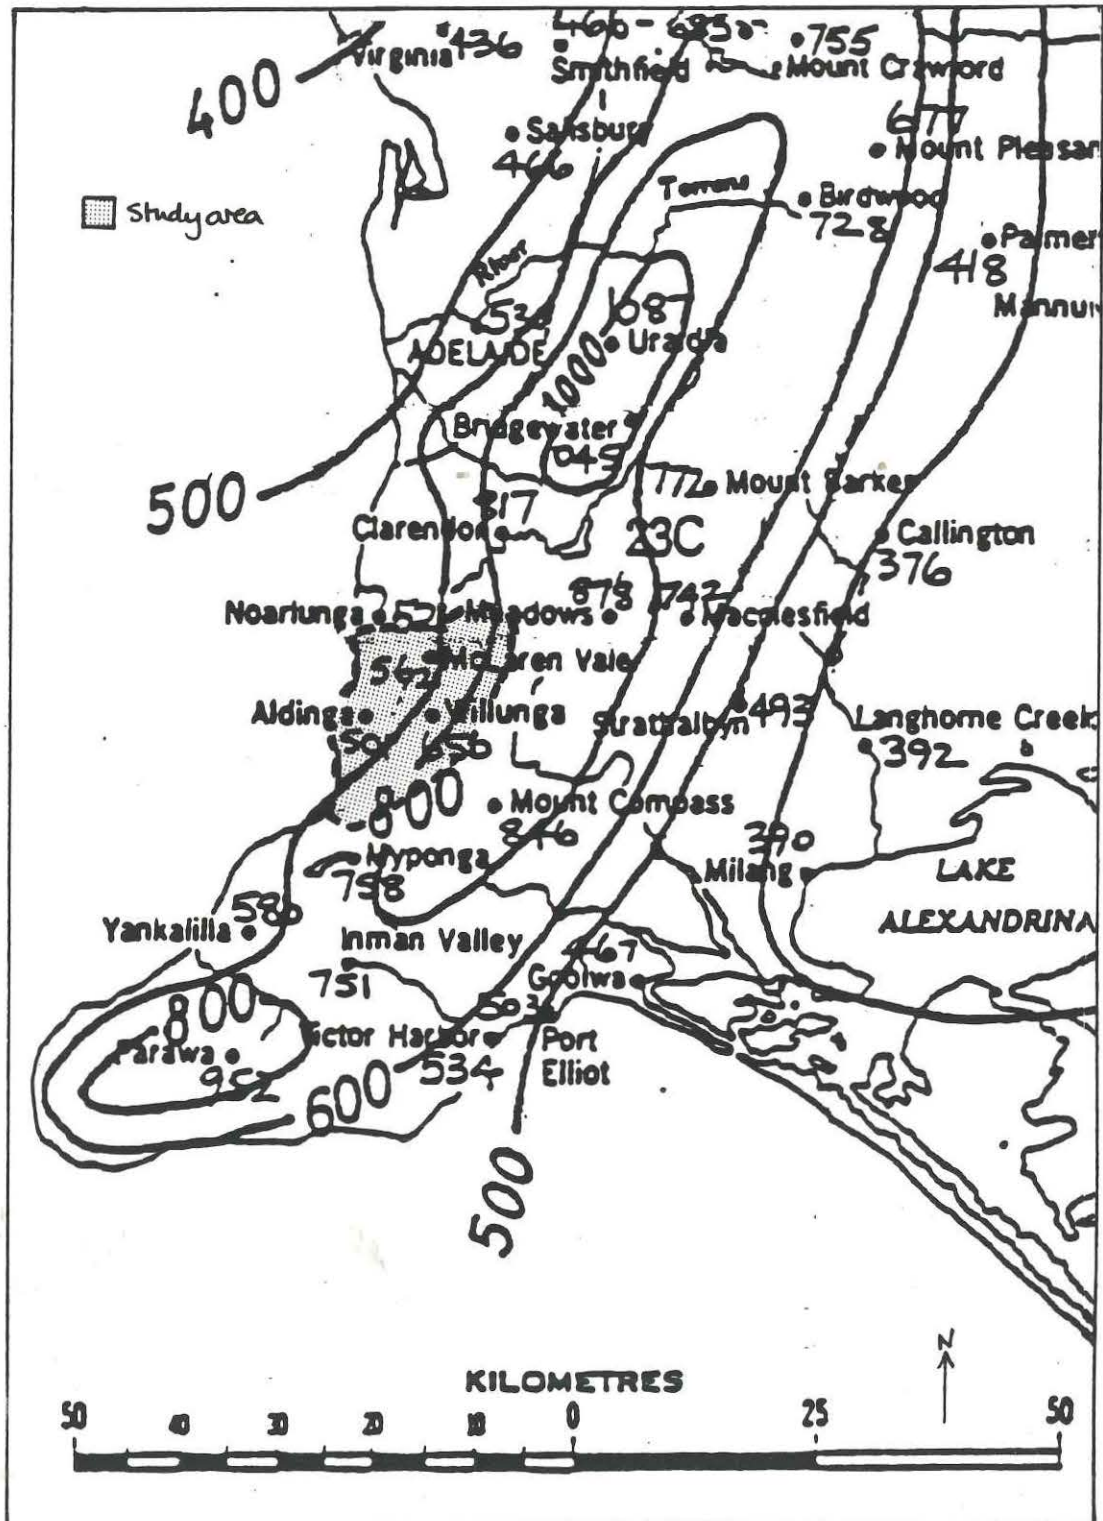
Figure 9

Surface drainage and catchment boundaries in the Willunga Basin 1992.

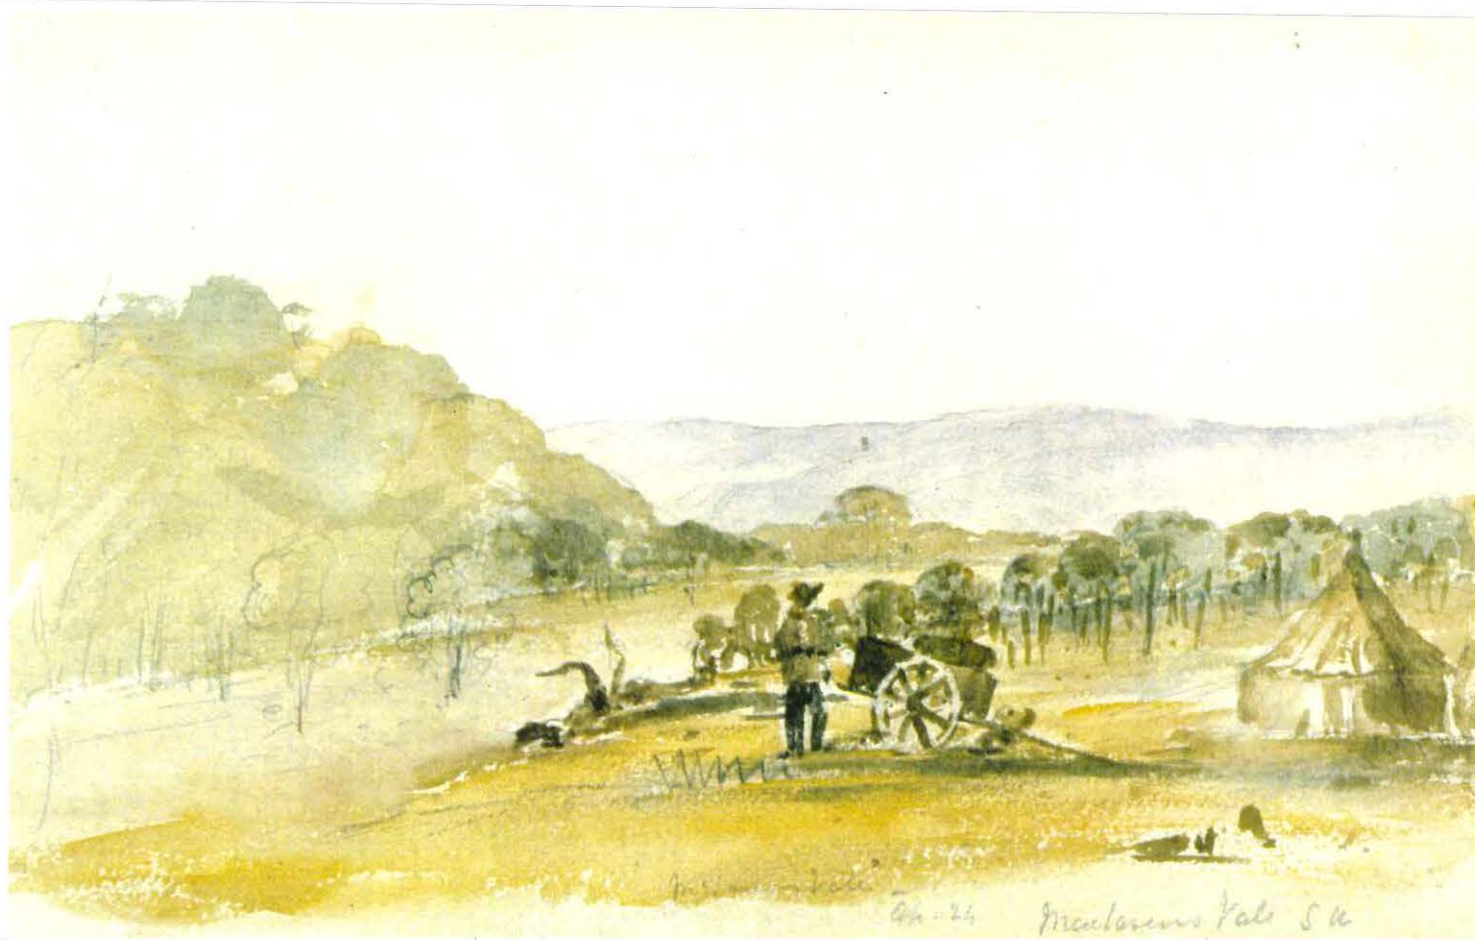
McLaren's Vale by E C Frome, probably in 1840. *Source:* Art Gallery of South Australia. (Caption and further explanation in footnote 1 on next page).

The sketch in Plate 1 shows some detail of early vegetation. It was drawn at McLaren Vale, probably in 1840, and the site was easily recognised by a local resident who provided the photograph in Plate 2, which was taken at roughly the same location. The 1840 sketch looked north-east towards the main Sellicks Hill Range and indicated that in 1840 there was a good cover

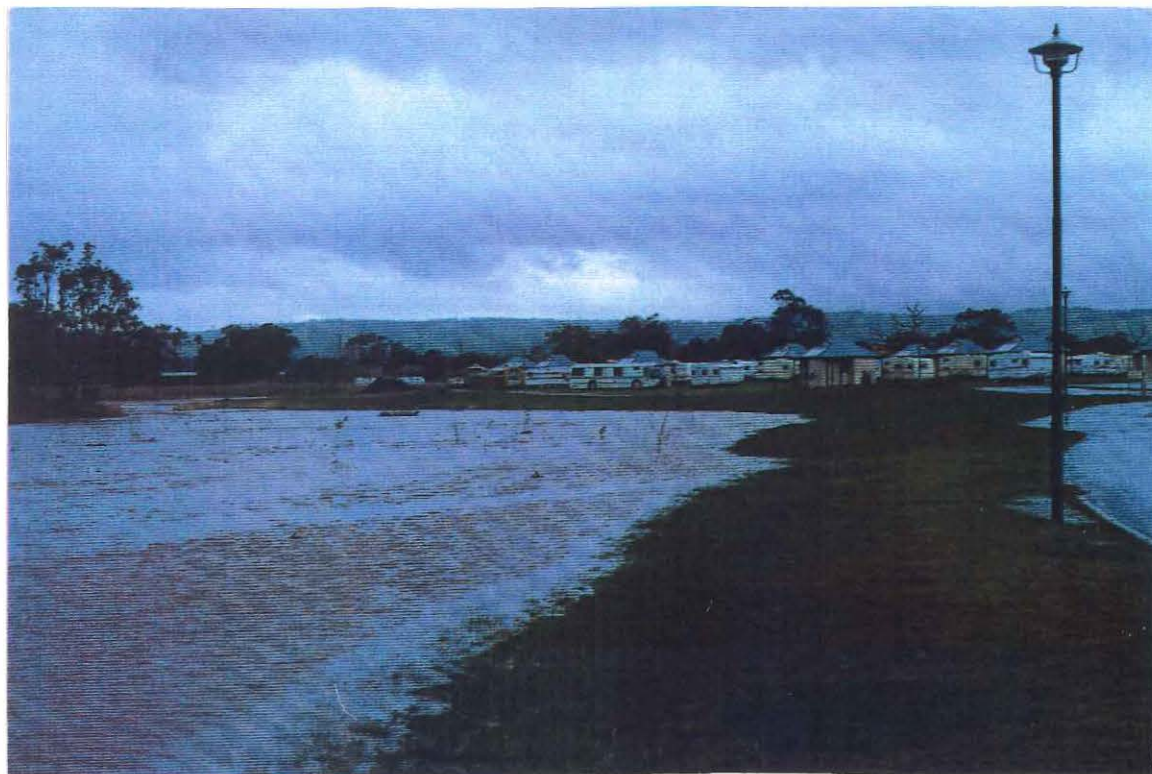
Plate 2

Photograph taken in 1992 near the site of the 1840 sketch in Plate 1. The photograph shows the upper Pedler Creek in flood in August 1992 near to the McLaren Vale caravan park. Source: Ruth Baxendale, McLaren Vale.

tree cover in the north-east (also visible in Plate 2), it was concluded that many of the patches which were not shown in Figure 35 were tree cover without native understorey. However, this does not explain the absence from the maps in Planning Advisory Services (1992) and Withers (1993) of a substantial patch of gums on grazed land at the bottom of the Old Sellicks Hill Road, which were already large trees in the 1949 aerial photographs.

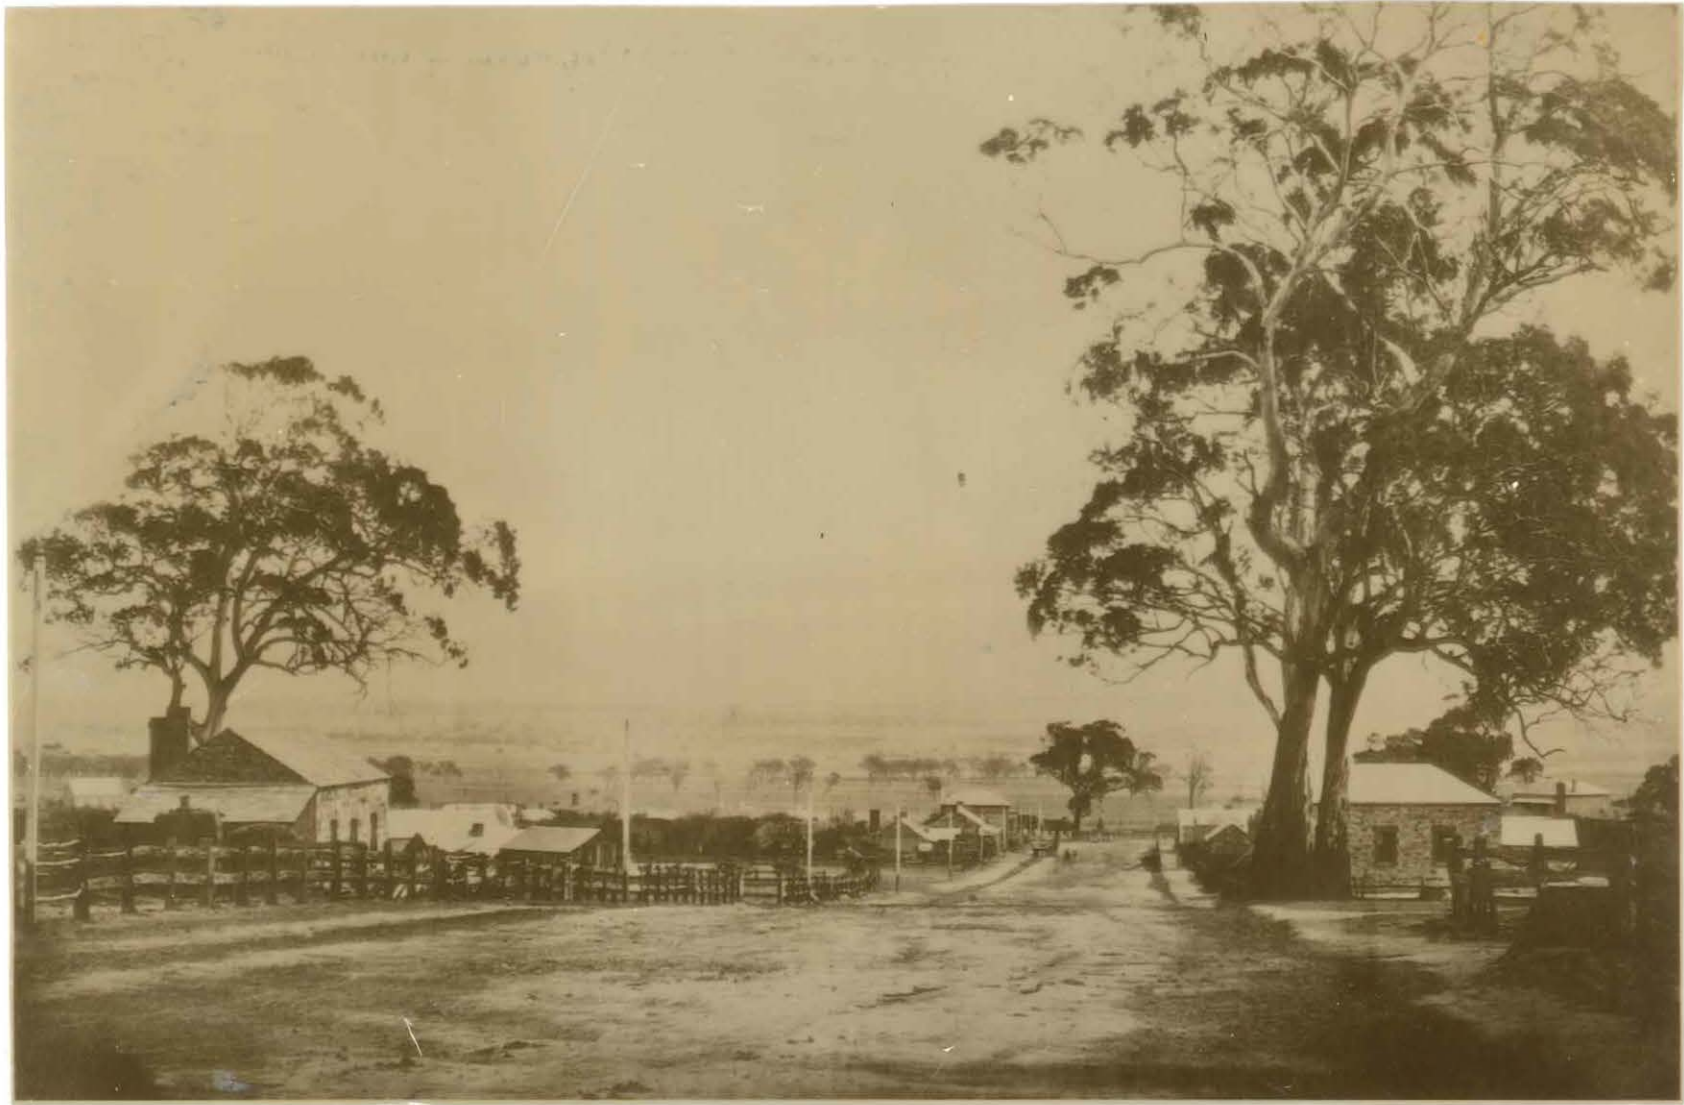
A view down the main street of Willunga towards the plains to the north-west, c1870.

Plate 3 shows a scene of the plains in 1870, thirty years after the first surveys. At this time, the plains had an open appearance, with scattered trees and belts of trees, both on the plains and the foothills. The main band of trees on the plains may have lined one of the major creeks. It is impossible to say what the general understorey cover was but the darker patches of vegetation were possibly swamp vegetation or crops. Comments by Sutherland (1889) suggest that fifty years after the first surveys were made substantial changes had occurred to land cover on the plains. In a rather romantic description of the countryside scene, Sutherland (1889) described the view from McLaren Vale, with hayfields stretching as far as the eye could see and wide expanses of grassy paddocks between. He wrote of:

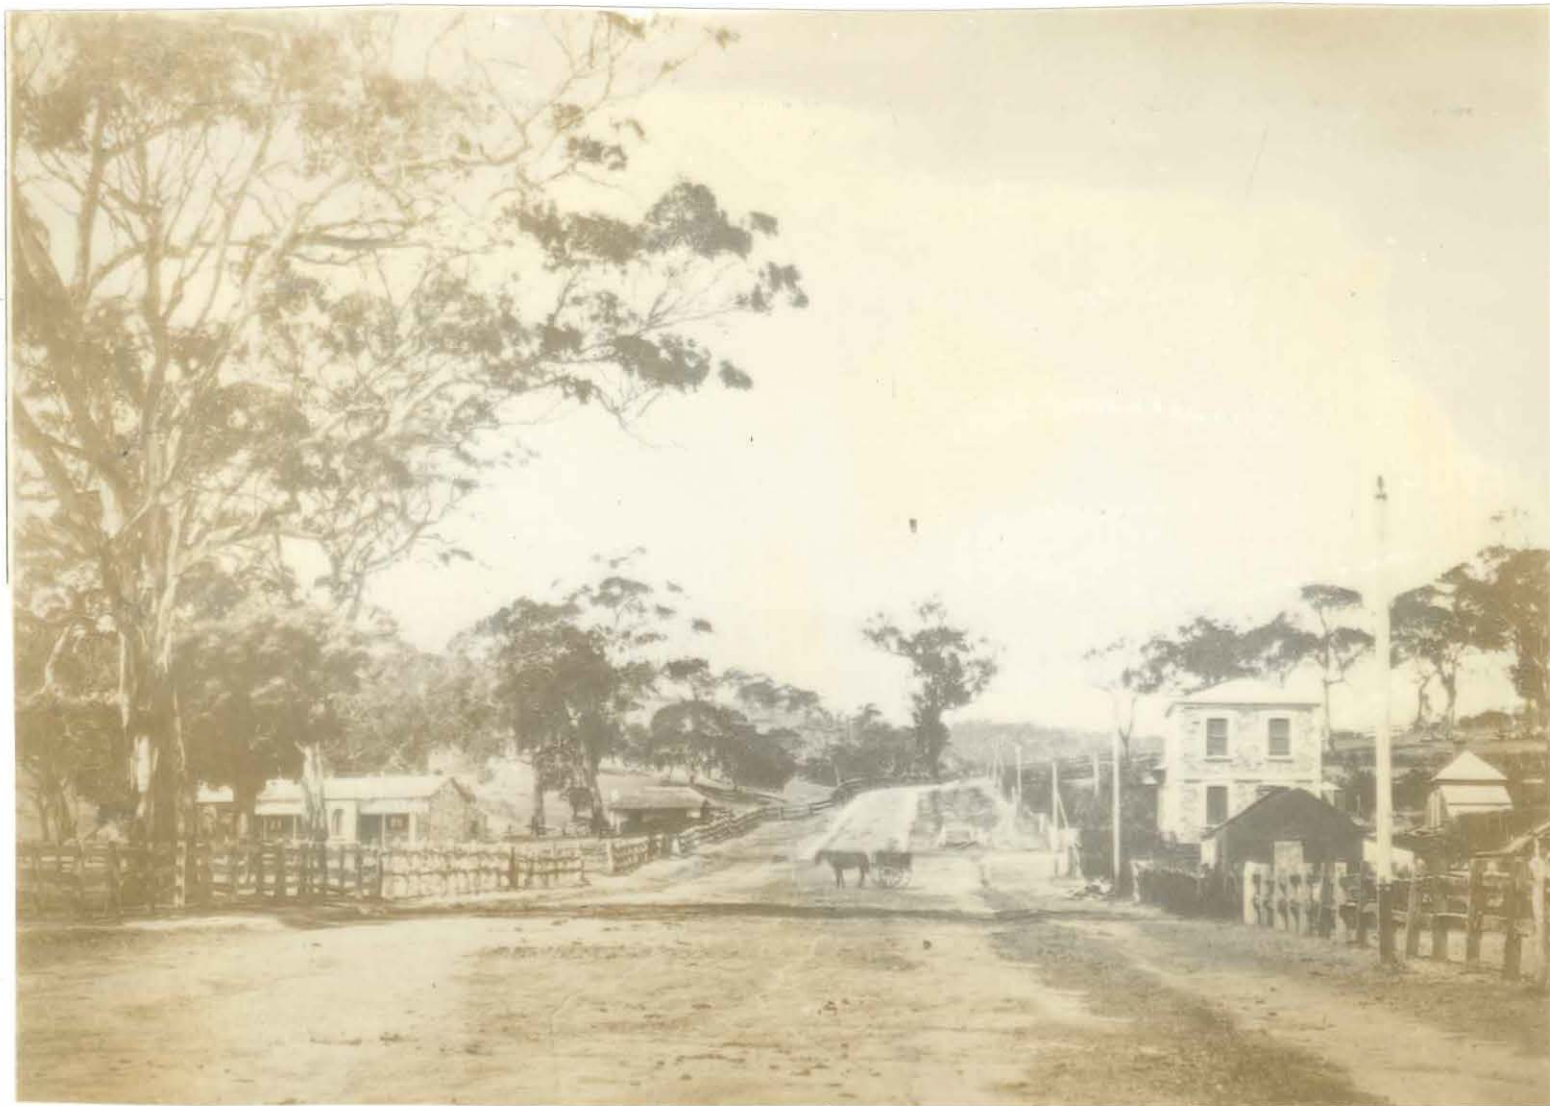
A view of George Sara's shop on Section 59 at the corner of High Street and St Andrew's Terrace in Willunga, Probably in the 1860s. Further explanation is given in footnote 2 on the previous page. *Source:* Mortlock Library SSL:M B45282.

² The date of Plate 4 is important in establishing how long the tree cover remained on the hills around Willunga. Although the Mortlock Library dates the photography as c1885, two large trees are seen growing outside the same house in Plate 7, which was taken around 1889. The trees could not have grown to such a size by 1889 if they had not even been there five years earlier. Linn (1991:54) dated Plate 4 as the 1850s. However, local resident D Vaudrey, who has researched the history of the Sara family, dates the photograph as late as the 1860s, based on the fact that the site was unimproved and owned by H Malpas until 1858 (D Vaudrey, pers comm, July 1994). If the photograph was taken in the 1860s, the trees in Plate 7 could then be 20-30 years old. Thus, from this evidence tree cover remained on the hills behind Willunga to the 1860s.

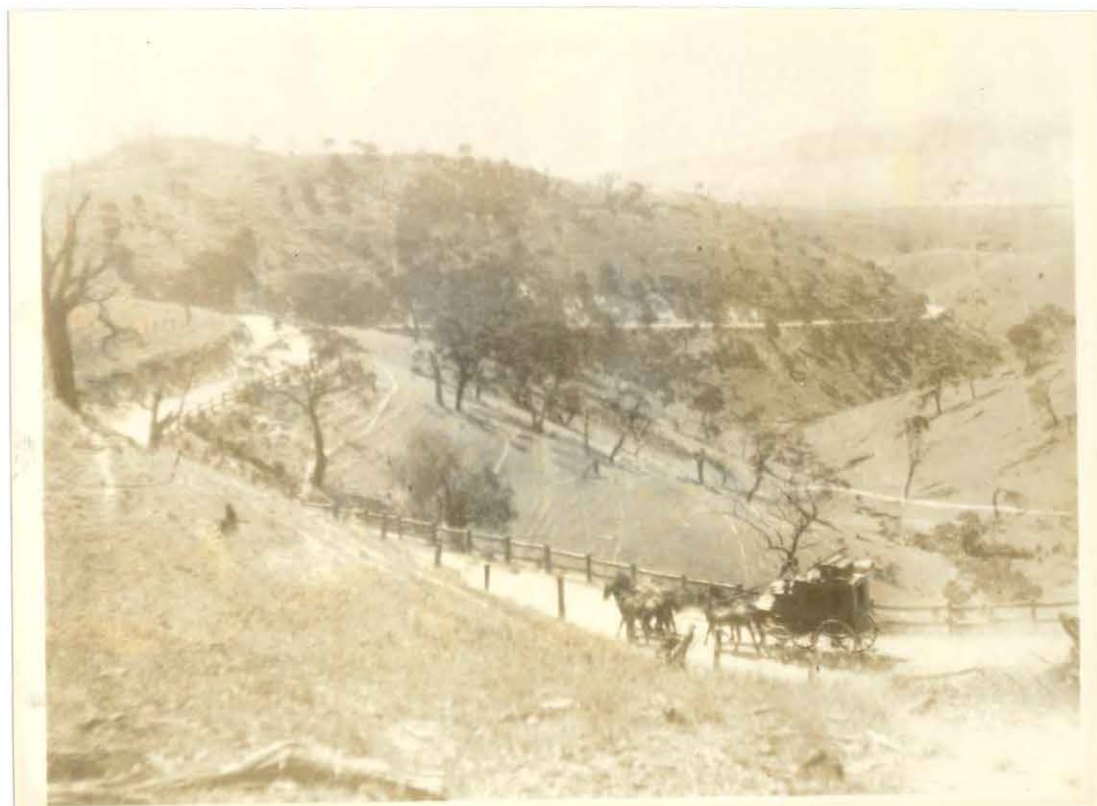
Old Sellicks Hill Road c1870. This road runs alongside the top part of the Sellicks Creek Gully in the hills about eight kilometres south-west of Willunga. Although the tree cover was not continuous in 1870, this photograph is significant, since the area is today almost completely devoid of tree cover. *Source: Mortlock Library SSL:M B26739/14.*

A decline in tree cover also occurred on the hills along the Old Sellicks Hill Road between 1870 and 1909. The 1850's surveys recorded that the hills area generally had been wooded, and in 1861 the area along the higher part of this road was interpreted as thickly timbered. However, Plates 8 and 9 show that tree cover there declined between 1870 and 1909. The landcover in Plate 8 was about 60% tree canopy and 40% grass. The trees appeared to be healthy, and low bushes covered parts of the hillside and gully bottom. However, Plate 9 shows that by 1909 the tree cover was much reduced and grasscover dominated. There were some dead and dying trees, and what may be terracettes on the slope below the road. Low bushes still grew in the gully bottom but the trees on the distant hilltops had largely gone. Today this area along the Old Sellicks Hill Road has only grasscover, with a few isolated sheoaks, wattles and yacca in rocky roadside crevices.

By 1858 the amount of land enclosed had risen rapidly to 16,000 hectares. This correlates with the extensive amount of wooden post and rail fencing in Willunga by 1872, when the photograph shown in Plate 14 was taken. Both sides of the Old Sellicks Road had also been fenced in this manner by 1870 (Plate 8). The timber requirements of early settlers had the potential to remove a huge number of trees, since according to Dutton (1846:203) about 4,500 pieces of timber were required to enclose a standard 80-acre section with a three rail fence. Paddocks much smaller than this were fenced in the township of Willunga, as shown in Plate 14, and therefore could have necessitated the cutting of even larger amounts of timber.

Downcutting in the lowest section of the Sellicks Creek Gully might be related to the appearance of a small gully at the very top of the range between 1870 and 1909 (Plates 8 and 9). More channels were mapped in this area in 1896, suggesting that channels either became more visible or that gullying had occurred. However, the different sections along the Sellicks Creek are isolated by roads so that shallow gullying near the hilltop might be more related to the localised vegetation loss and soil erosion, shown by the development of terracettes between 1870 and 1909, rather than to downcutting in the lowest section. Quarry operations at Sellicks Hill cannot be related to the initiation of the Sellicks Creek Gully since quarrying did not commence until the 1920s, and probably remained on a small scale until operations increased in the 1970s. Even if mine tailings contributed sediment to the gully, increasing the likelihood of erosion and deposition, the impact was probably much less than the cutting of channels on the plains and the increasing erodibility of the soil related to early European farming practices. The current impact of the mine beside the gully is difficult to ascertain without a further investigation of the movement of sediments and materials from the tailings dumps.

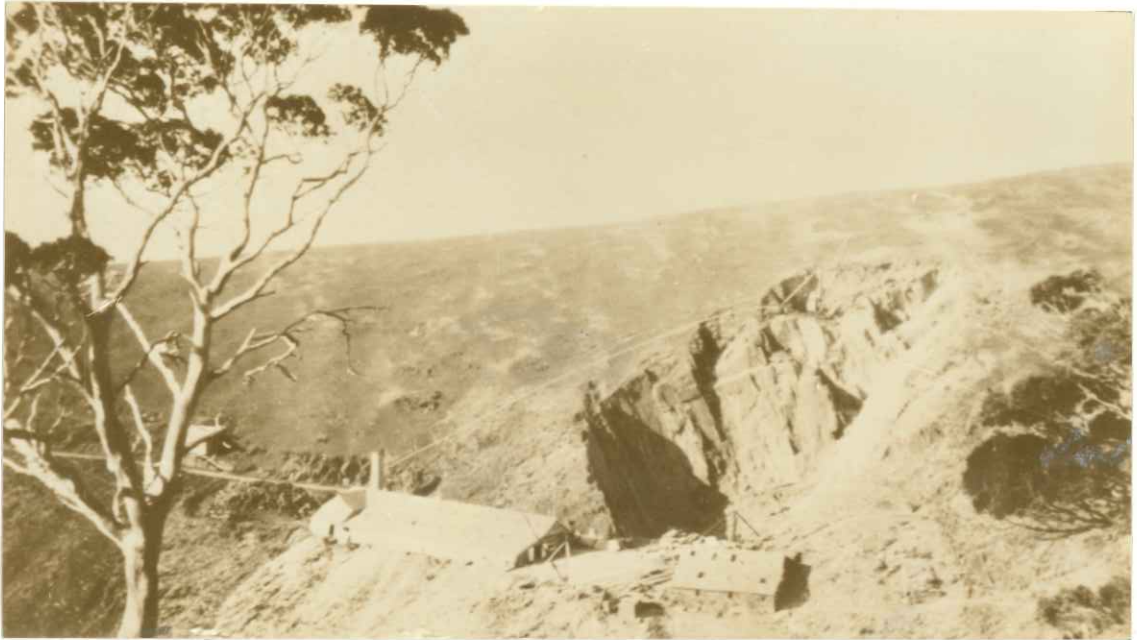
Plate 10

Bangor Quarry 1922.

A few changes are obvious since the 1922 photograph (Plate 10), including a new gum tree in the lower left hand corner and soil instability in the form of landslumps along the road behind the chimney and on the waste dump.

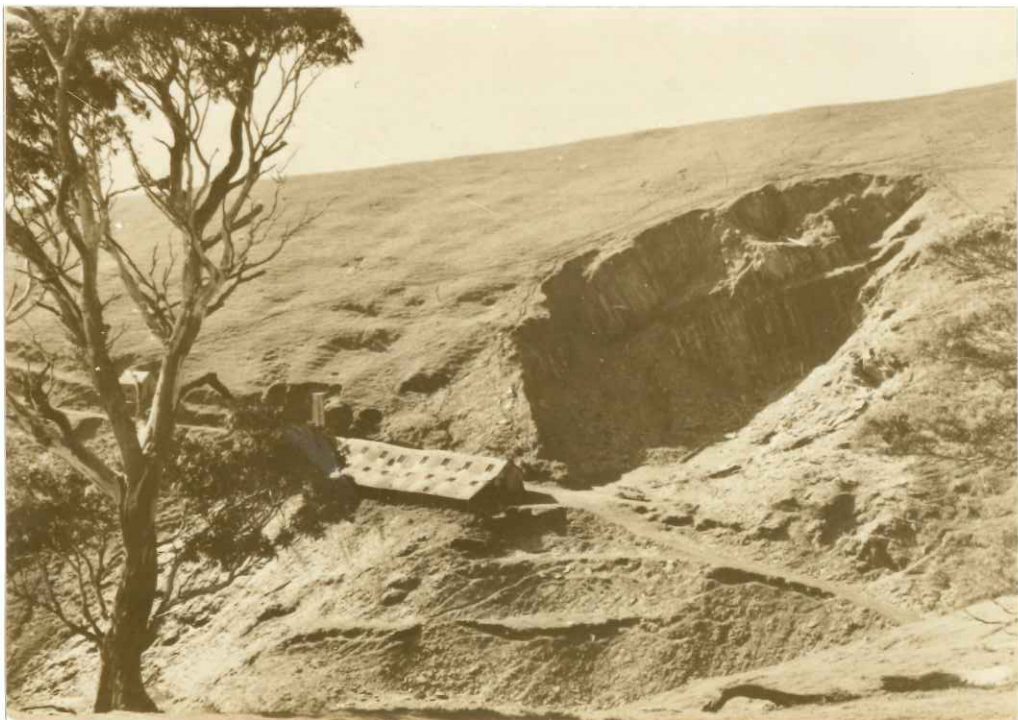
**Plate 11**

Bangor Quarry 1974.

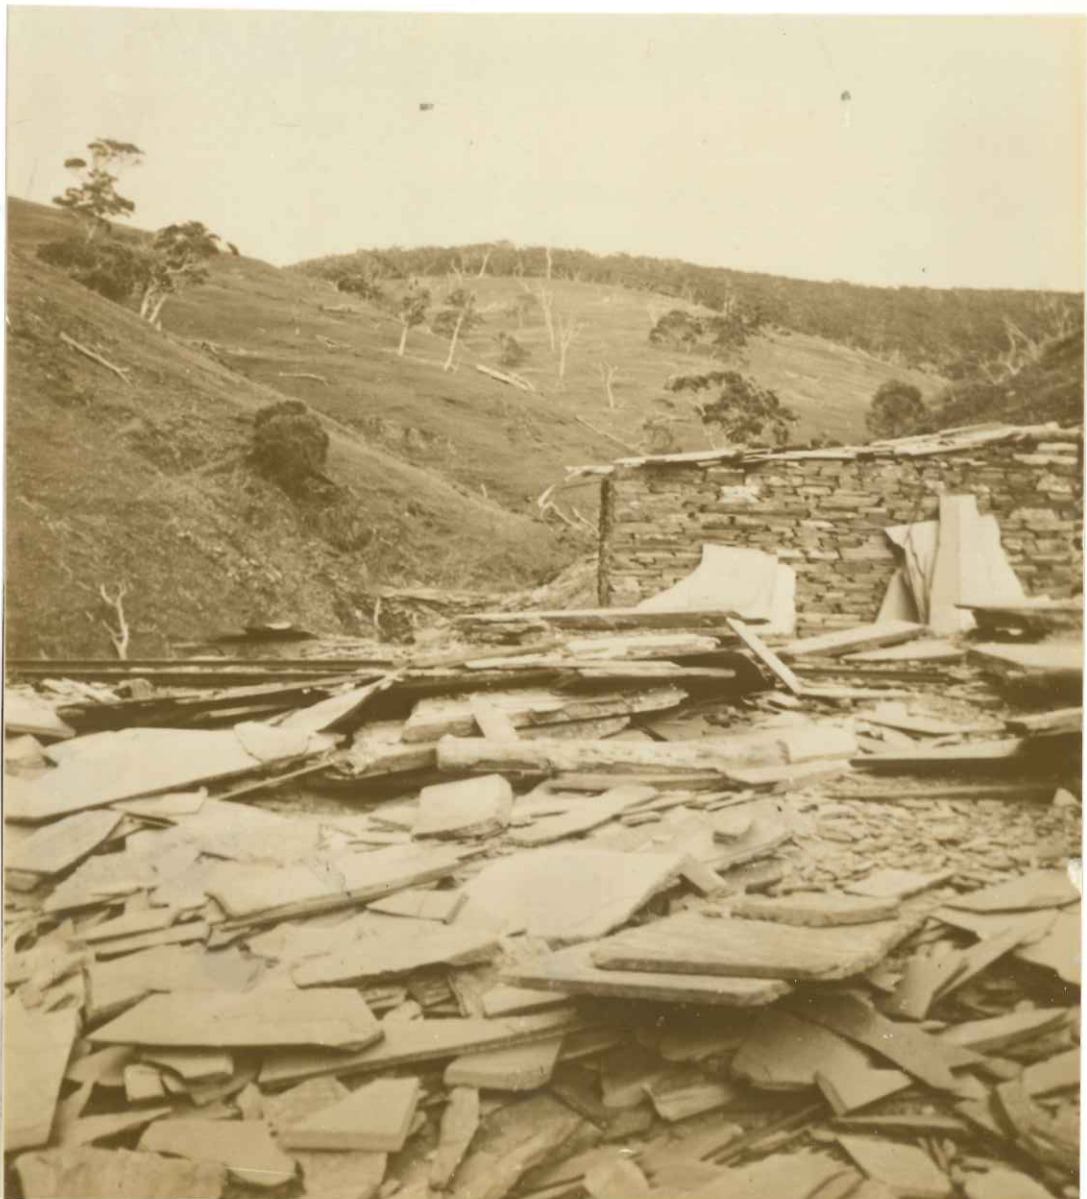
Bangor Quarry 1911 or earlier. *Source:* Department of Mines & Energy SA Historic Pictures Library, Photograph Number 2905.

This undated photograph appeared in a 1911 Mines Review publication. It shows that large gums were cleared on the hills above Willunga, probably to remove the canopy cover and encourage grass growth. Low understorey species appear to have survived on the hillside behind the building.

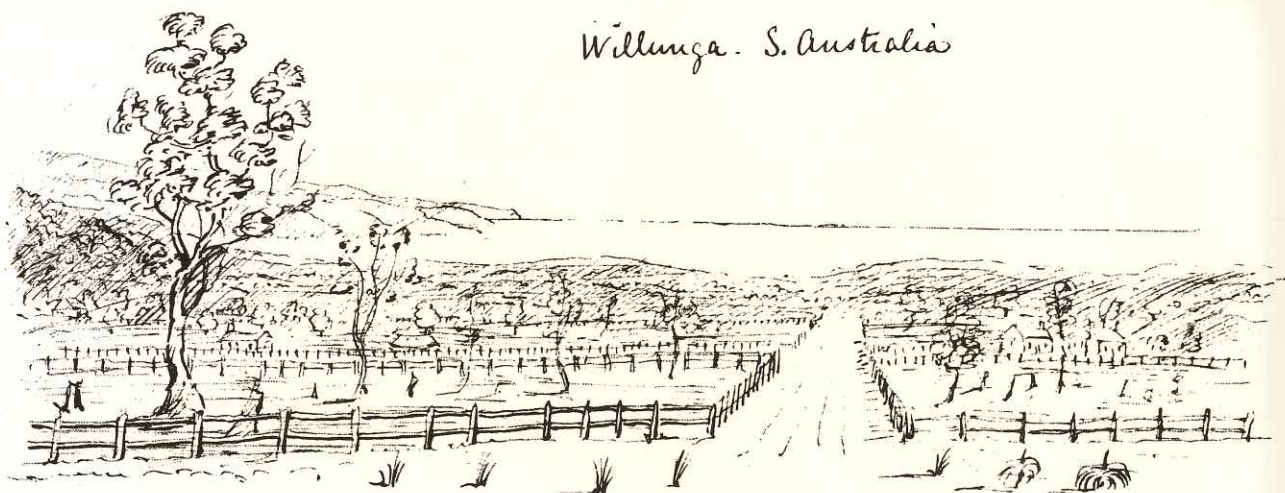
Plate 13

Willunga. S. Australia

This is one of the earliest sketches of Willunga to show the landscape in any detail. The view is down the main street of the township towards the coast, with the first Bush Inn situated on the right (Baxendale, pers comm, 1994). Tree stumps still remained in the paddocks, suggesting recent fencing activities. What appear to be grasstrees (yacca) are also visible in the foreground. They may be remnants of the native understorey which was cleared to prepare the land for cultivation.
