The Effect of Surface Roughness and a Collar on  
Fixation of Cemented Femoral Stems *in vivo*

Scott Andrew Brumby B.M. B.S.(Flind)

University of Adelaide

Thesis submitted in September 1996 for the degree of  
Doctor of Philosophy in the University of Adelaide

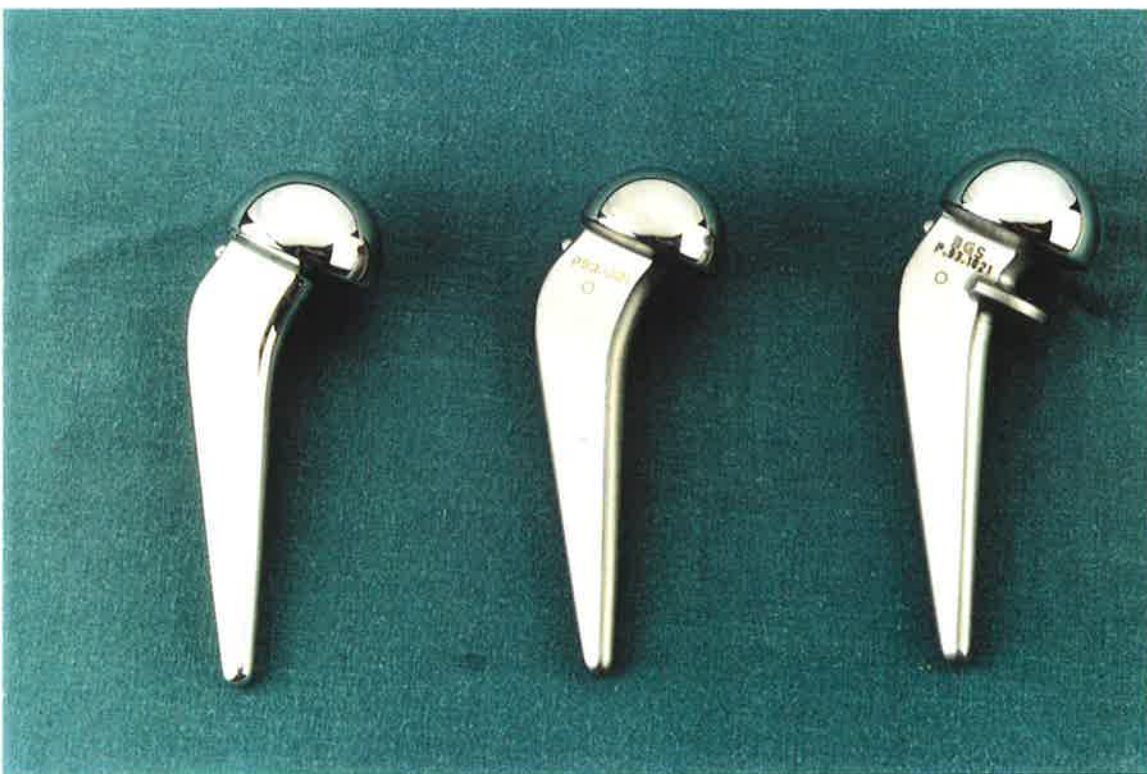
Figure 3.3. Sheep Hip prostheses (polished, matt and collared)

implants are commercially available with matt surface and collar with this shape. The sheep femoral prosthesis was inserted as a hemiarthroplasty. It was decided not to use a polyethylene acetabular component as this might have complicated the histological analysis with polyethylene wear debris.

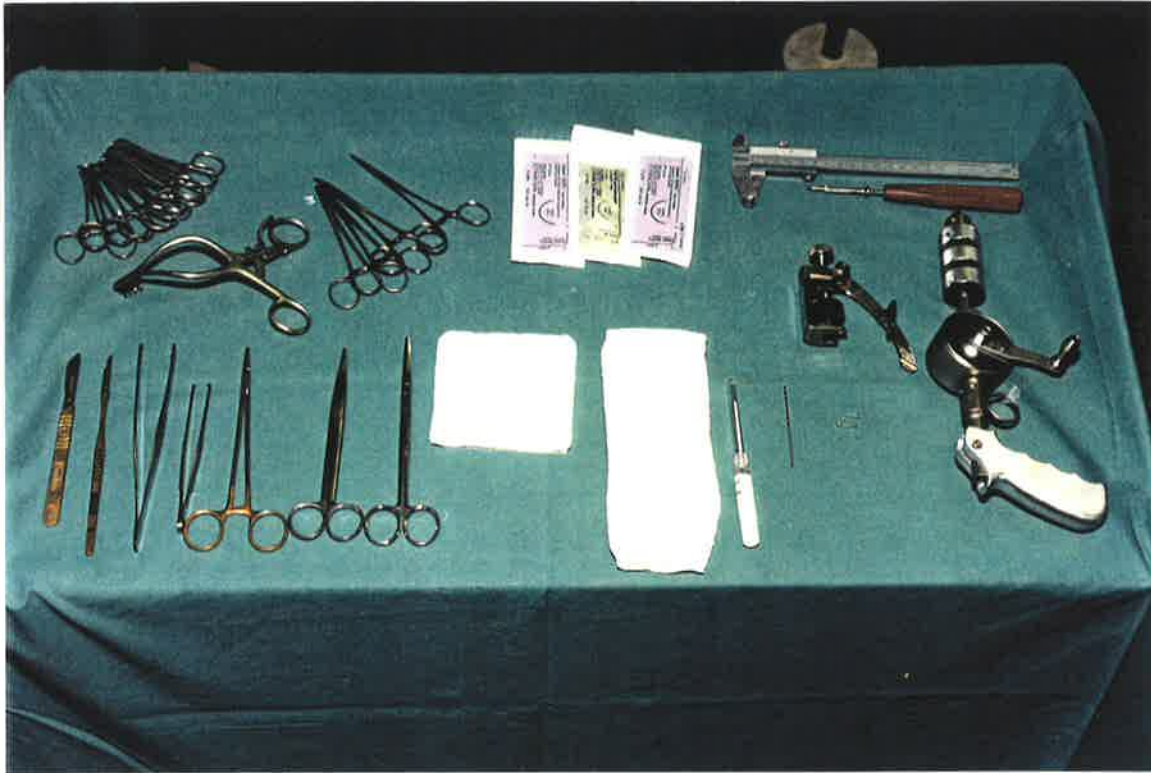
**Figure 3.4.** Instruments for dissection, sutures for closure and instruments for inserting marker screws and balls.

Surgical instruments were sterilised and placed on four trays and disposable equipment was opened in a sterile manner and placed on the trays (Figures 3.4 - 3.7).

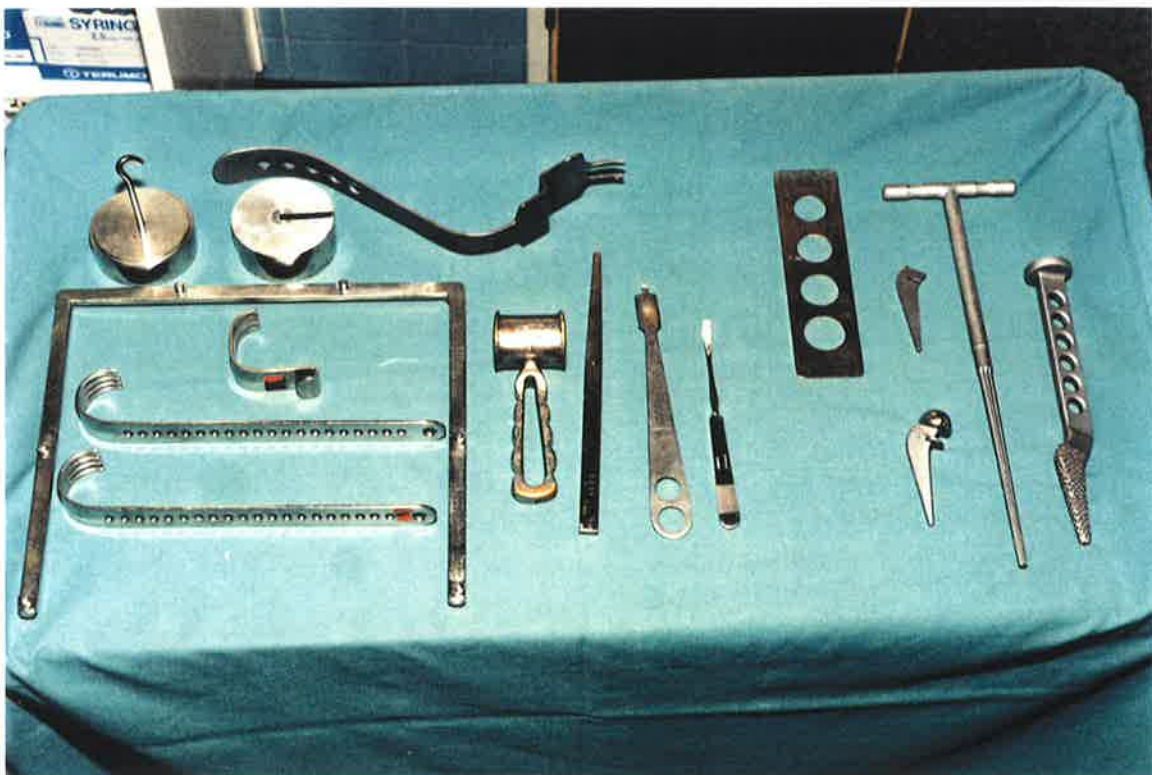
**Figure 3.5.** Instrumentation for exposure and preparation of the femoral neck and trial insertion.

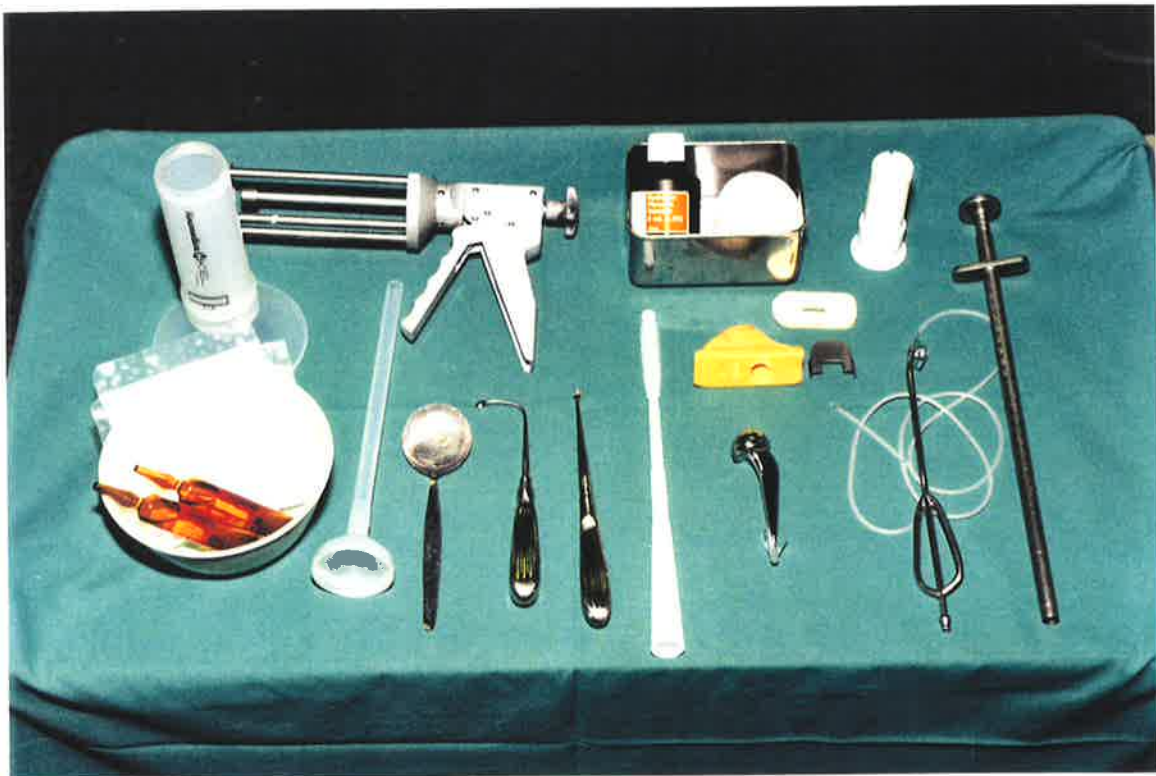
**Figure 3.7.** Equipment for medullary plug insertion, canal packing, cement insertion and pressurisation and femoral implant.

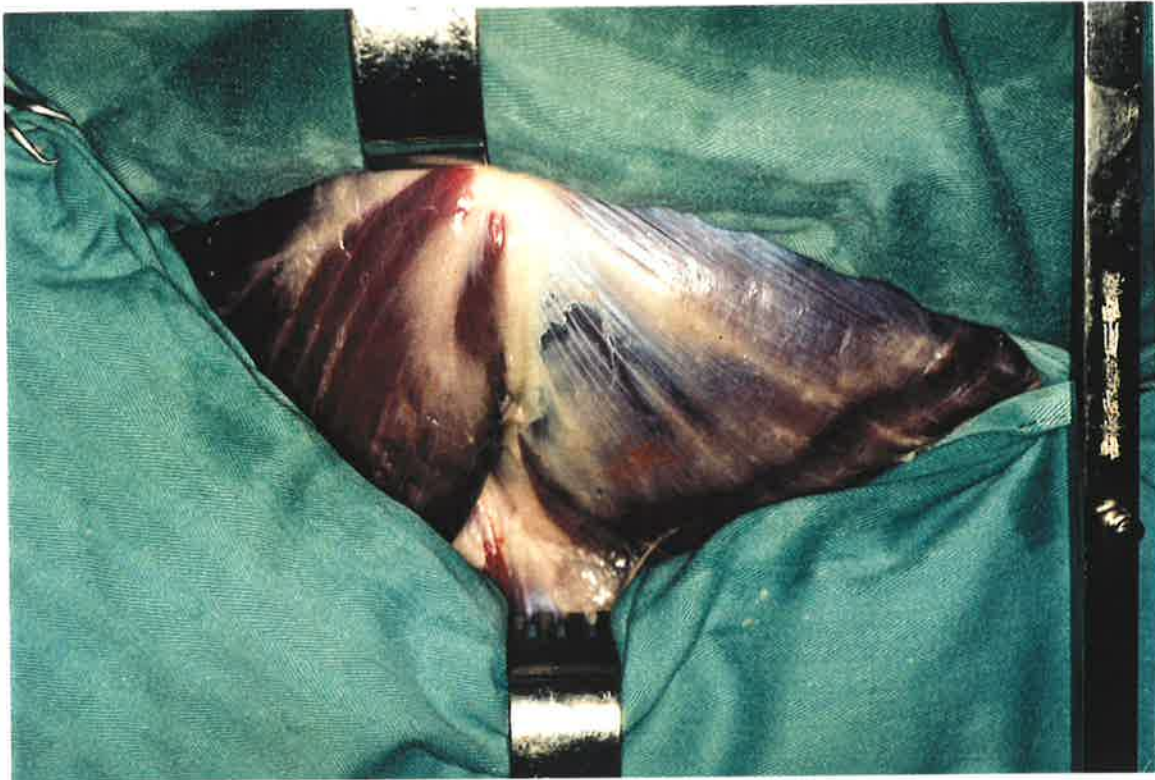
**Figure 3.10.** Exposure of Gluteus medius and Vastus lateralis.

A curved skin incision (convex caudal) was made centred over the greater trochanter extending distally ten centimetres in line with the femur and proceeding six centimetres above the trochanter (Figure 3.8). The deep fascia was incised and the biceps femoris muscle identified caudally. The cranial margin of the muscle was defined and retracted caudally behind the greater trochanter (Figure 3.9). The gluteus medius running supero-cranial from the greater trochanter and vastus lateralis running inferiorly were identified and the fatty tissue lying between them was cleared (Figure 3.10). Lying in the interval between gluteus medius and vastus lateralis is a small muscle, gluteus superficialis (the human gluteus maximus analogue), which was released. Huck towels were sutured to the margins of the wound. A Charnley retractor was placed beneath the deep fascia and a self-retaining retractor was positioned to separate the gluteus medius and vastus lateralis.

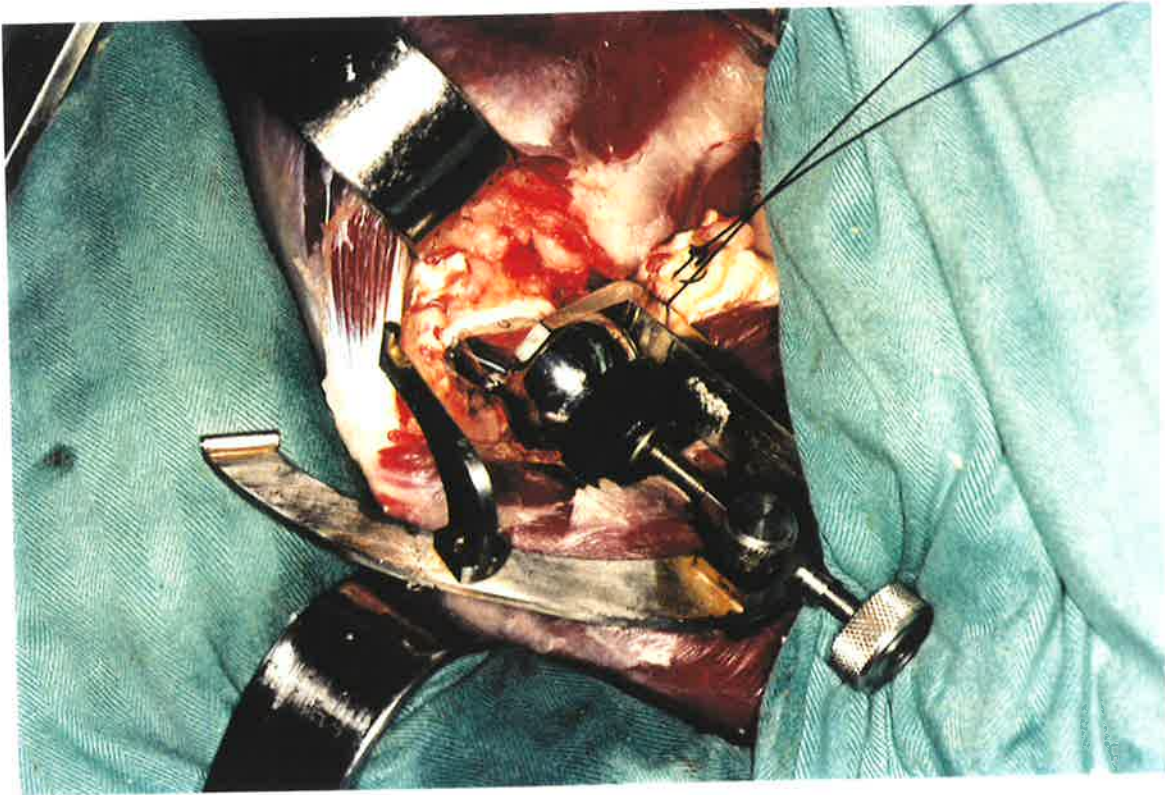
**Figure 3.18.** Drill guide attached to femoral implant and guide holes situated over greater trochanter.

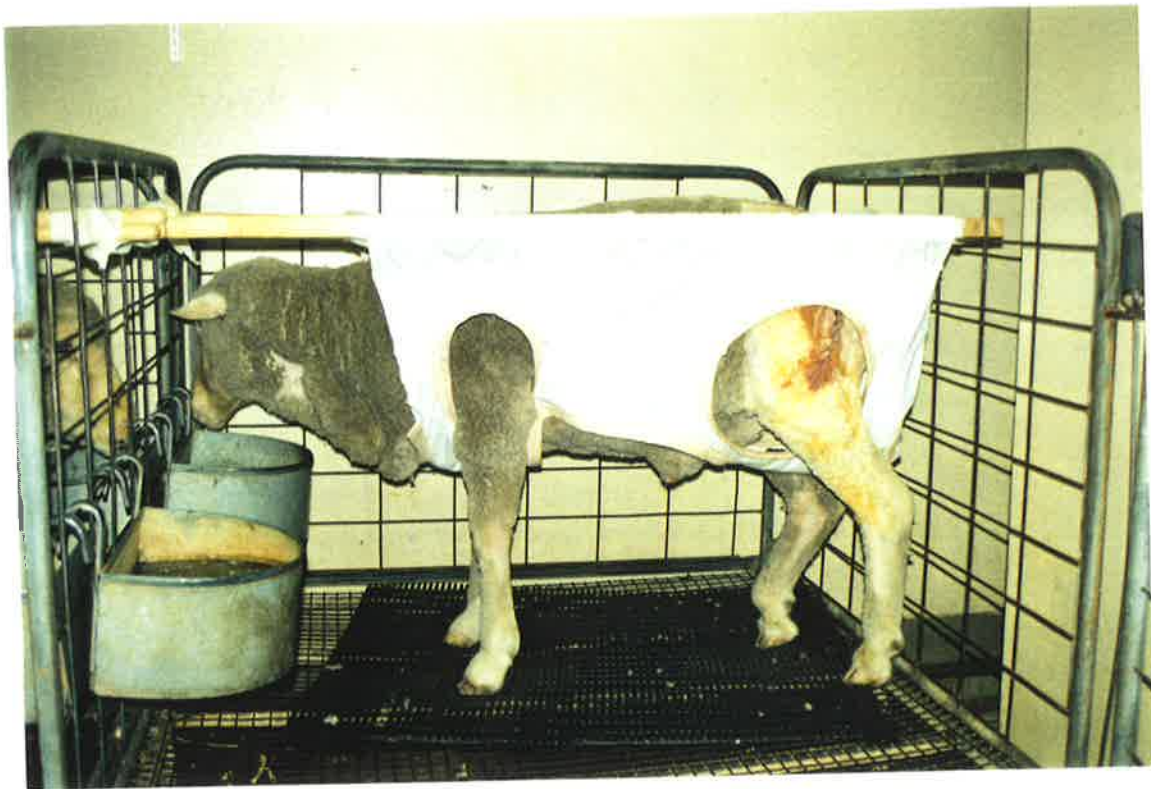
**Figure 3.21.** Sheep in sling and crate.

Post-operatively, the sheep was suspended in a canvas sling that was supported between 2 wooden poles in a small crate (Figure 3.21). The sheep was allowed free access to food and water. The height of the sling was such that the sheep could stand weight bearing or could rest in the sling. At twenty-four hours post operation, the sling was lowered by 10 cm to encourage full weight bearing and movement forwards and backwards while still providing lateral support. The sling was removed at forty-eight hours post-operation and the sheep allowed to stand unsupported. The sheep were housed in an indoor pen for 21 days. The sheep were released into the paddock at a suitable time about 3 weeks to 1 month post-operation.

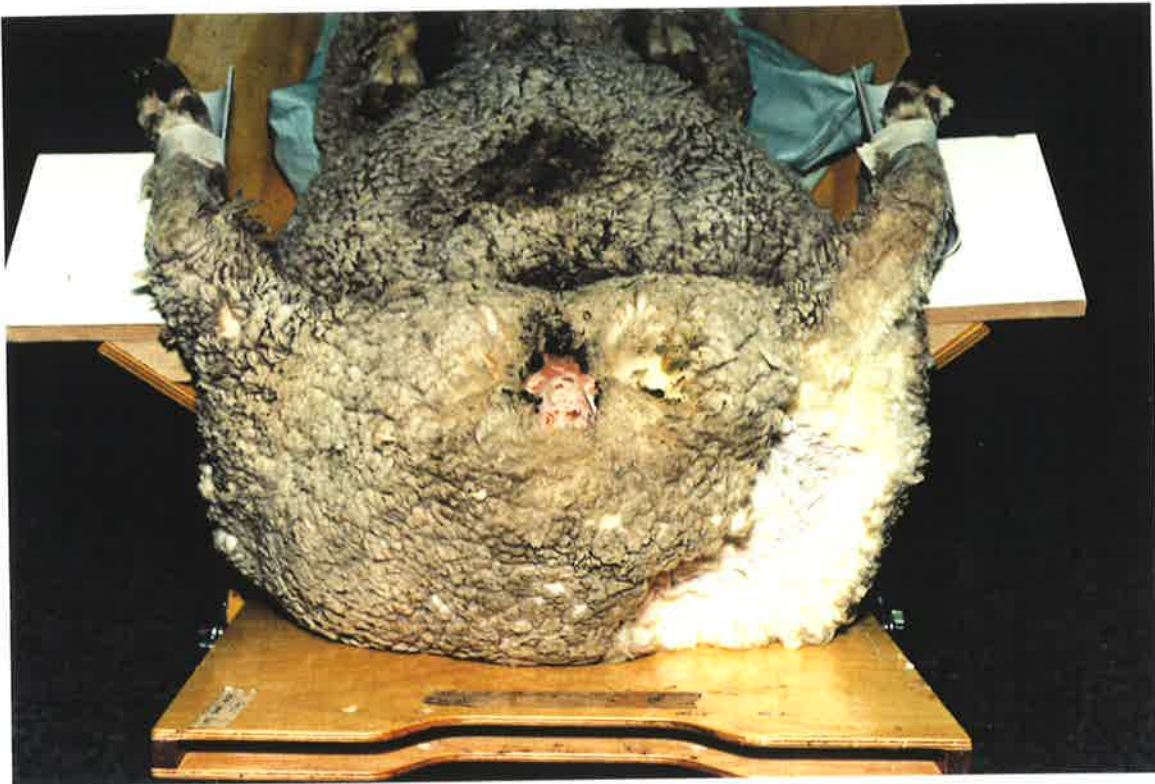
**Figure 4.1(a).** Caudal view of sheep in positioning device to allow reproducible AP pelvis radiograph to be taken. Radiograph cassette and grid are placed in slot at rear of device and distal limbs are fixed to ensure standard positioning.

The anteroposterior (AP) pelvis radiograph was taken with the hip joint extended and abducted, internally rotated and all other joints extended. The distal extremity was fixed to the radiographic plate holder and the stifle joints were held in internal rotation with a velcro strap (Figure 4.1). The lateral (LAT) hip radiograph was taken with the femora abducted, the stifle joint (knee) flexed, the hock joint (ankle) flexed and the distal lower limbs fixed to the radiographic plate holder (Figure 4.2).

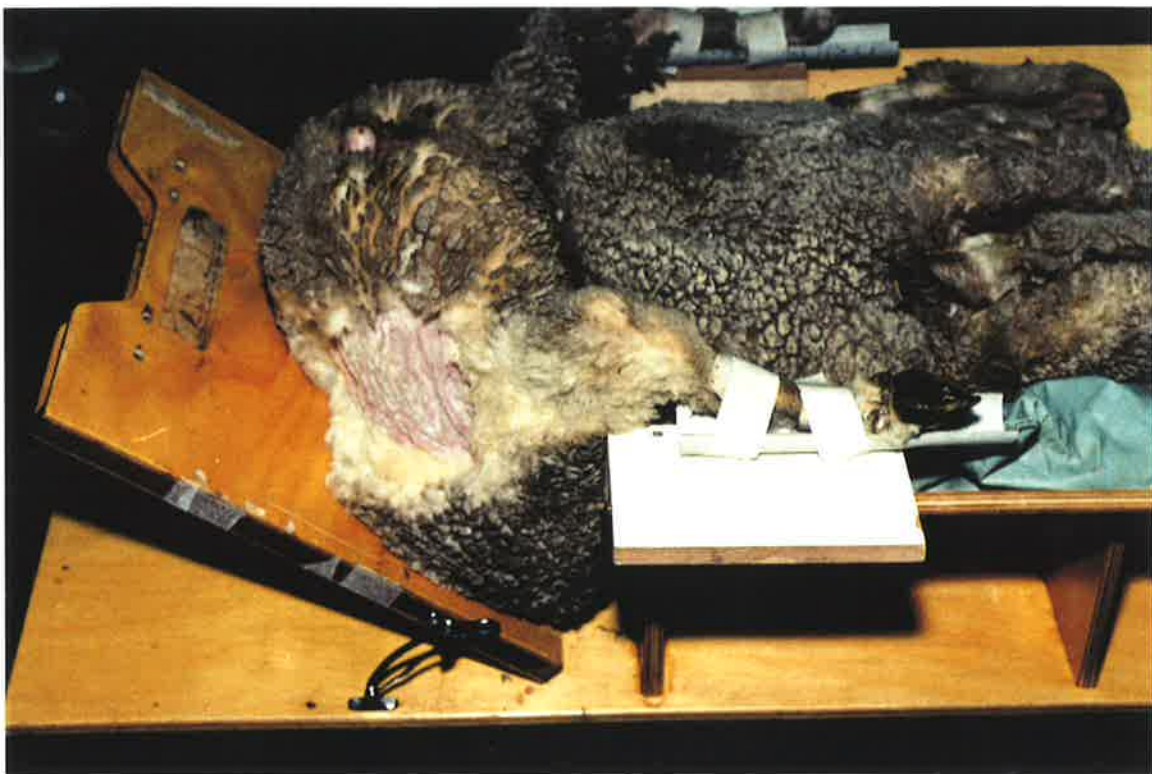
**Figure 4.1(b).** Lateral view of sheep in positioning device for AP pelvis radiograph.

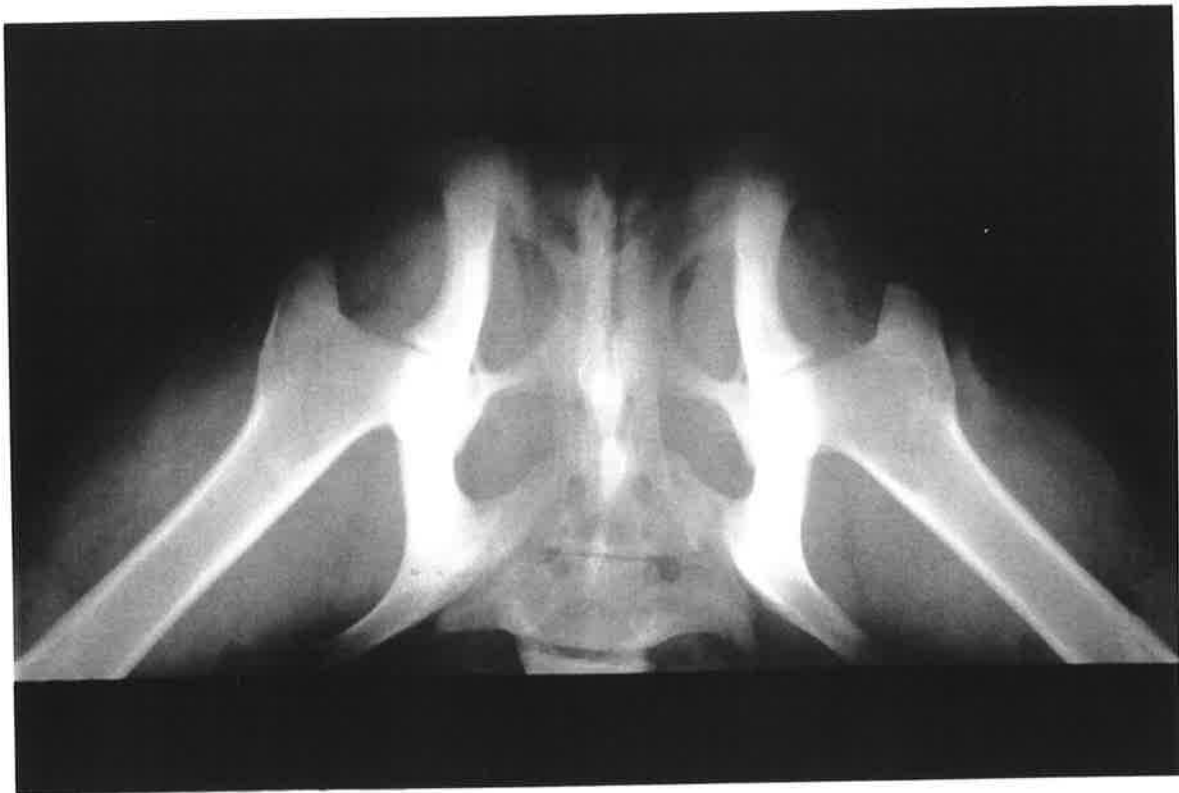
**Figure 4.1 (c).** AP pelvis radiograph

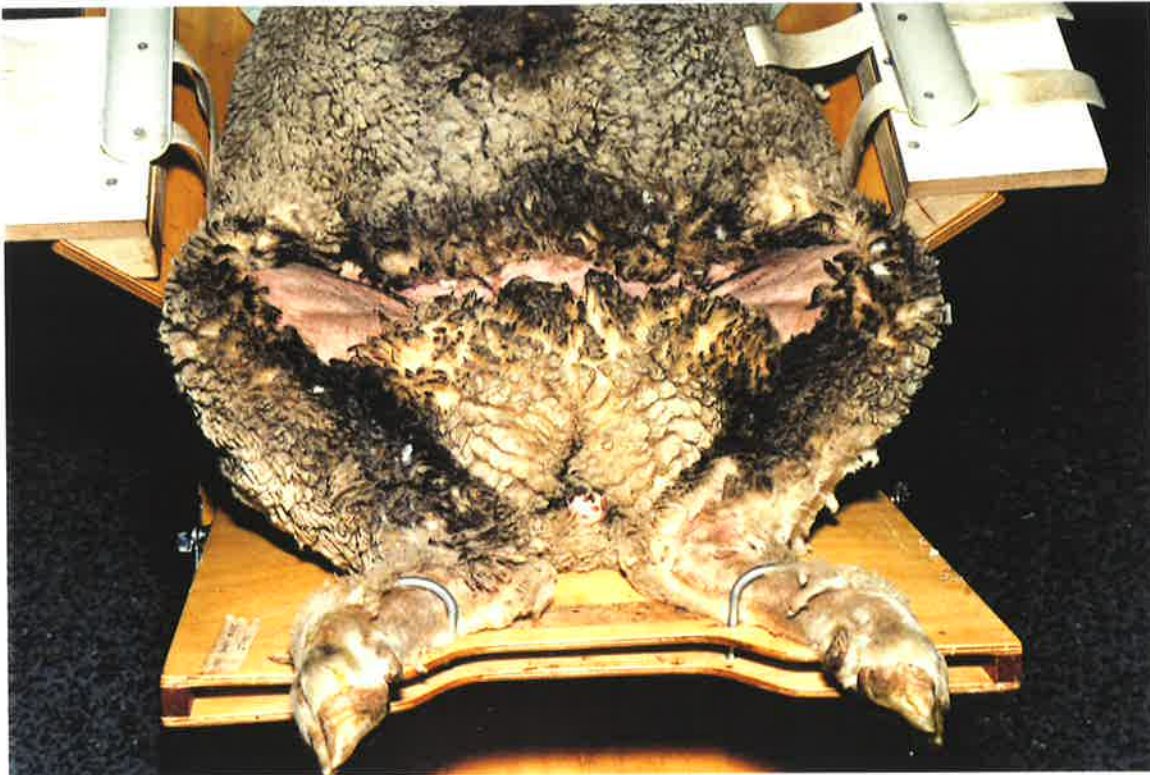
**Figure 4.2(a).** Caudal view of sheep in positioning device for lateral radiograph. Radiograph cassette and grid are placed in slot at rear of device and distal limbs are fixed to ensure standard positioning.

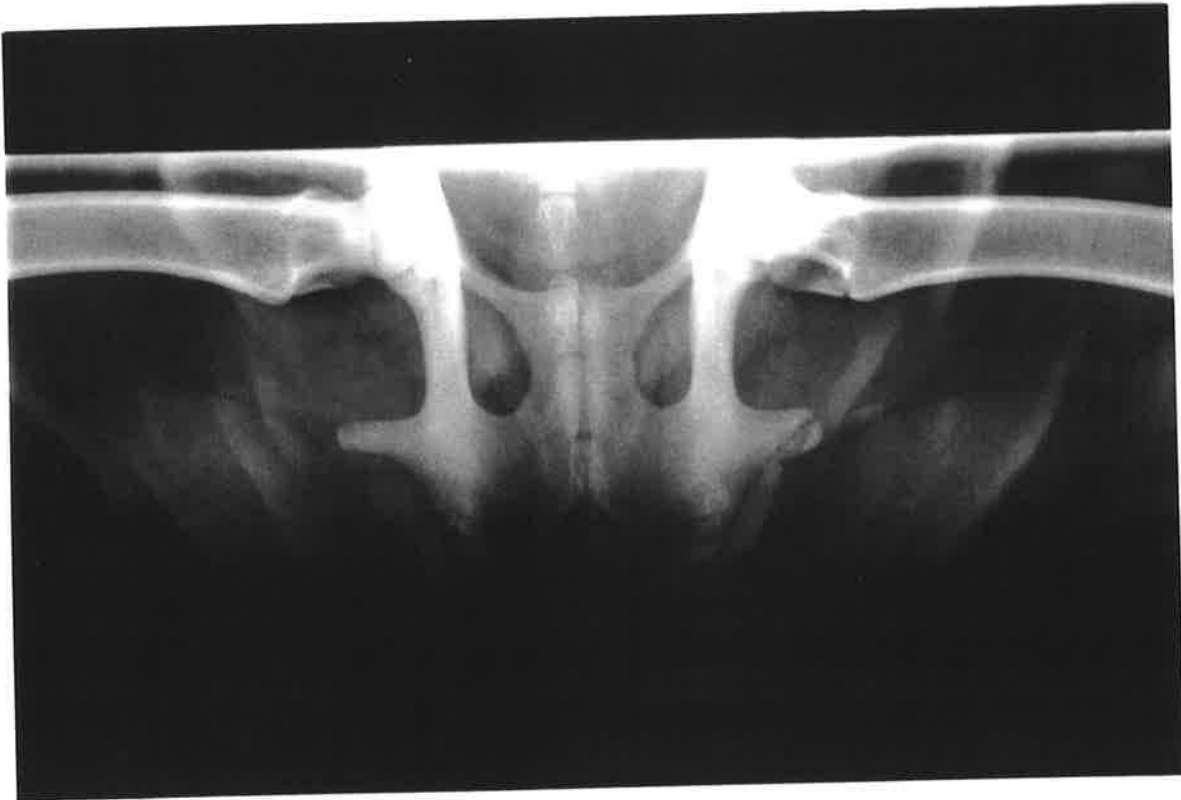
**Figure 4.2 (c).** Lateral radiograph

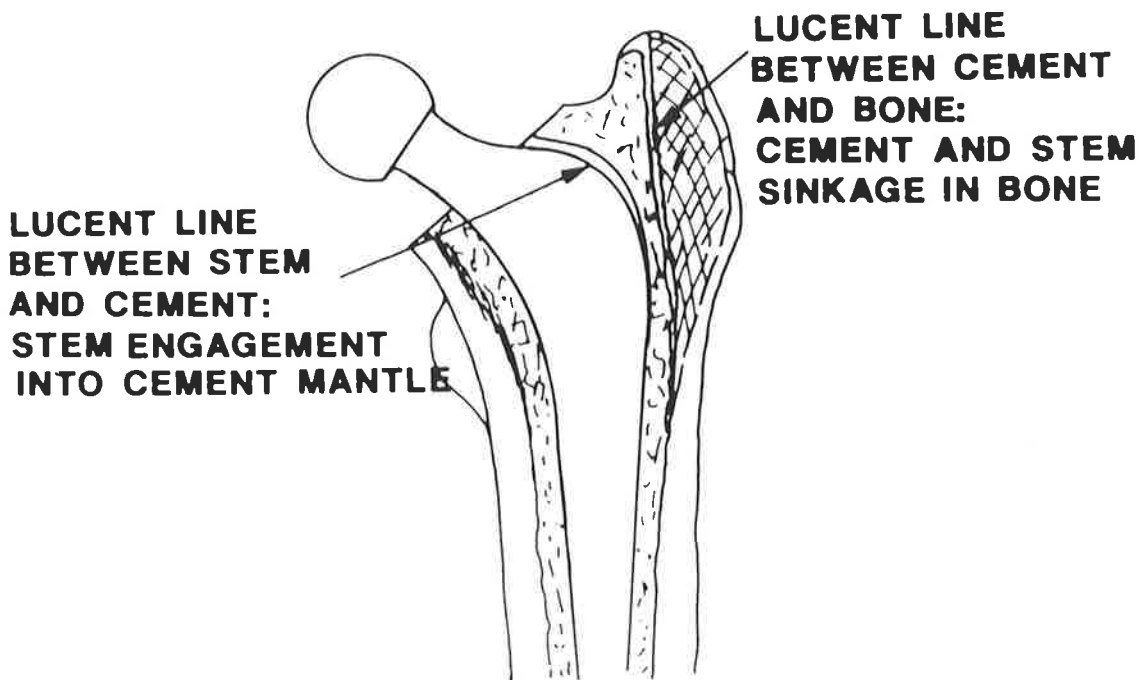
**Figure 4.5.** Diagrammatic representation of p-c subsidence according to the method of Fowler et al. (1988) for the AP radiograph in the supero-lateral zone (Gruen zone 1).

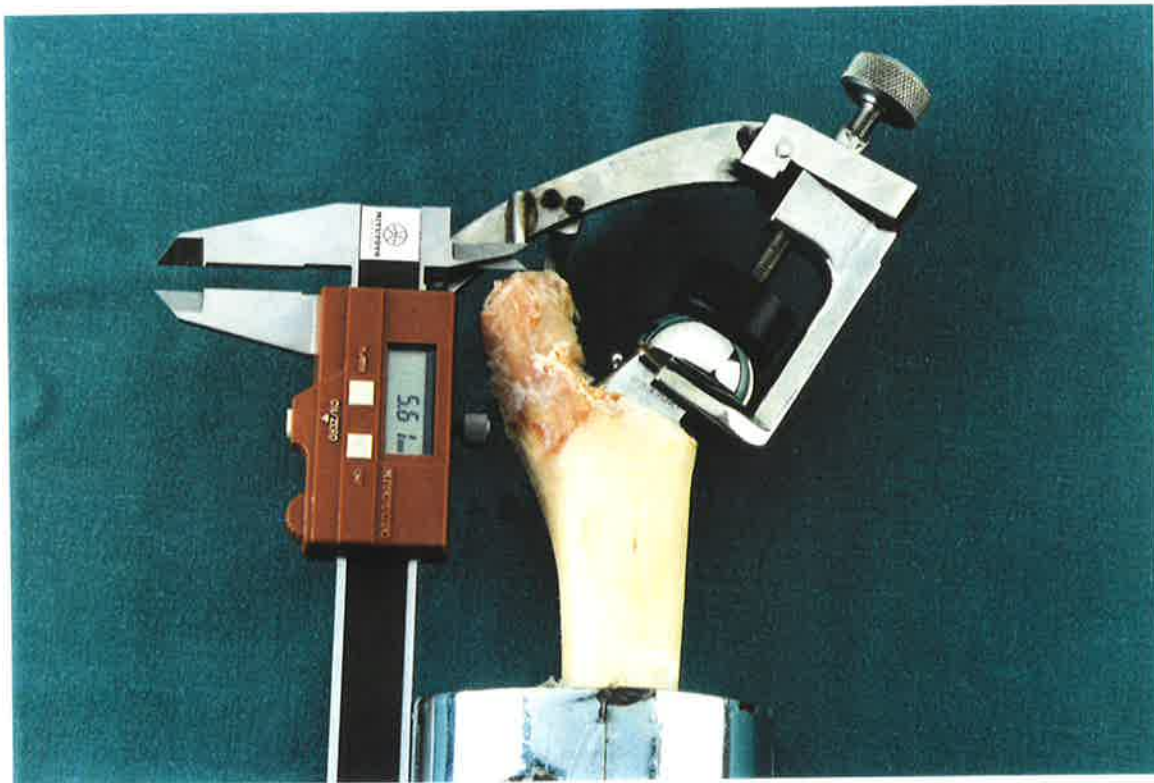
**Figure 4.7.** Measurement of the distance between the drill guide and marker screws.

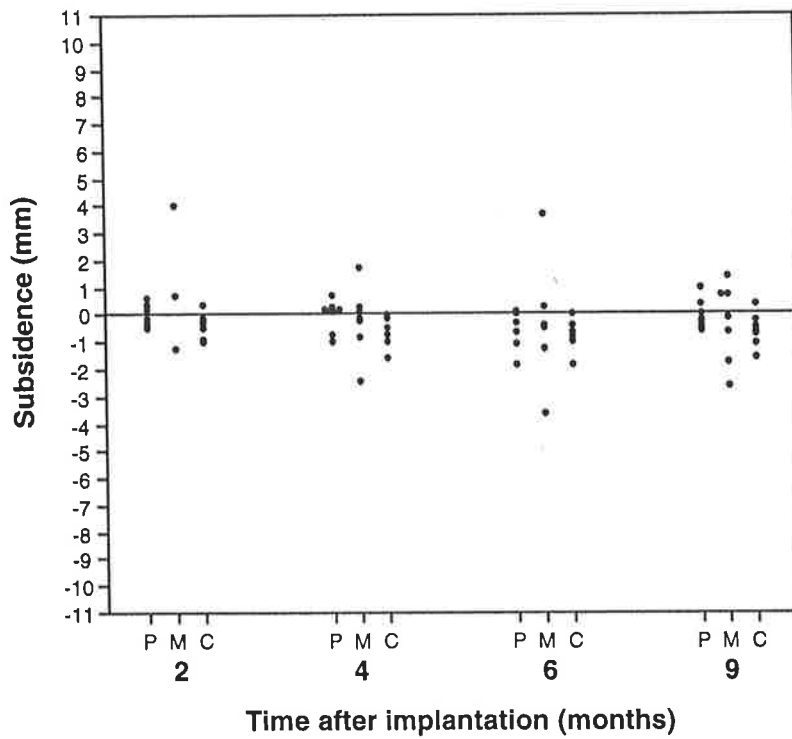
**Figure 4.8.** Scatter plot of the prosthesis-cement subsidence measured between the distal markers over nine months following implantation for polished, matt and collared prostheses.

Prosthesis-cement subsidence at nine months after implantation measured between the distal tip of the prosthesis and the distal cement marker ball is shown in Figure 4.8. At nine months after implantation there was no difference between a polished surfaced prosthesis and a matt surfaced prosthesis when prosthesis-cement subsidence was measured between the distal markers ( $p = 0.9$ ).

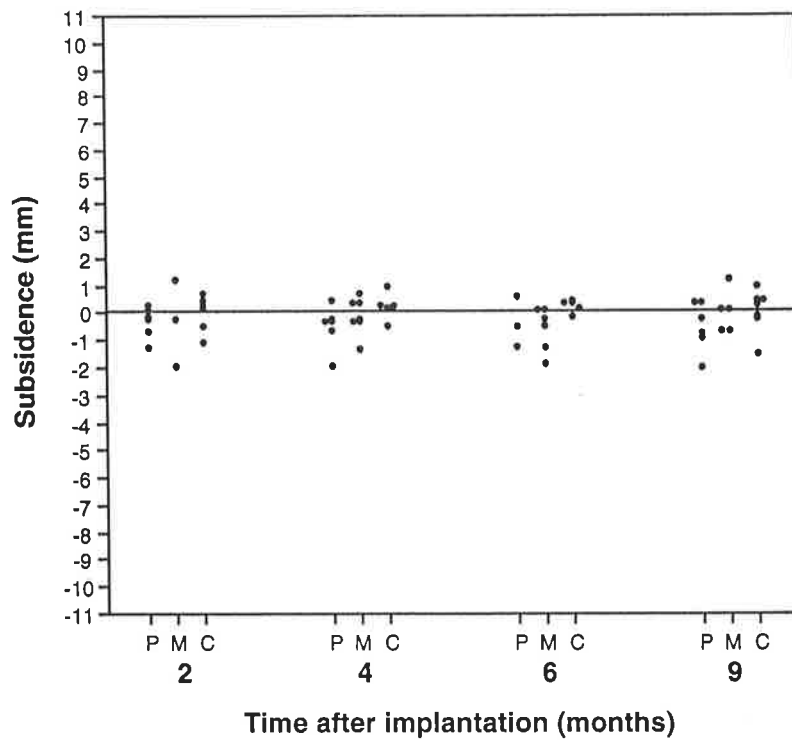
**Figure 4.9.** Scatter plot of the prosthesis-cement subsidence measured between the proximal markers over nine months following implantation for polished, matt and collared prostheses.

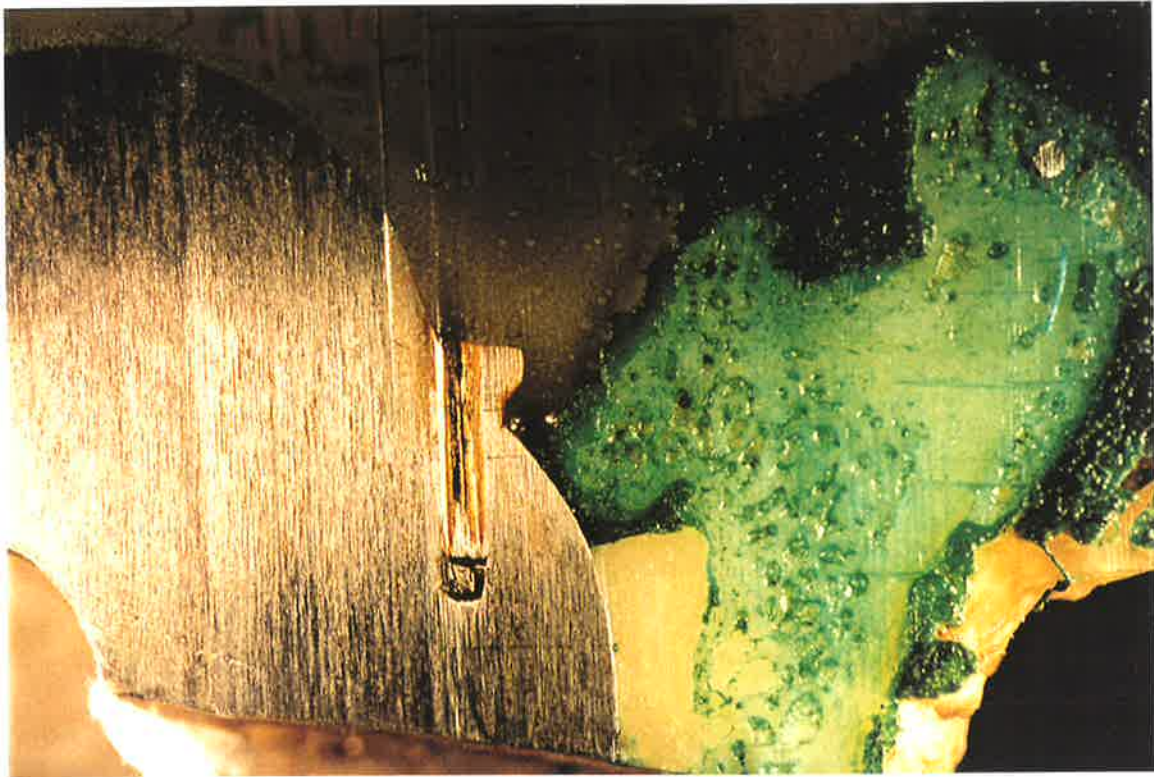
**Figure 4.10.** Mid-coronal section of proximal femur. There is direct contact between the prosthesis and cement in the supero-lateral zone (Gruen zone 1) without evidence of migration or intervening fibrous tissue.

The observations from the assessment of high contrast plain radiographs and mid-coronal photographs confirmed the radiographic assessment that there was no prosthesis-cement subsidence of any stem.

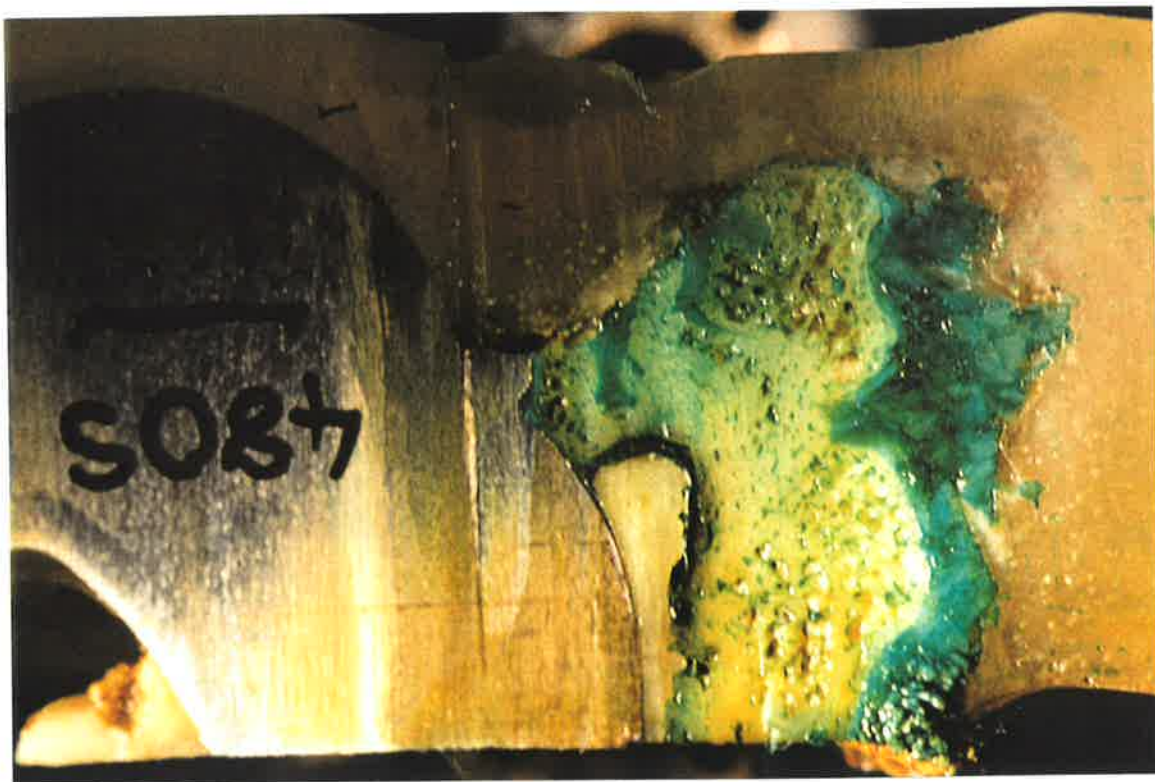
**Figure 4.11.** Mid-coronal section of proximal femur. There is new bone growth over the cement mantle.

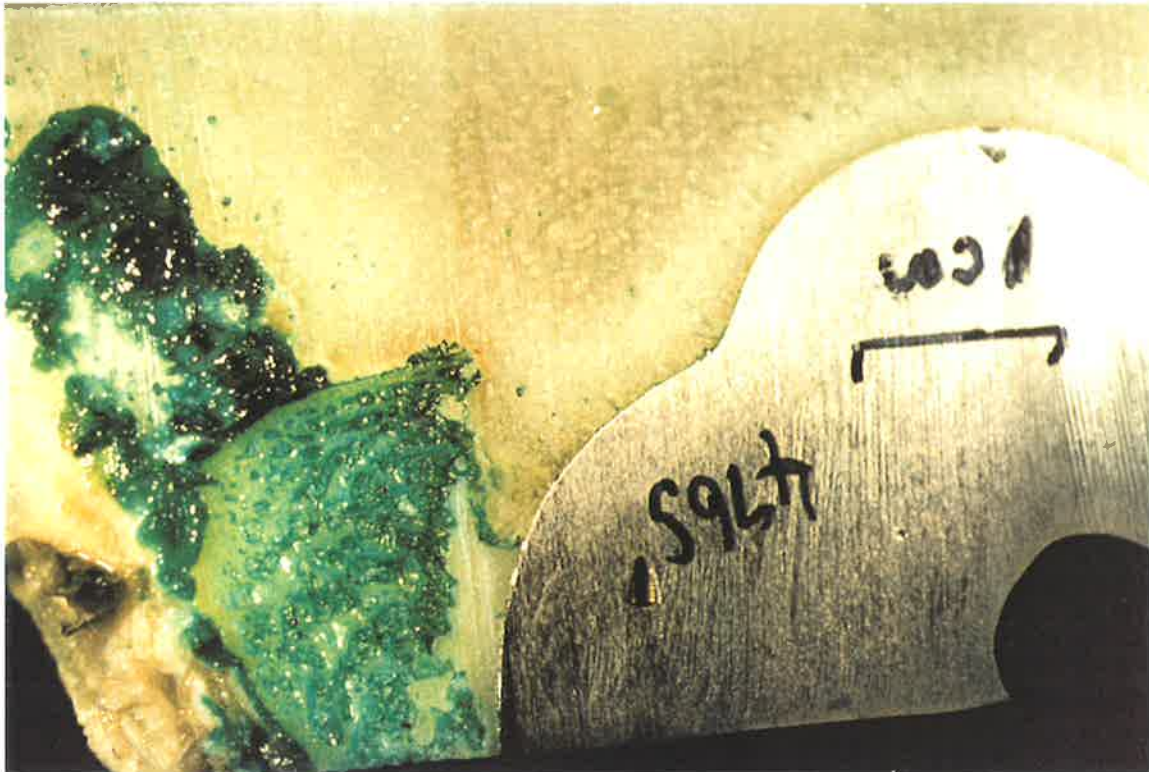
**Figure 4.12.** Mid-coronal section of proximal femur. There is new bone growth over the greater trochanter.

New bone growth over the greater trochanter was seen (Figure 4.12).

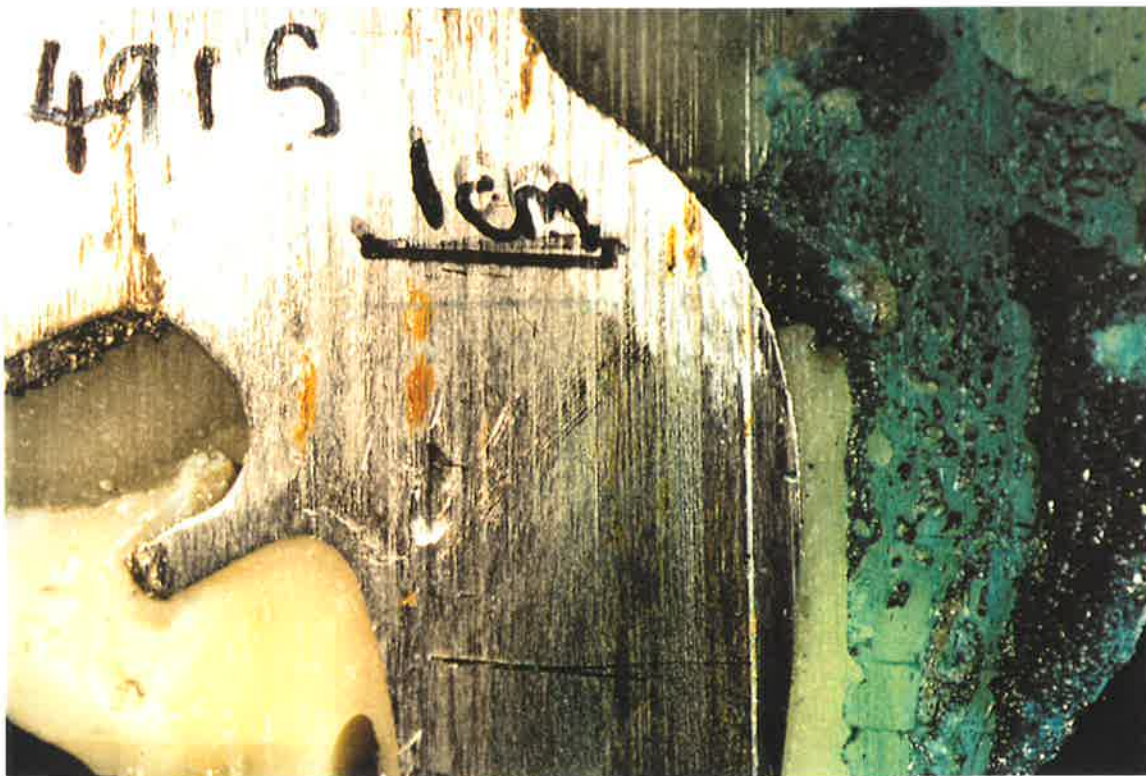
**Figure 4.13.** Mid-coronal section of proximal femur. There is a uniform cement mantle with no fracture and good cement-bone interdigitation.

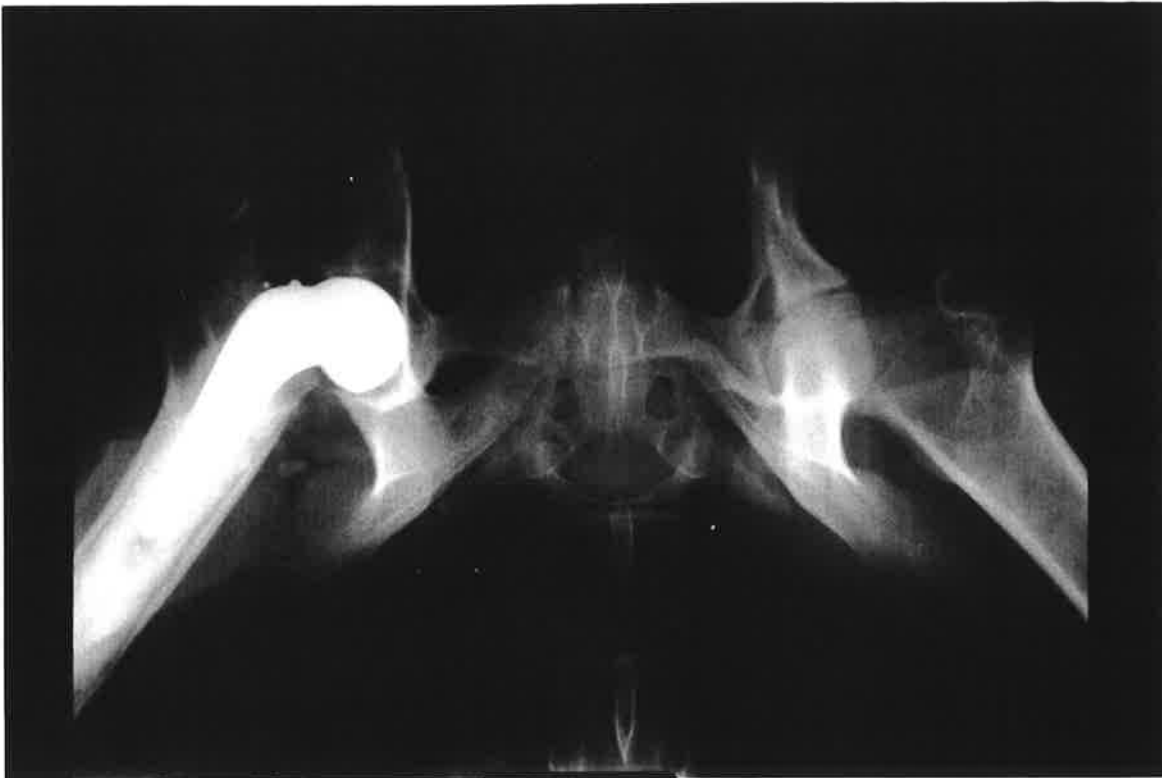
**Figure 6.2.** Radiographs of the polished implant #23.  
(a) Immediate post-op. (b) Nine months after implantation.

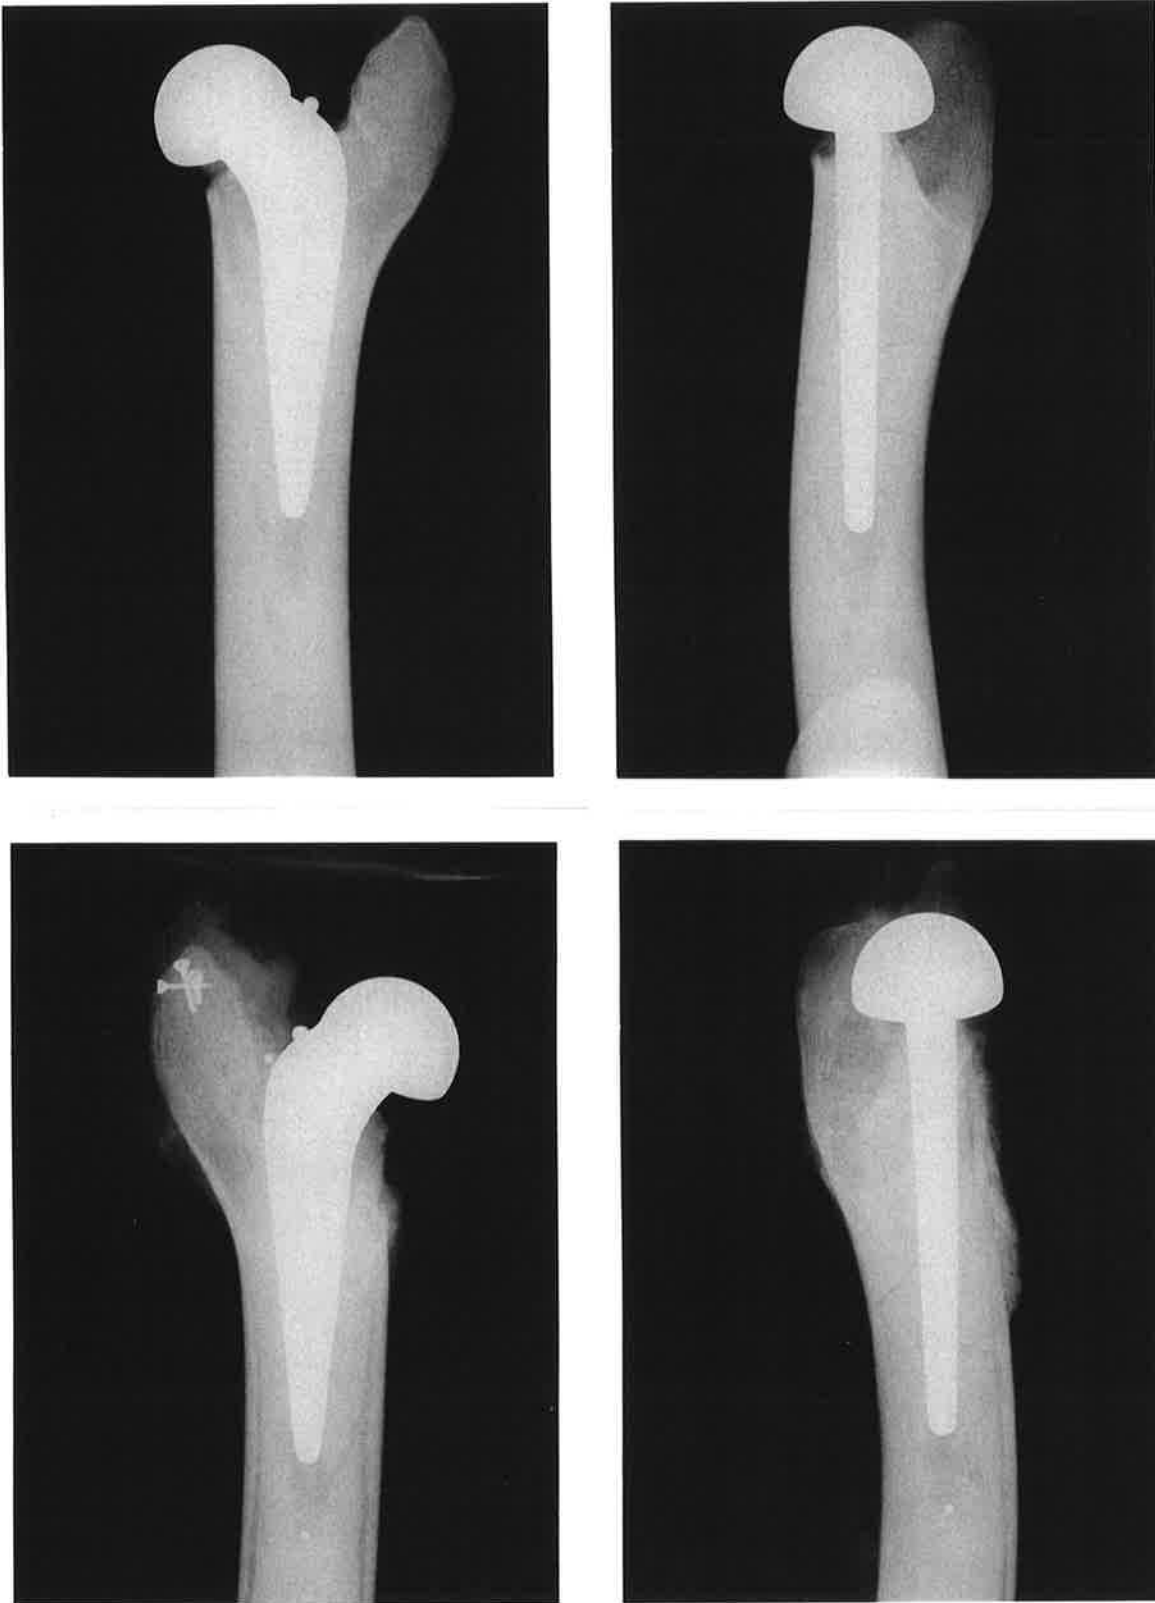
**Figure 6.3.** Explanted femur contact radiographs of polished implant #23.  
(a) Contralateral femur immediately after implantation (AP and lateral).  
(b) Nine months after implantation (AP and lateral).
