The Effect of Surface Roughness and a Collar on  
Fixation of Cemented Femoral Stems *in vivo*

Scott Andrew Brumby B.M. B.S.(Flind)

University of Adelaide

Thesis submitted in September 1996 for the degree of  
Doctor of Philosophy in the University of Adelaide

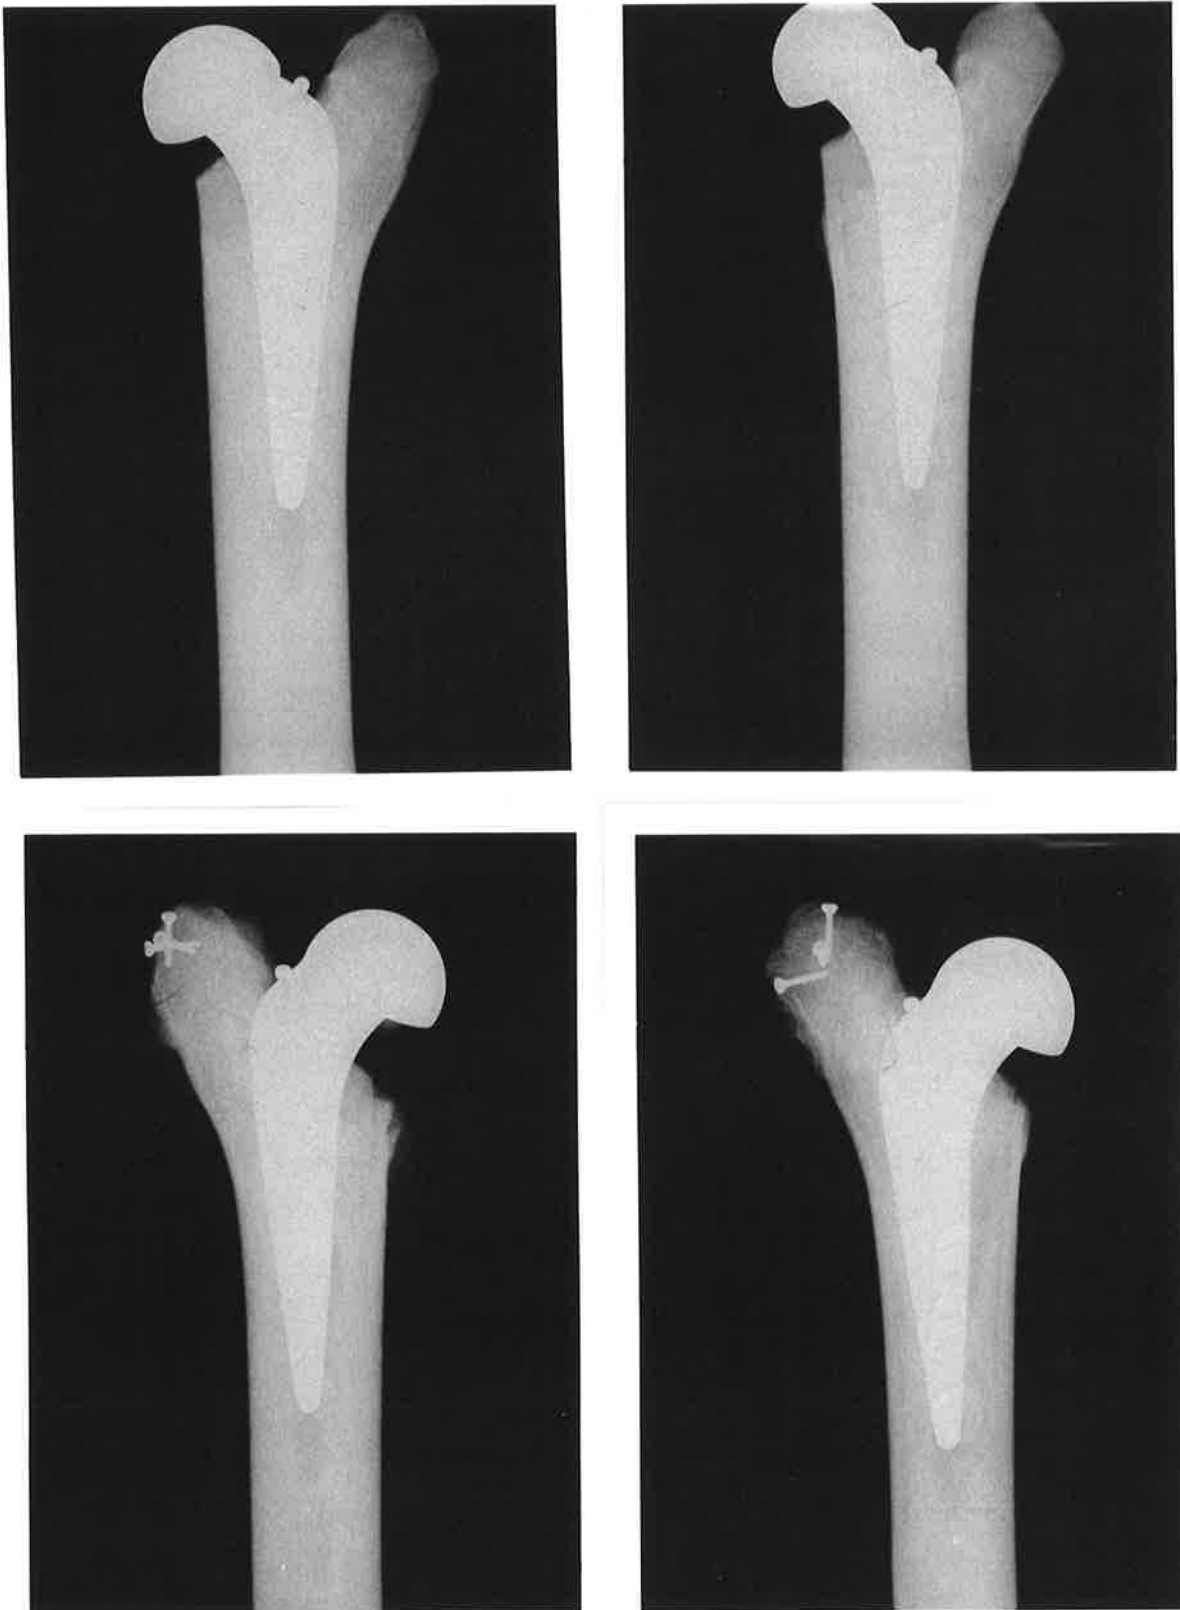
**Figure 6.4.** Explanted femur contact radiographs of polished implants #5 and #7 showing mild calcar resorption.

When c-b lucent lines greater than 1 mm were used to diagnose loosening from the contact radiographs, all seven were assessed as having solid fixation. Medial cortex remodelling and some calcar resorption was seen in all femurs (Figure 6.4).

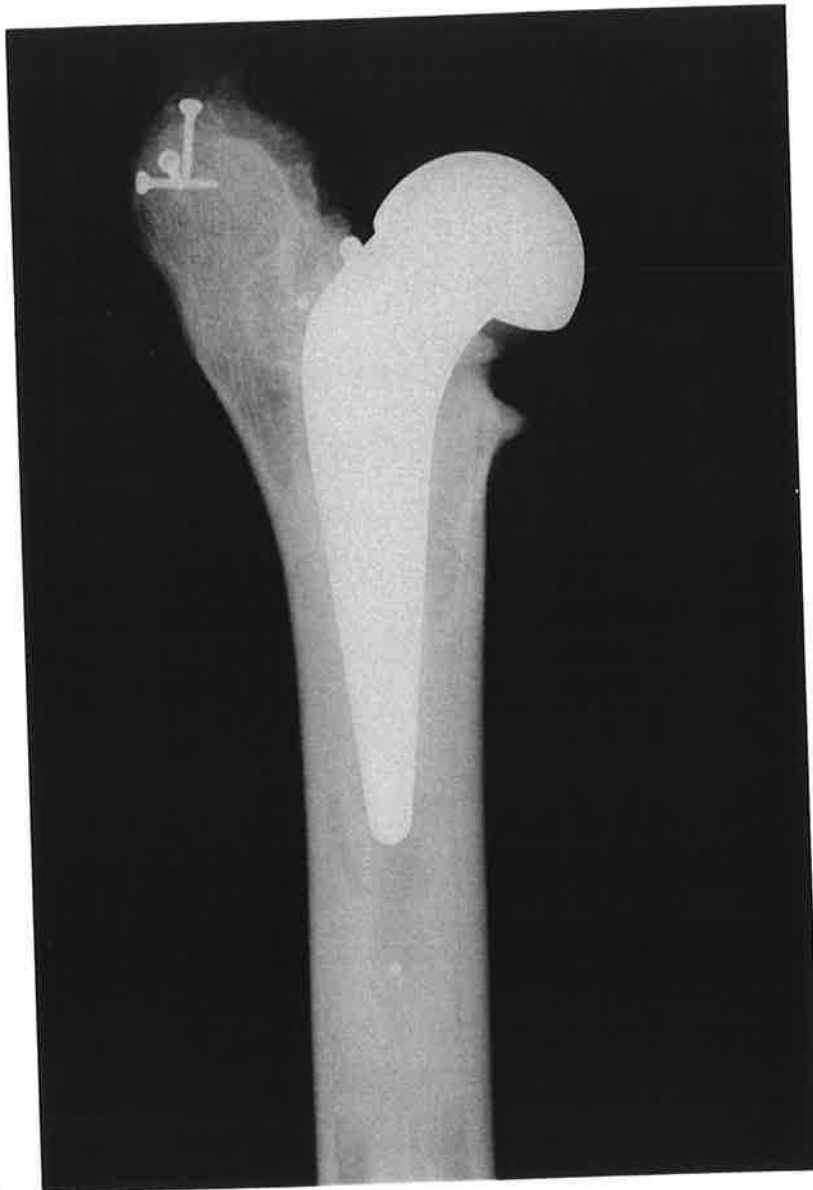
**Figure 6.5.** Explanted femur contact radiograph of matt implant #24 showing solid fixation.

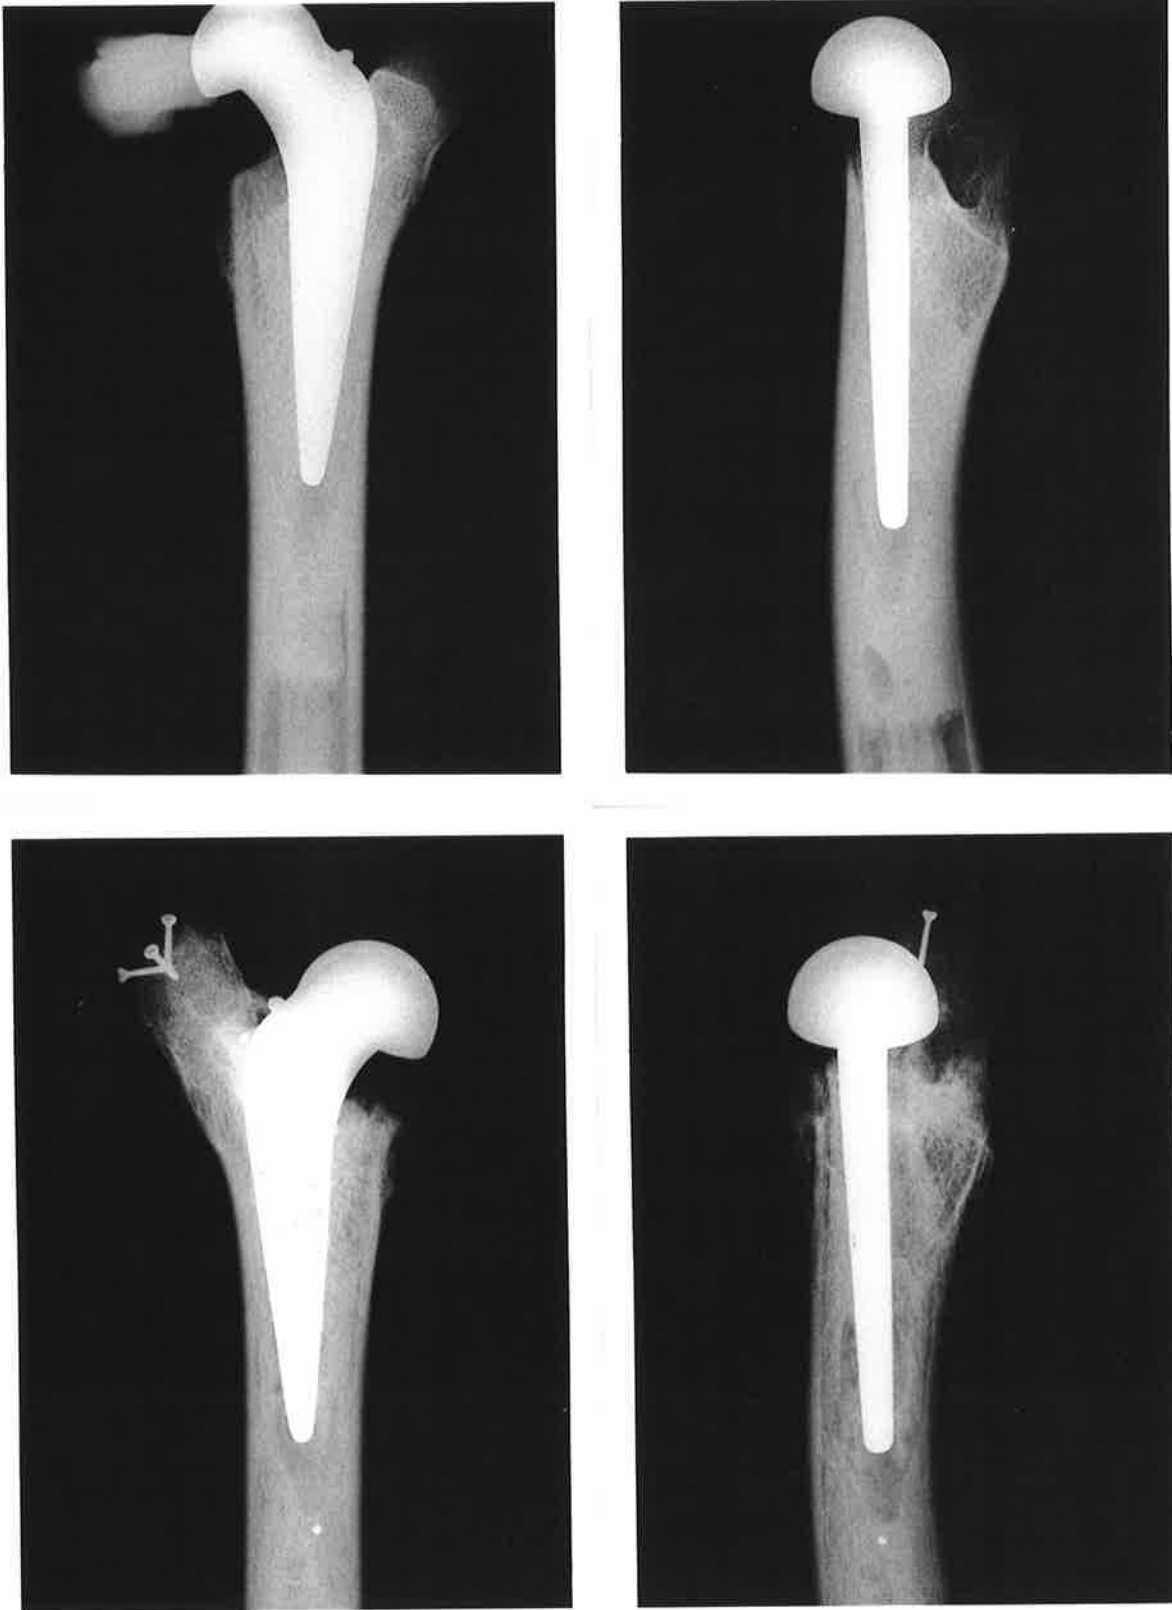
**Figure 6.6.** Explanted femur contact radiographs of matt implant #13 showing calcar resorption and possible loosening.  
(a) Contralateral femur immediately after implantation (AP and lateral).  
(b) Nine months after implantation (AP and lateral).

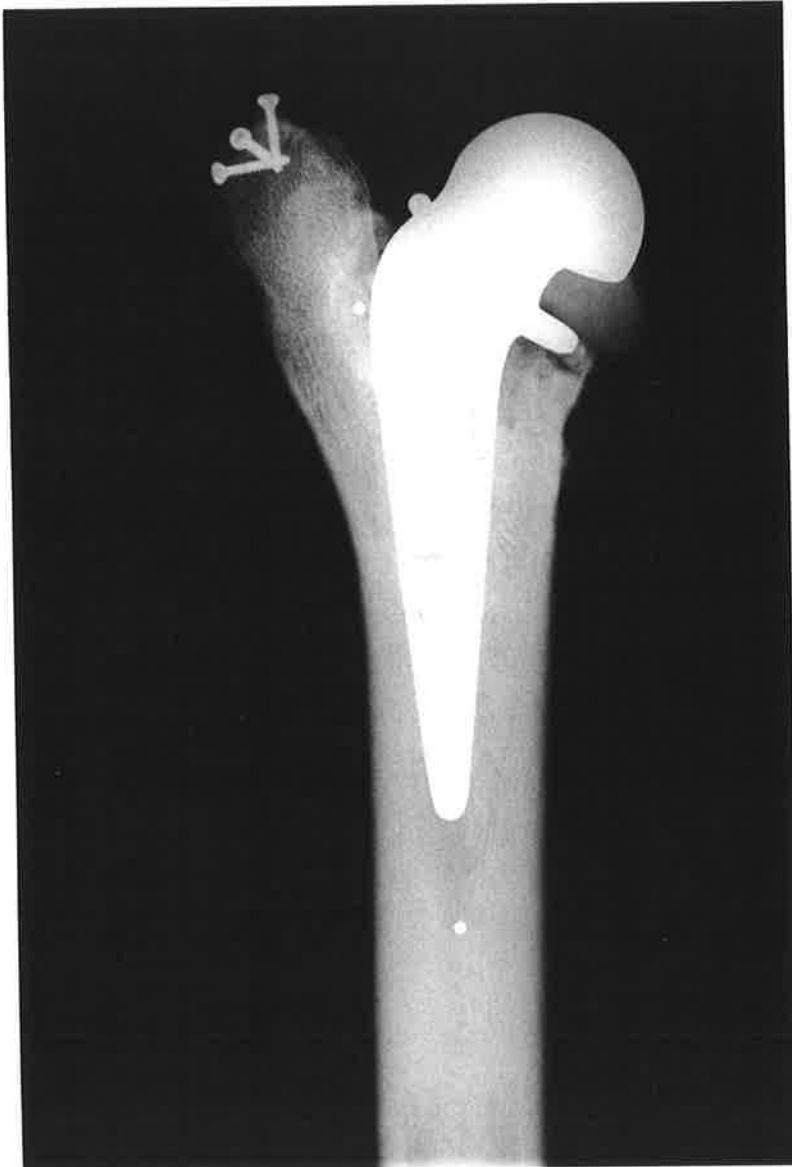
**Figure 6.8.** Explanted femur contact radiographs of collared implant #16 showing a solid cement-bone interface with calcar resorption under the collar.

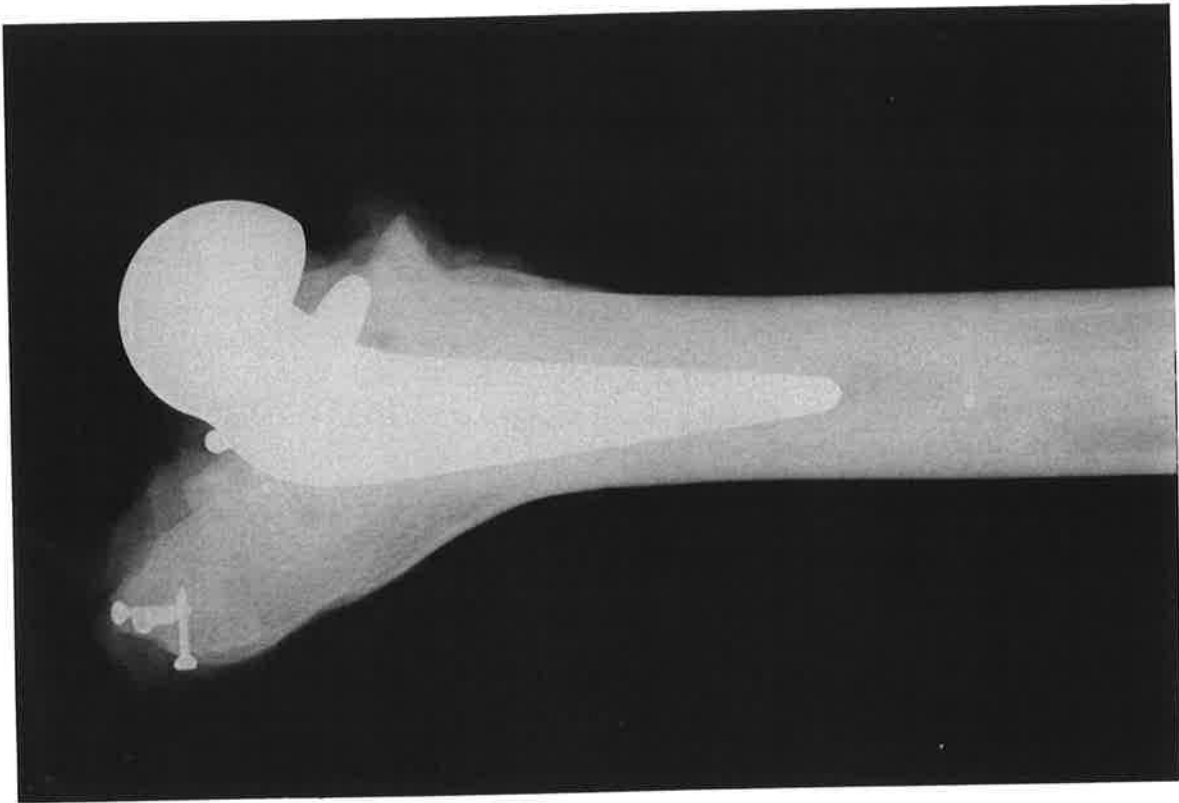
**Figure 6.9.** Explanted femur contact radiographs of collared implants # 9 and #28 showing calcar remodelling.

Due to exposure differences between radiographs it was not possible to detect an objective measurement of calcar resorption below the collar (Figure 6.9). Calcar resorption was seen with all implant types and not unique to the collared implants.

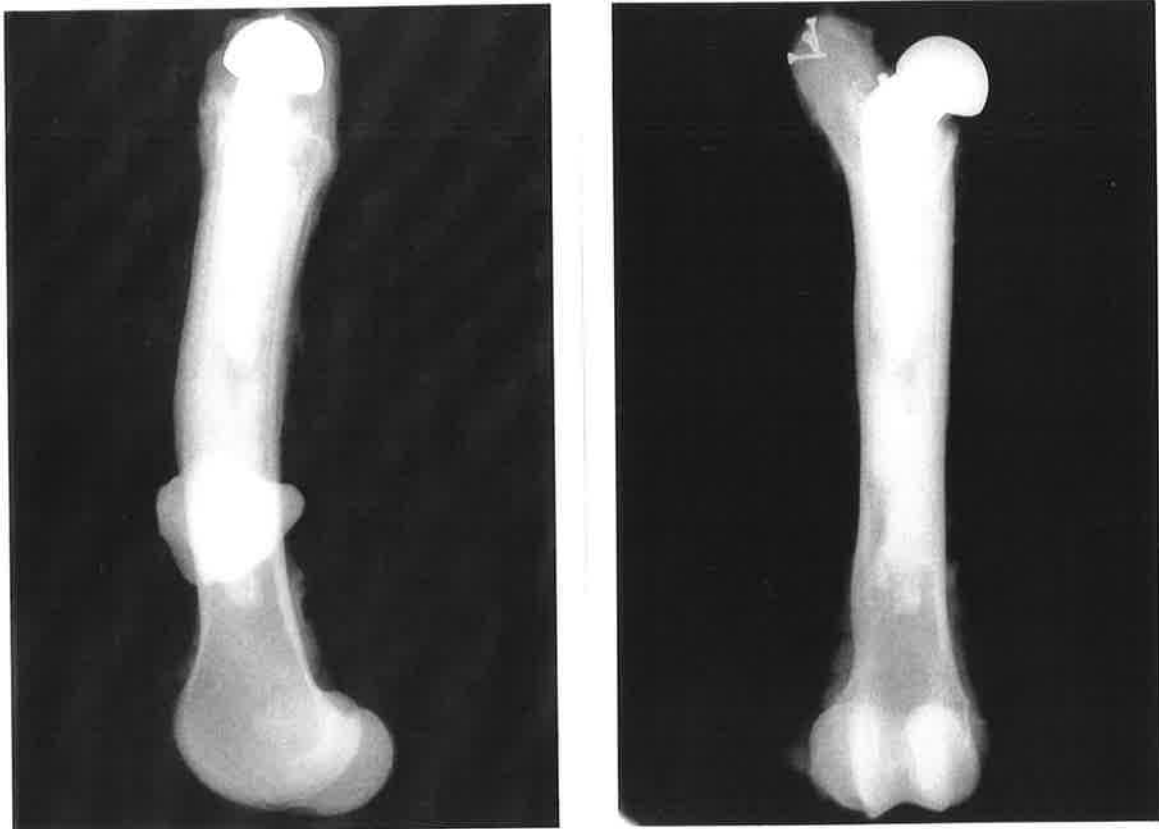
**Figure 6.10.** Clinically loose implant that was diagnosed on plain radiographs as probable loosening (sheep #R3).

The one clinically loose polished implant (#R3) had a complete cement-bone lucency greater than 1 mm on the lateral radiograph, and a complete cement-bone lucency on the AP pelvis radiograph that was greater than 1 mm in four zones and 0.5 mm in three zones and therefore by definition was probable loosening. The findings on the contact radiographs were similar with greater width lucent lines on the lateral radiograph.

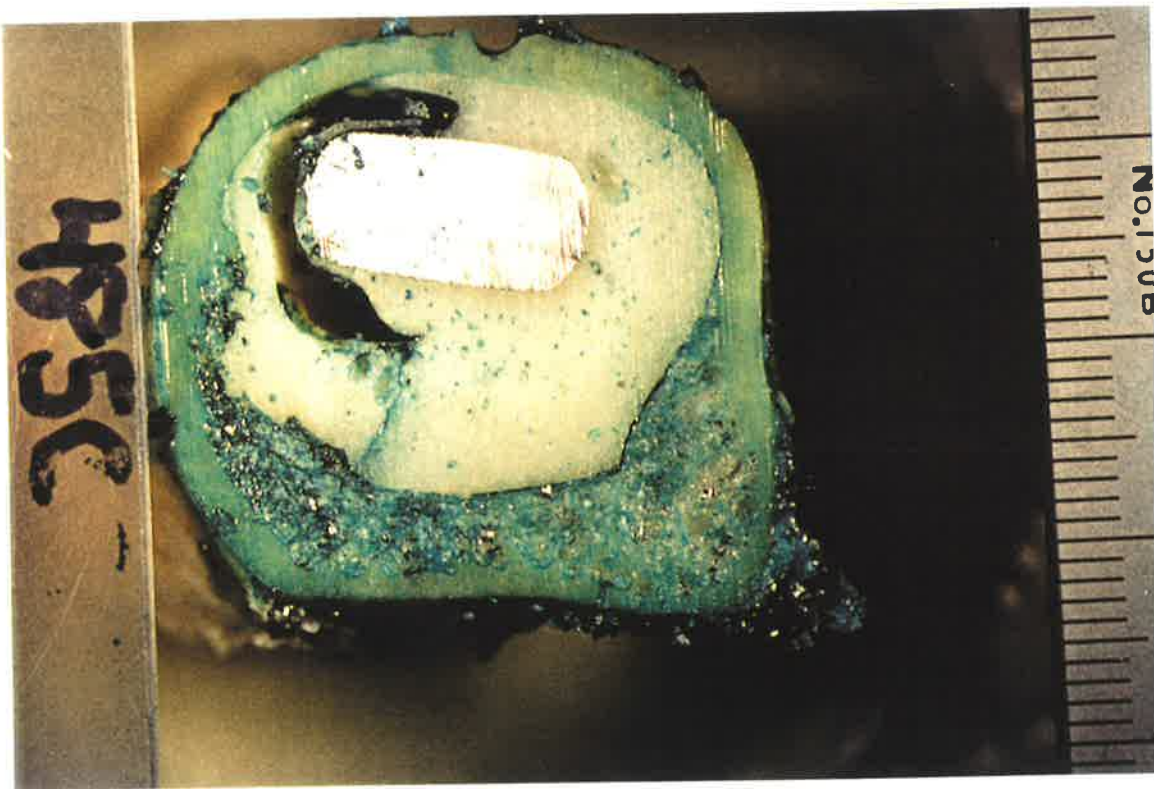
**Figure 7.14.** Microphotographs of cement mantle fractures.

There was one cement mantle fracture seen in two proximal sections of one femur (#485, polished, Figure 7.14). This was associated with a void that extended to the proximal cement surface and was thought to be a sectioning artefact. Voids were common within the cement mantle and varied in size from less than 1 mm to 30 % of the cement mantle area in several sections (Figure 7.15).

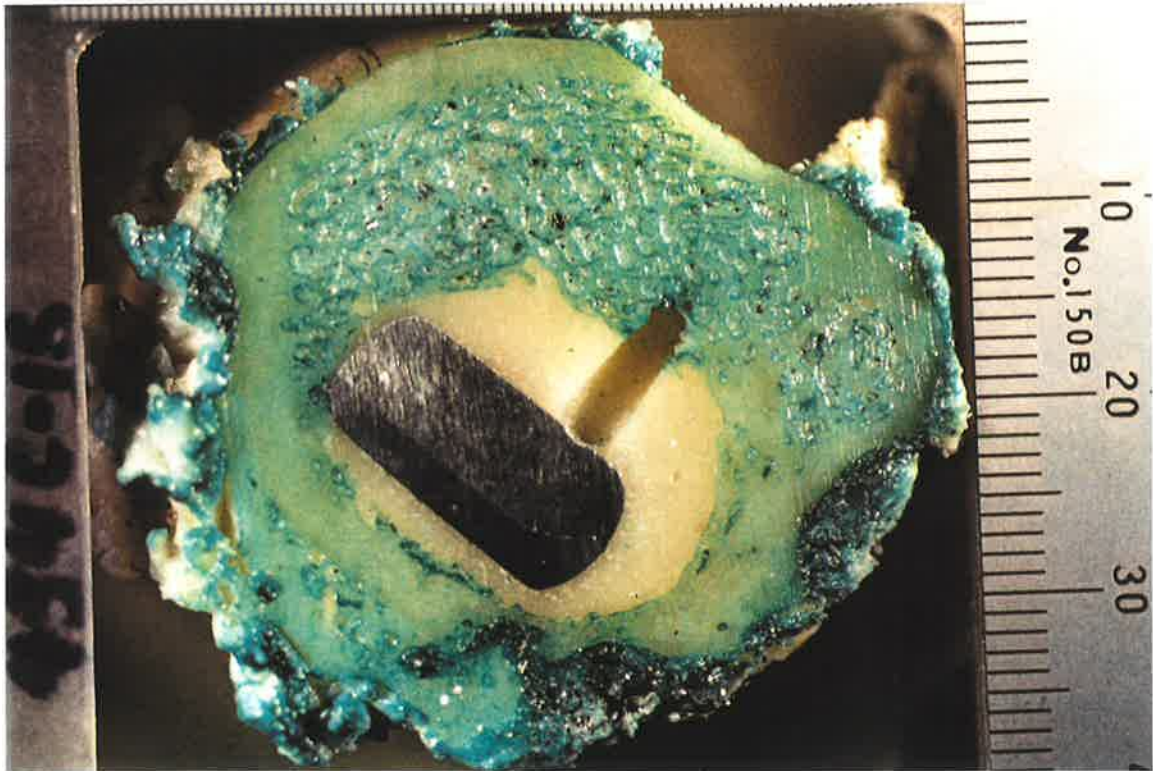
Figure 7.23. Proximal heterotopic bone (a) sheep #11, polish. (b) sheep #R2, matt..

Heterotopic bone was prominent around the medial cortex of the most proximal sections in all implants (Figure 7.23).
