Anaesthetic Breathing Circuit Obstruction Due to Blockage of Tracheal Tube Connector by a Foreign Body—Two Cases

Department of Anaesthesia, The Queen Elizabeth Hospital, Adelaide, South Australia

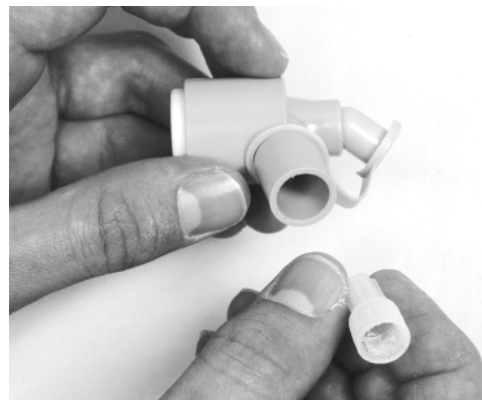
pulmonary contusion and a mesenteric tear. Examination of the tracheal tube connector revealed an intravenous giving set cover had lodged in the fresh gas inlet of the Portex Blue Line swivel connector, totally blocking inflow of fresh gas (Figure 1).

FIGURE 1: Showing Portex Blue Line swivel connector in the left hand and intravenous giving set cover held in the direction in which it lodged.

A significant number of the reported obstructions to anaesthetic breathing circuits occurred in equipment which was opaque. The entire anaesthetic breathing circuit should be composed of "clear" transparent material. Packaging material of anaesthetic equipment and items such as caps for intravenous ports and gas sampling sites should be composed of brightly coloured material so that they can be easily identified if accidentally incorporated into the circuit.

of the obstruction, the tracheal tube connector, was retained in the process of attempting to relieve the obstruction by changing equipment. These two case reports illustrate very clearly the dangers of failing to eliminate the “whole” circuit (including tracheal tube connectors, filters, etc) when dealing with a case of unexpected airway obstruction.

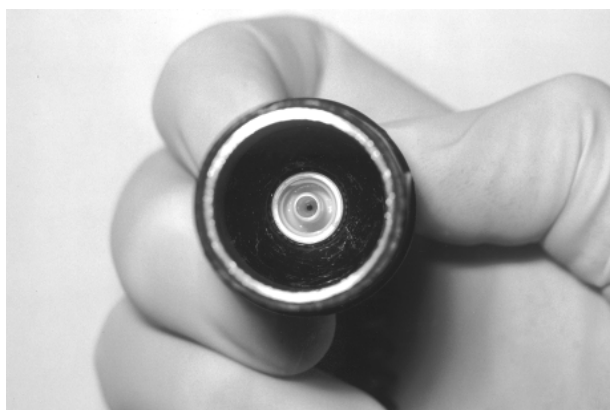
FIGURE 2a: Braun luer lock injection site tightly wedged in black endotracheal tube connector.

In this case a concerted effort was made to eliminate the circuit as the cause of obstruction to ventilation. Despite this, when the patient was transferred from the induction room to theatre to access another anaesthetic machine, the tracheal tube connector, which had remained on the patient's bed, was incorporated into the new circuit on the second anaesthetic machine. Examination of the anaesthetic breathing circuit revealed that the black flexible tracheal tube connector ("Liquorice Stick") was

nearly totally obstructed by a BRAUN luer lock injection site ("yellow bung") for intravenous cannulas (Figures 2a and 2b).
