GEOLOGICAL STUDIES FOR THE PLANNING
AND CONSTRUCTION OF TUMUT 2 UNDERGROUND
POWER STATION

By David H. Stapledon, B.Sc.
Engineering Geologist, Snowy Mountains
Hydro-Electric Authority, Australia.

Thesis for the Degree of
Master of Science, submitted
to the University of Adelaide
Economic Geology Department.

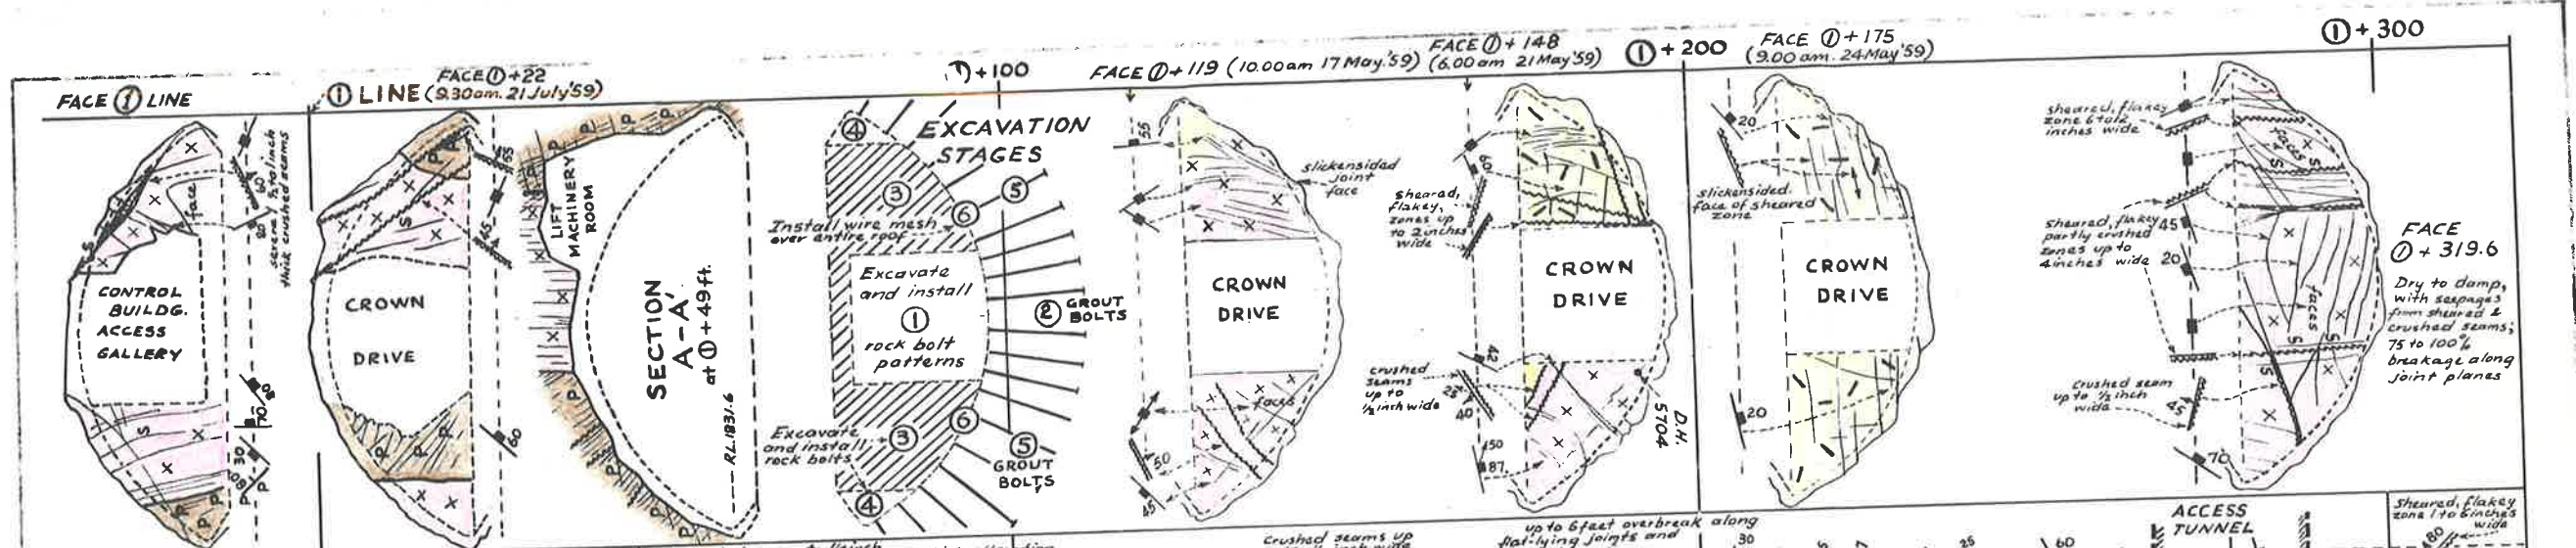
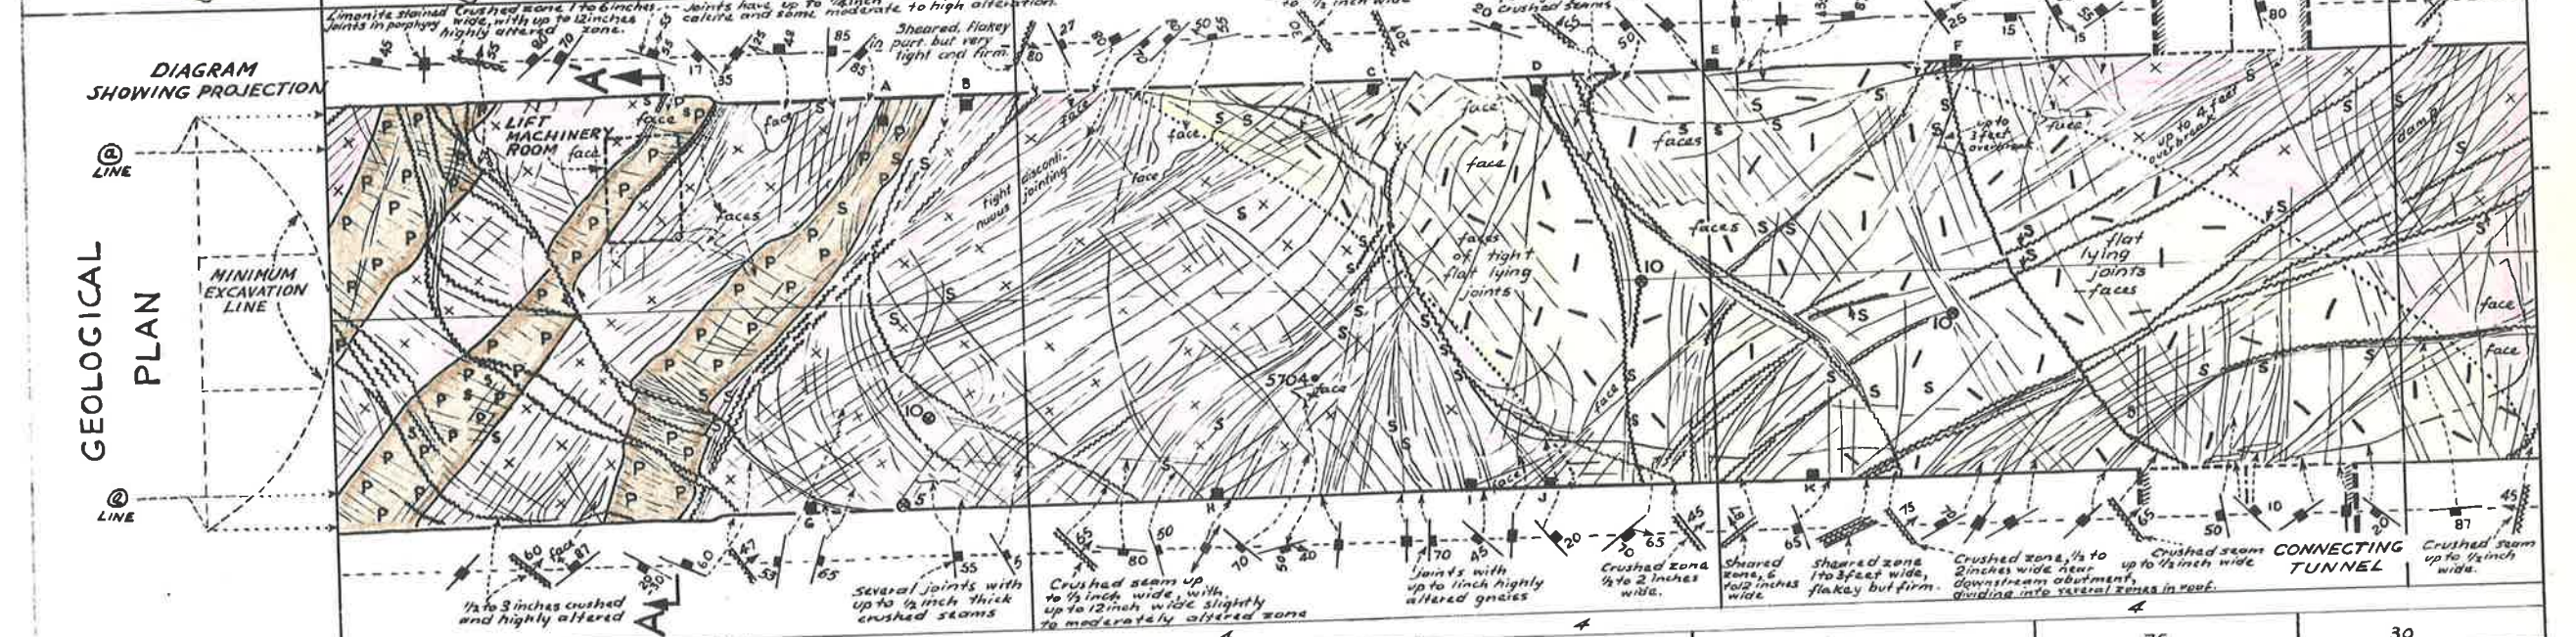
The maximum overbreak in the roof arch was of the order of 6 feet, and occurred in the upstream "shoulder" of the arch near station (1) + 180, as shown on Figure 10. It occurred along the flat-lying joints and steeply dipping crushed seams already mentioned in the section on the crown drive.

ROCK CONDITION	3 to 4		20		80 to 100		50		75		30																
PERCENT BREAKAGE ALONG JOINTS	75																										
SUPPORT DURING CONSTN.	UPSTREAM SIDE	32 R.B. : 14 ft.	157 R.B. : 12 ft.	96 R.B. : 14 ft.	221 R.B. : 12 ft.	54 R.B. : 14 ft.	82 R.B. : 12 ft.	35 R.B. : 14 ft.	79 R.B. : 12 ft.	21 R.B. : 14 ft.	82 R.B. : 12 ft.	11 R.B. : 14 ft.	17 R.B. : 14 ft.														
	CROWN	46 R.B. : 14 ft.	48 R.B. : 12 ft.	230 Rock Bolts, each 14 feet long.		110 R.B. : 14 ft.		105 R.B. : 14 ft.		85 R.B. : 14 ft.		48 R.B. : 14 ft.	60 R.B. : 14 ft.														
	DOWNSTREAM SIDE	25 R.B. : 14 ft.	186 R.B. : 12 ft.	85 R.B. : 14 ft.	170 R.B. : 12 ft.	50 R.B. : 14 ft.	65 R.B. : 12 ft.	27 R.B. : 14 ft.	60 R.B. : 12 ft.	31 R.B. : 14 ft.	61 R.B. : 12 ft.	10 R.B. : 14 ft.	19 R.B. : 14 ft.														
GROUND WATER	INITIAL QUANTITY	dump to dry, several seepages		mainly dry, few slight seepages as indicated		damp to dry, seepages and small flows as indicated		mainly dry with few seepages - 16 June '59		mainly damp, many seepages as indicated		dry to damp, few seepages, 16 June '59

QUANTITY, DATE	many seepages on downstream side 8 July '59		mainly dry with very few seepages 16 June '59								13759															
PHOTOGRAPHS		14075	13952	13762	13744	13741	13756	13757	13760	13734	13736	13737	13738	13761	13742	13735	13758	13755									
FINAL SUPPORT OR LINING		1	2	3	4	5	6	7	8	9	10	11	12	13	14	15	16	17	18	19	20	21	22	23	24	25	26

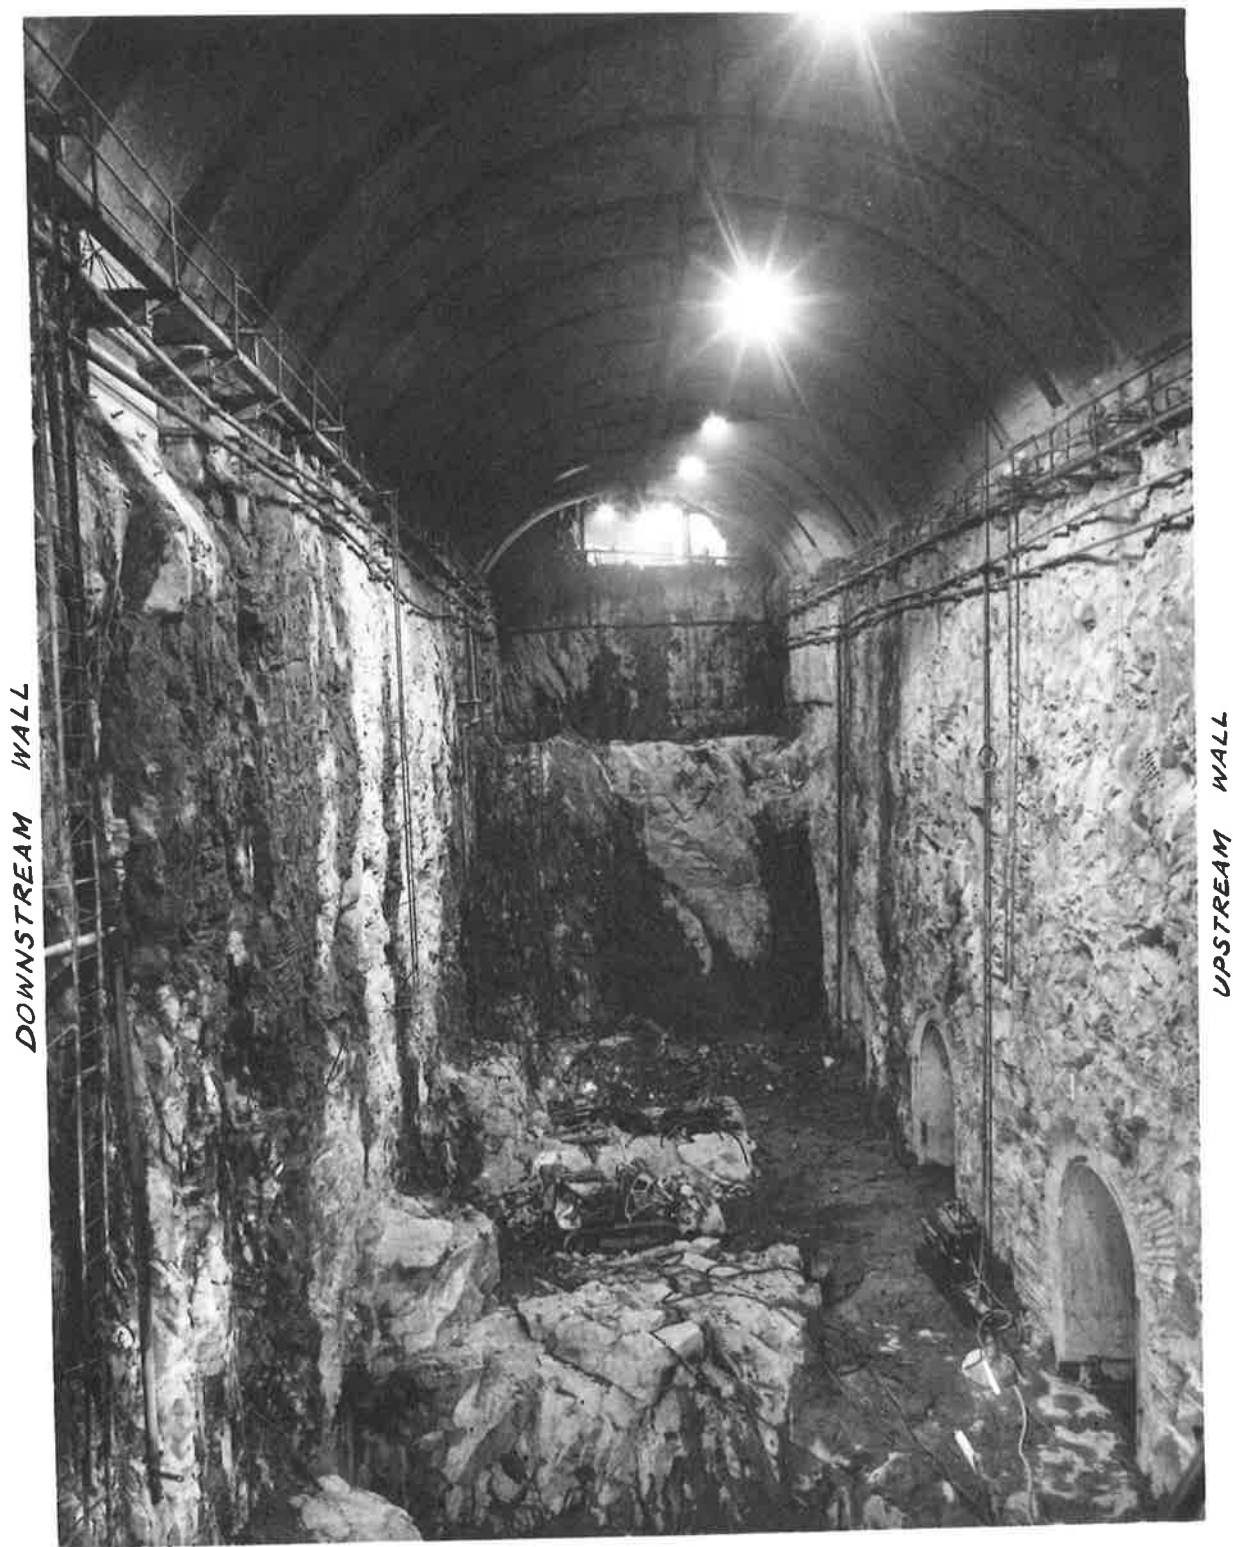
PLATE 14. EXCAVATION OF MACHINE HALL (CONTINUED)

STAGE 7. Completion of excavation by benching downwards. Rock spoil was removed through the Draft Tube tunnels, which are at the base of the downstream wall, on the left hand side of the photograph.

The reinforced concrete collars at the portals of the penstock and draft tube tunnels were highly successful in preventing overbreak at these places. The upstream wall was line-drilled radially from within the tunnels, and the smooth breakage which resulted can be seen on Plate 14.

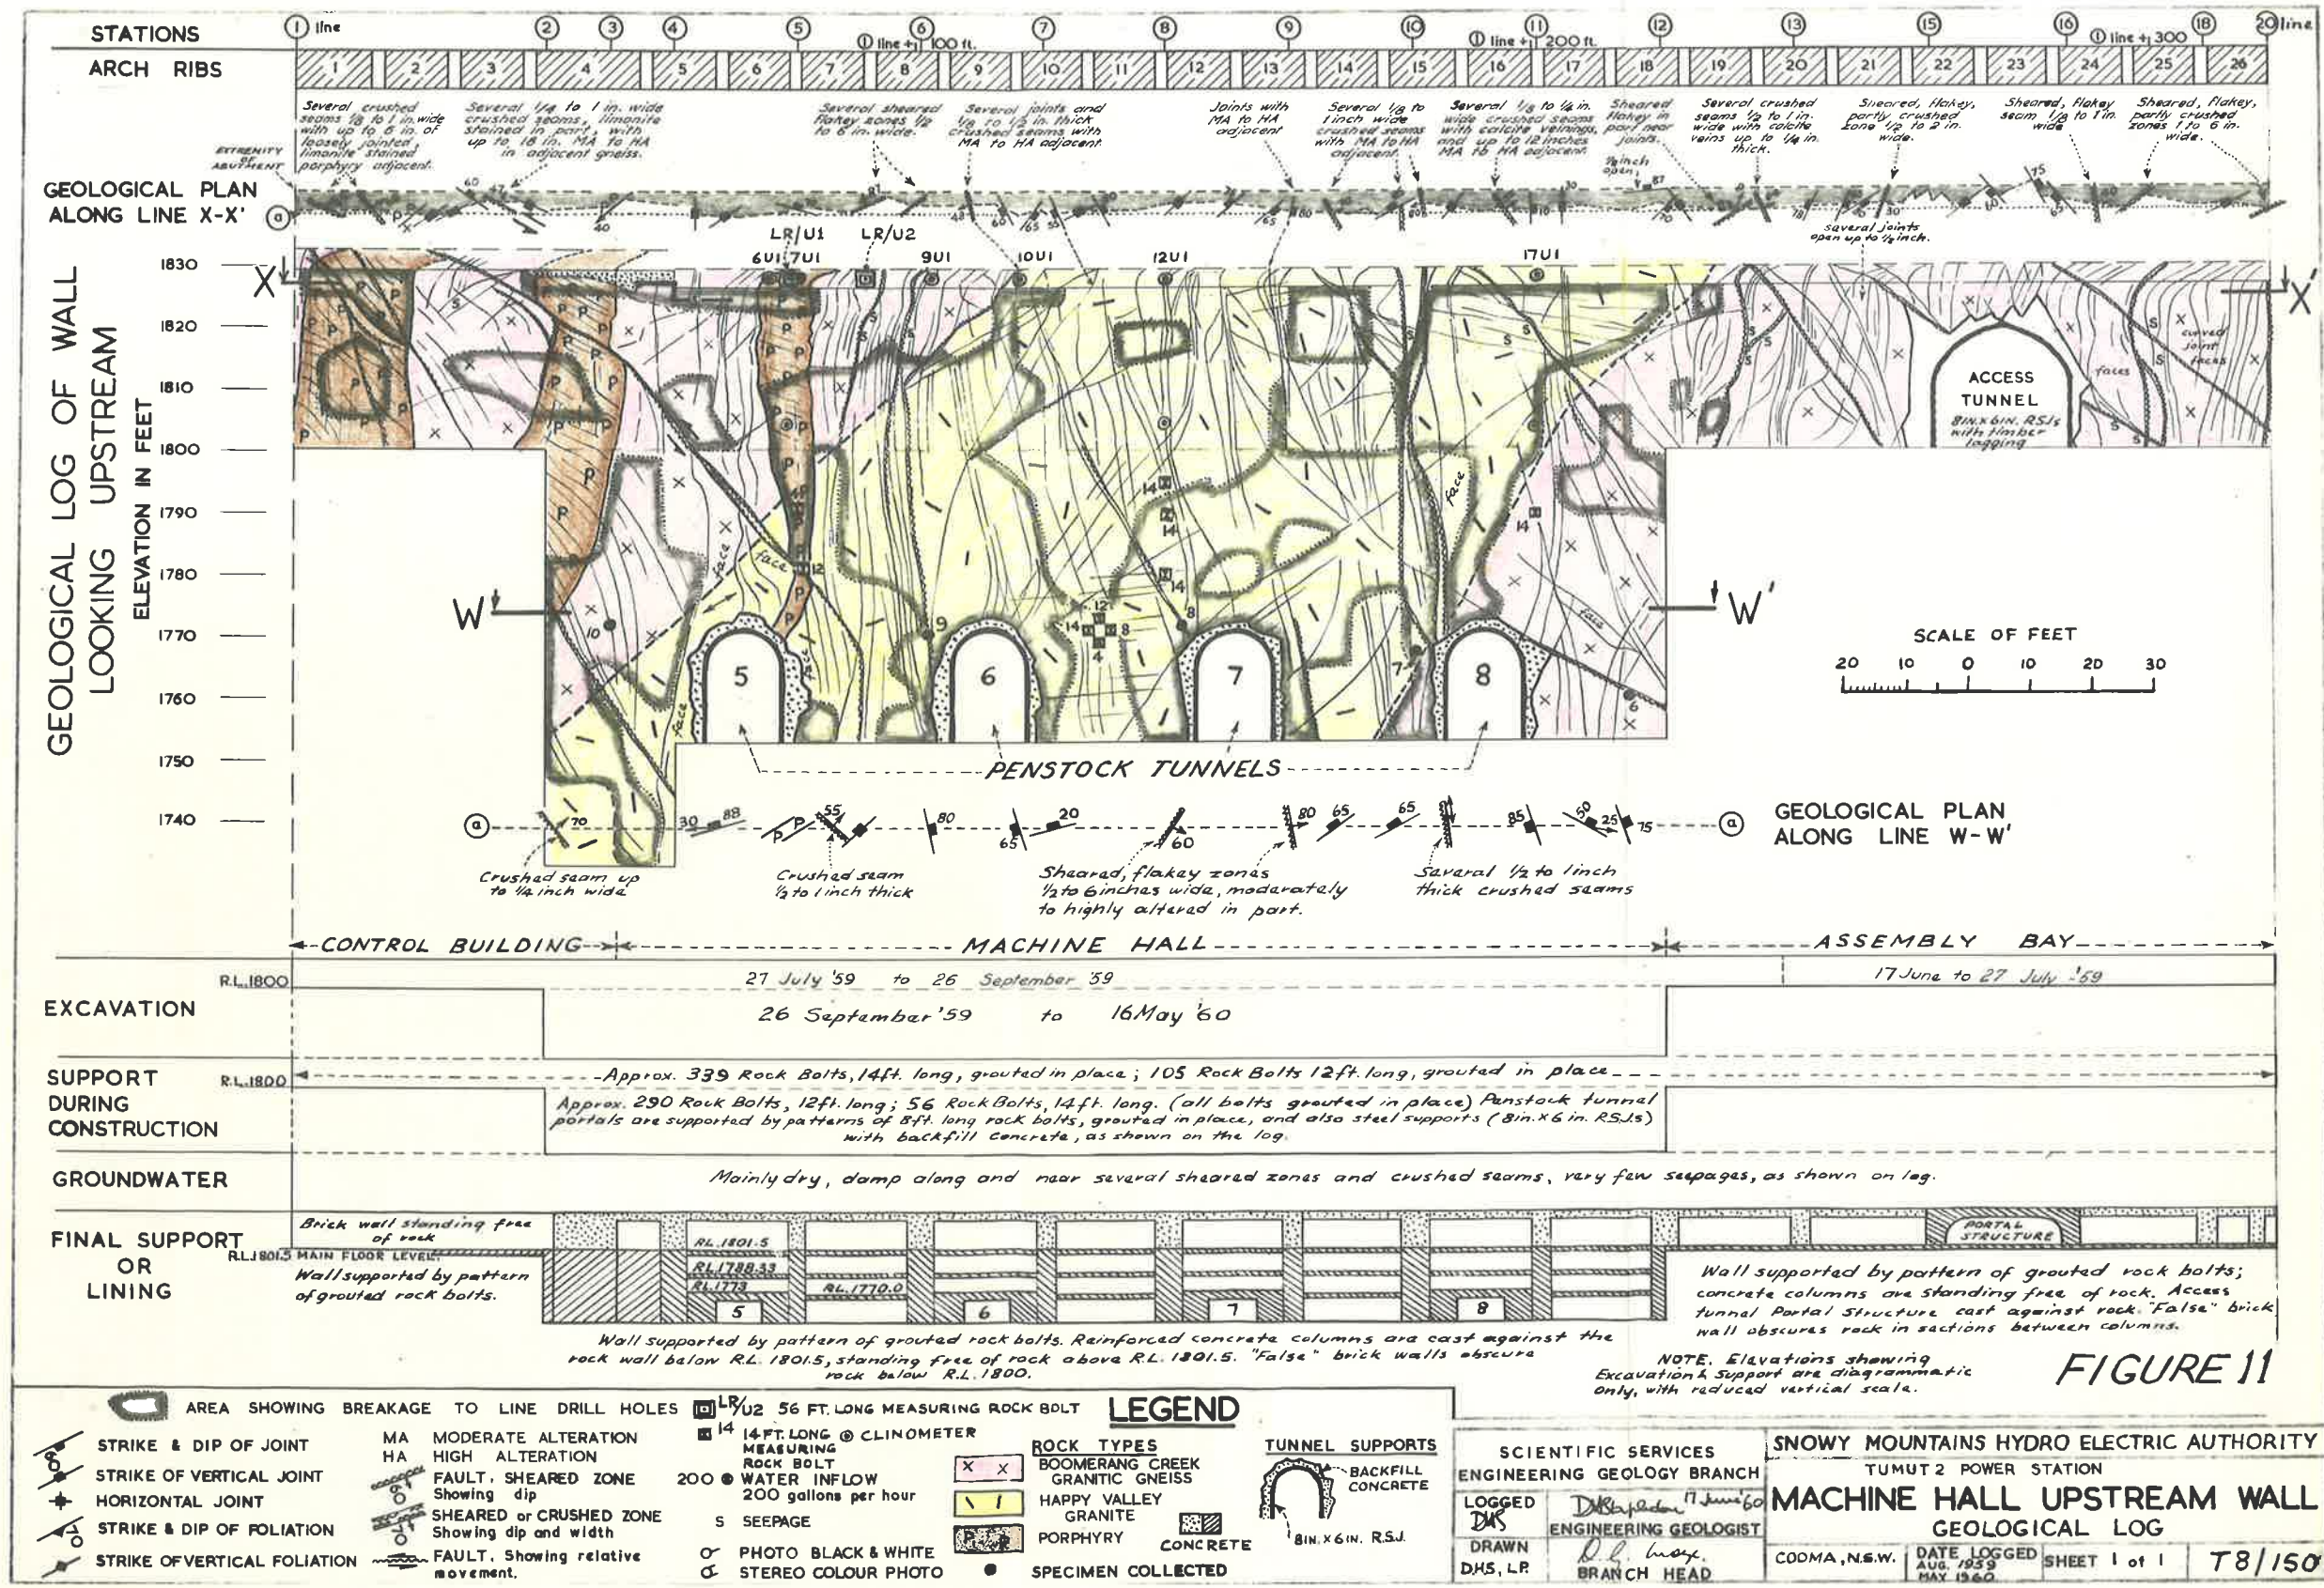
FIGURE 11

Figure 11, the log of the upstream wall, shows a plan 2 feet below abutment level, along line X - X'. This plan shows the extremity of the abutment, together with the (a) Line, or minimum excavation line, for the wall, and also the actual shape in plan of the excavated wall surface at this level. The sloped distance from the (a) Line to the abutment extremity, i. e. the designed maximum width of the abutment, is 4 feet 10 inches. The minimum allowable abutment width was 2 feet 6 inches, i. e. the nominal thickness of the concrete roof-ribs at this point. It can be seen from the plan that the abutment was preserved close to its maximum width for about half the length of the upstream wall. In most of the parts showing the full abutment width, the elevation shows that the wall broke along the line-drill holes. The remaining half broke mainly along joints, resulting in overbreak

Overbreak was usually greatest where joints or seams made shallow angles with the wall line. The worst section was above the Access tunnel portal, where the abutment rock was unconfined on three sides instead of the normal two. It had also been affected by several more close blasts than the rock elsewhere. It was necessary to extend the reinforced concrete portal structure upwards in this area to form the roof abutment. The worst overbreak section in the downstream wall is shown on Plate 14, in the left foreground, and also on Figure 12. As much as 4 feet of overbreak occurred in this area, along three steeply dipping joints which intersected behind the wall and isolated a wedge shaped slab of granite. A 10-foot long section of the wall and abutment was replaced by concrete in this area.

It was observed while logging that many joints in the rock within 10 to 15 feet of abutment level had opened up during the excavation. Many in the abutment itself were open as much as 0.05 inches, and a few as much as 0.2 inches. A high percentage of the rock breakage at these levels was along joint planes, and overbreak was more prevalent than at lower levels.

The visual observations near the abutments strongly suggested that progressive partial failure of the type shown on Figure 7, Diagram B, was occurring. Almost without exception the failure appeared to be occurring along existing joint planes. The avoidance of any total failure in the form of rockfall, and the relatively small amounts of total failure as overbreak, are attributed to the pattern rock bolting, performed as soon as possible after exposure of the rock in each lift.

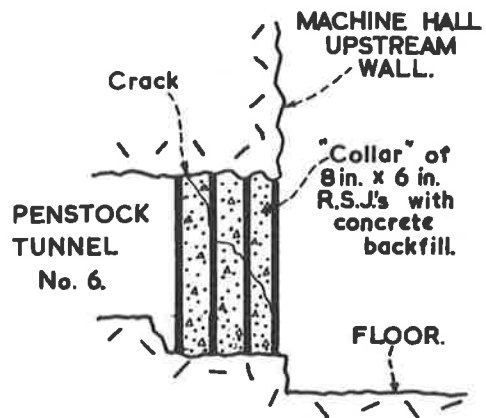
PLATE 17.

Crack open as much as 0.05 inch developed in the reinforced concrete collar of Penstock Tunnel No. 6, during excavation of the Machine Hall.

As the portal of each penstock and draft tube tunnel became exposed by the deepening, cracks similar to that shown on Plate 17 developed in their 10-foot long concrete collars. The worst cracking was seen in Draft Tube No. 8 tunnel, where several cracks with total opening of 0.2 inches occurred. The cracks were in some places en-echelon, and in every instance were dipping steeply (50° to 80°) towards the Machine Hall excavation, and indicated slight rock movements towards the Machine Hall. In some places the bond between the concrete collar and the rock was clearly broken, and hence the concrete movements had probably only reflected part of the actual rock movements which occurred. There was no definite evidence that additional rock failure occurred further back along the tunnels during the deepening. Small movements could have occurred along joints, some of which were slightly open both before and after the deepening. Moye (1958) describes similar cracking in concrete collars in the penstock tunnels at Tumut 1. Rock failure which occurred further back along the penstock tunnels is also described. This occurred both along joints and by spalling across the rock fabric.

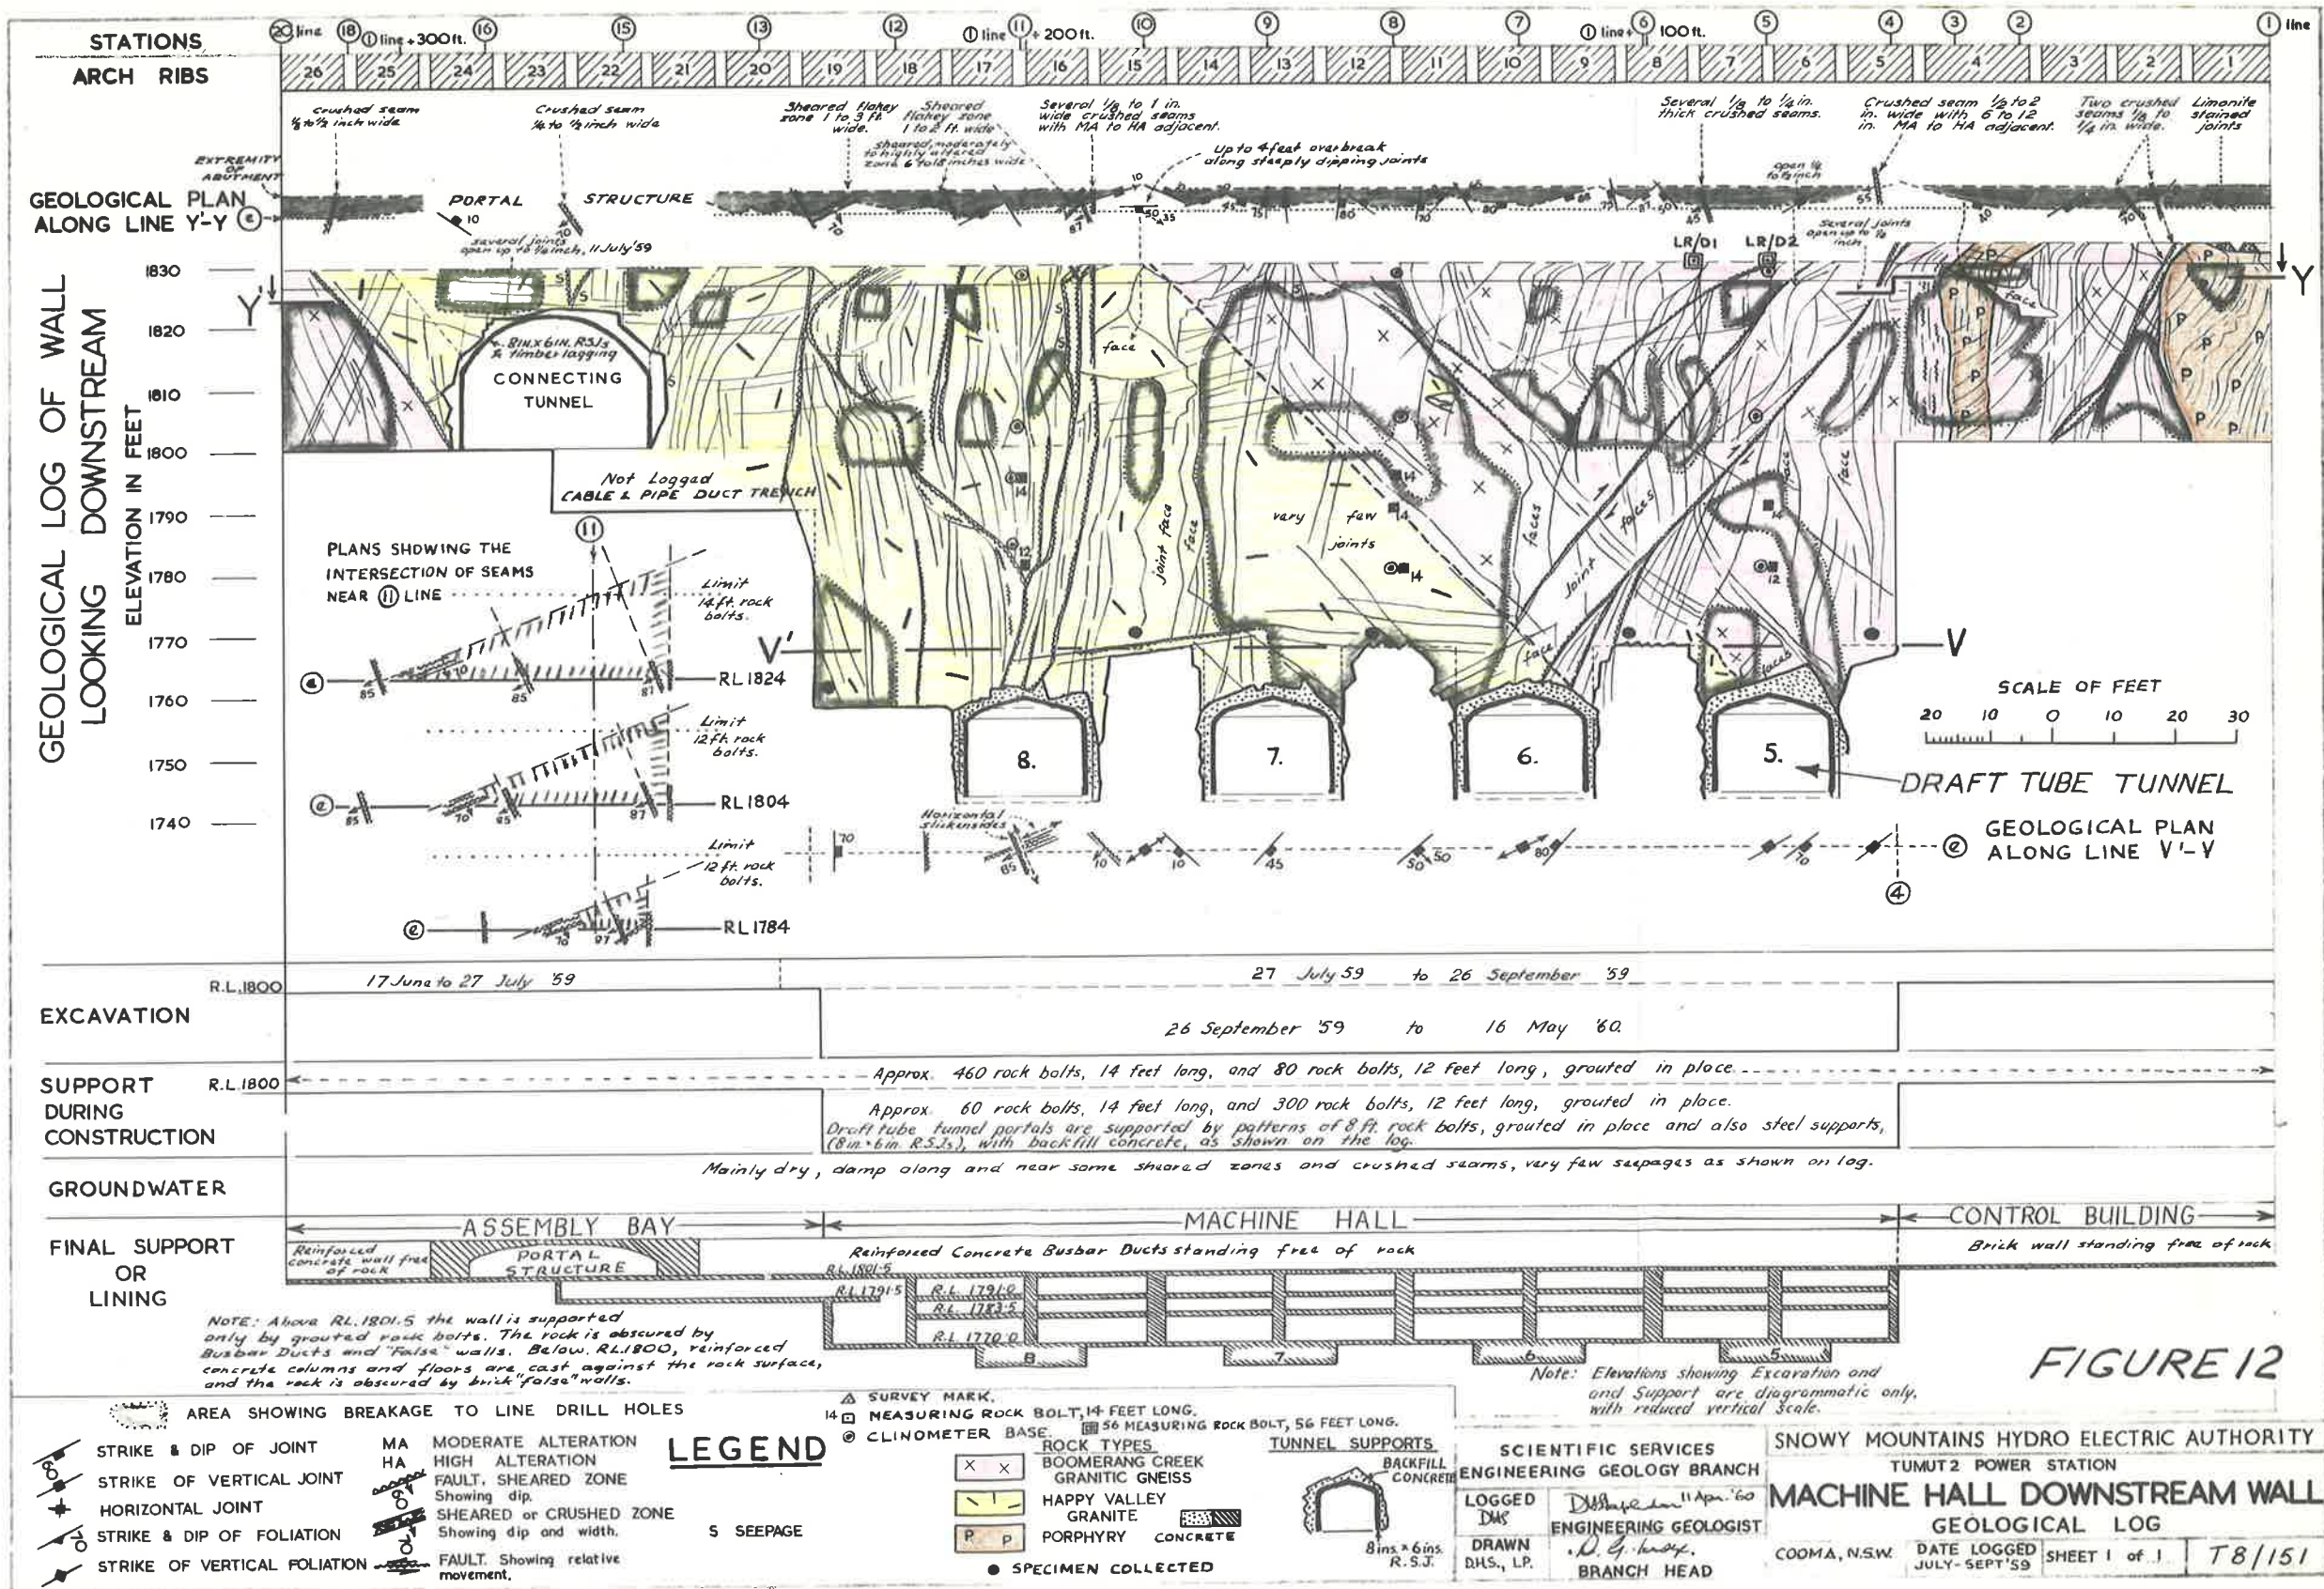
FIGURE 12

reference rods. Diagram C on Figure 7 was prepared by L.G. Alexander (1960, Reference 4) to show the large extensions which were obtained in some of these bolts. The four bolts referred to in the diagram were located between RL. 1790 and 1795 in the downstream wall of the Machine Hall, and are shown on Figure 12. It can be seen that large extensions were obtained, indicating loads which in two cases exceeded the elastic limit of the bolts.

Alexander (1959, Reference 2, and 1960, Reference 4) interprets these elongations as elastic strain in the rock due to stress reduction, together with some opening up along joints. The largest extension obtained was in bolt 11D, at RL. 1795 on the (11) line on the downstream wall. A close examination was made of this area when the large extensions became apparent. It appeared that an inverted triangular pyramid of rock was in effect isolated from the surrounding rock by the intersection of several minor faults, as shown by the three diagrammatic plans and the elevation on Figure 12. In many places at the face of this block, cracking of dust and grout films over joints indicated that slight movements were taking place as the excavation was deepened. A fall of rock estimated as one third of a cubic yard occurred from the very loose surface layer during an off-shift period. It was concluded that this block had moved inwards towards the excavation to a greater extent than the rock elsewhere, which mostly had well interlocked joint blocks. The sections on Figure 12 also show the limits of penetration of the rows of 14 and 12-foot long grouted rock bolts which supported this section of the wall. The final elongation recorded on bolt 11D indicated that these bolts were probably stressed close to their yield point, assuming that the strain was evenly distributed along them. As the bolts were grouted in place, it was possible that failure of the grout surround could occur locally and concentrate the strain on short sections of the bolts, and thus result

During the final excavation of the Machine Hall floor, three pillars of rock were left between the machine pits, as shown on Plate 14 and Figure 12. Rock bolts sloping downwards were employed to control overbreak and opening up along joints which occurred during excavation around the pillars. The deterioration of this rock was attributed partly to the number of close blasts to which it had been subjected, as it became unconfined on three and partly four sides. The partial development of tensile stresses in these projecting pillars, as indicated by Worotnicki's photoelastic studies, must however have been the main cause.

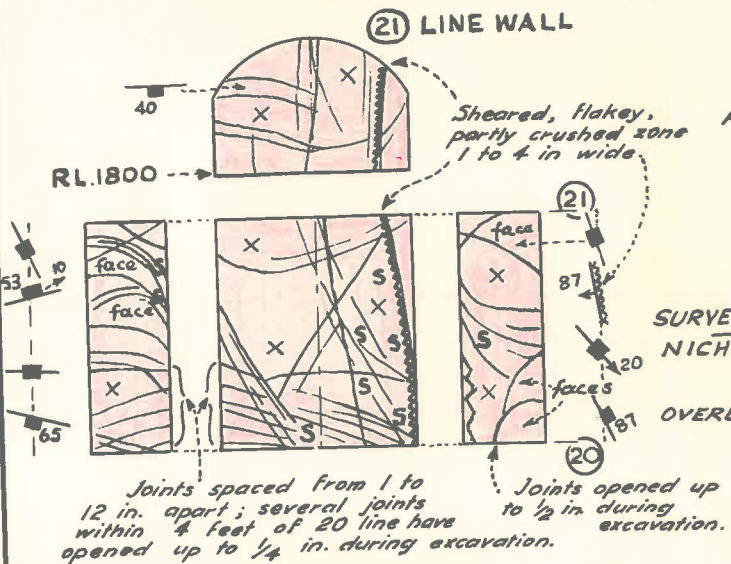
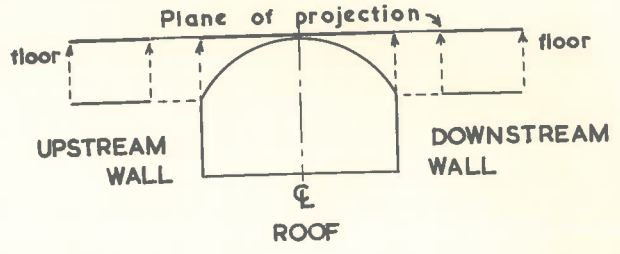
**WORKSHOP
 GEOLOGICAL LOG**

EXCAVATED: 30 July to 11 August, 1959
 ROCK CONDITION: Mainly 4, some 3 within 4 feet of 20 line.
 BREAKAGE TO JOINTS: Roof and 21 line wall 20%, walls 50 to 100%.
 SUPPORT DURING CONSTRUCTION: None. Reinforced Concrete Lining.
 GROUNDWATER: Mainly dry, seepages as shown.
 PHOTOGRAPHS: 14030, 14185

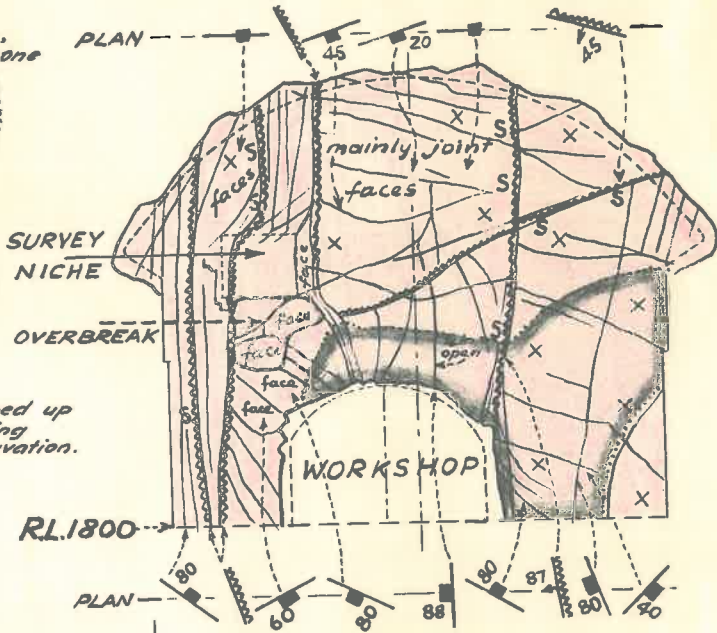
**(20) LINE WALL
 GEOLOGICAL LOG**

porphyry. This broke mainly along joints, but with very little overbreak. The wall was supported by a pattern of downwards sloping grouted rock bolts, mostly 12 feet long and spaced 4 feet apart horizontally and vertically. In the (20) Line or Assembly Bay end wall, considerable overbreak occurred along unfavourably oriented joints of set (ii), striking almost parallel to the wall, and dipping steeply towards the excavation. There was very little breakage along line-drill holes. Further overbreak and loosening of the rock along joints occurred when the excavations for the Workshop and survey niche were made into the wall. Downwards sloping grouted rock bolts, generally spaced 4 feet apart horizontally and vertically were installed as support. Many additional bolts were installed near the Workshop and Survey Niche.

ROCK CONDITION: Mainly 4
 BREAKAGE TO JOINTS: 75 to 100%
 SUPPORT DURING CONSTRUCTION: 155 rock bolts, mainly 12 feet long, grouted.
 GROUNDWATER: Mainly dry, seepages as shown.
 PHOTOGRAPHS: 14030, 13759, 13755, 14178, 14322, 14321

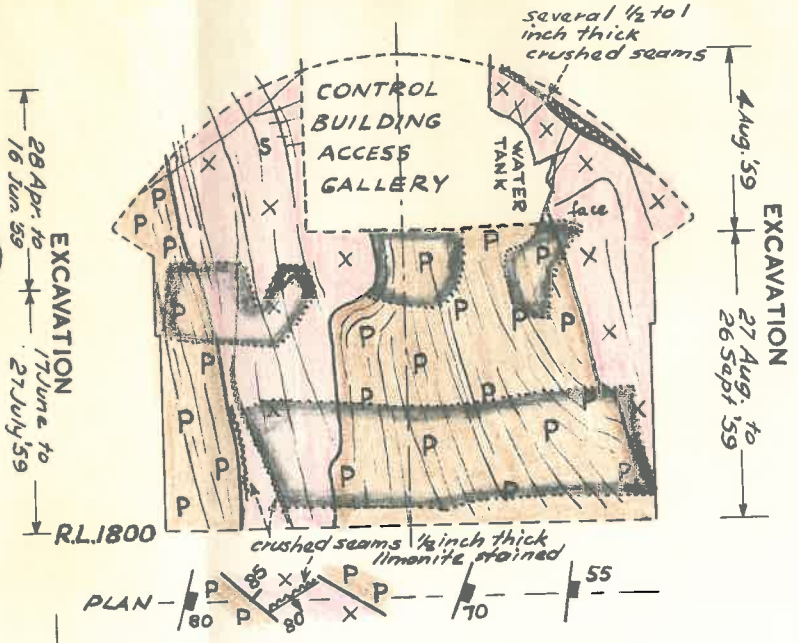
**(1) LINE WALL
 GEOLOGICAL LOG**

Geological logs of the vertical end walls of the upper portion of the excavation are shown on Figure 13. The (1) Line or Control Building end wall was composed mostly of tightly but closely jointed

ROCK CONDITION: 4
 BREAKAGE TO JOINTS: 50%
 SUPPORT DURING CONSTRUCTION: 112 rock bolts, each 12 feet long, grouted.
 GROUNDWATER: Mainly dry.
 PHOTOGRAPHS: 14331, 14337.
