ADELAIDE IN-DEPTH ACCIDENT STUDY

1975-1979

PART 6: CAR ACCIDENTS

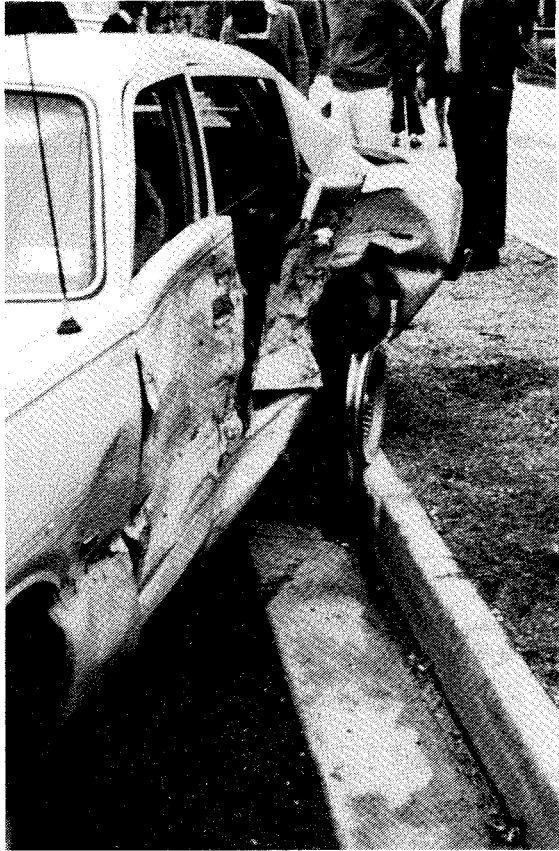
FIGURE 4.2:

Lower hinge fractured at point
of attachment to B-pillar
(Accident 012)

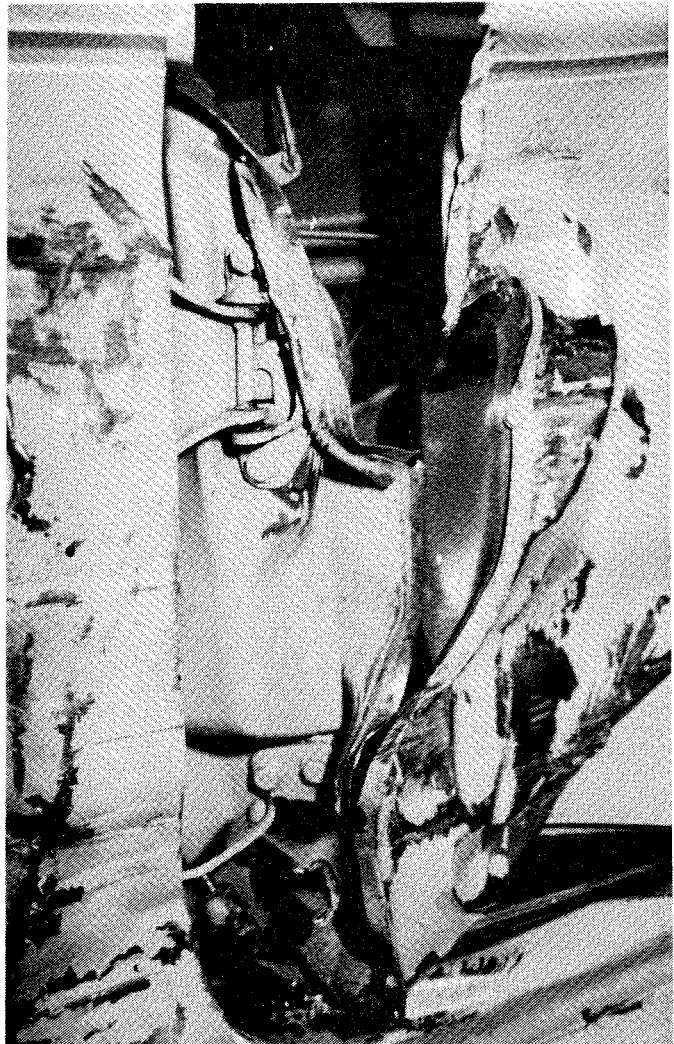
FIGURE 4.4:

Damage resulting from a right angle collision with another car (Accident 187, see also Figure 4.4)

Fractured lower hinge on rear door (see also Figure 4.3)

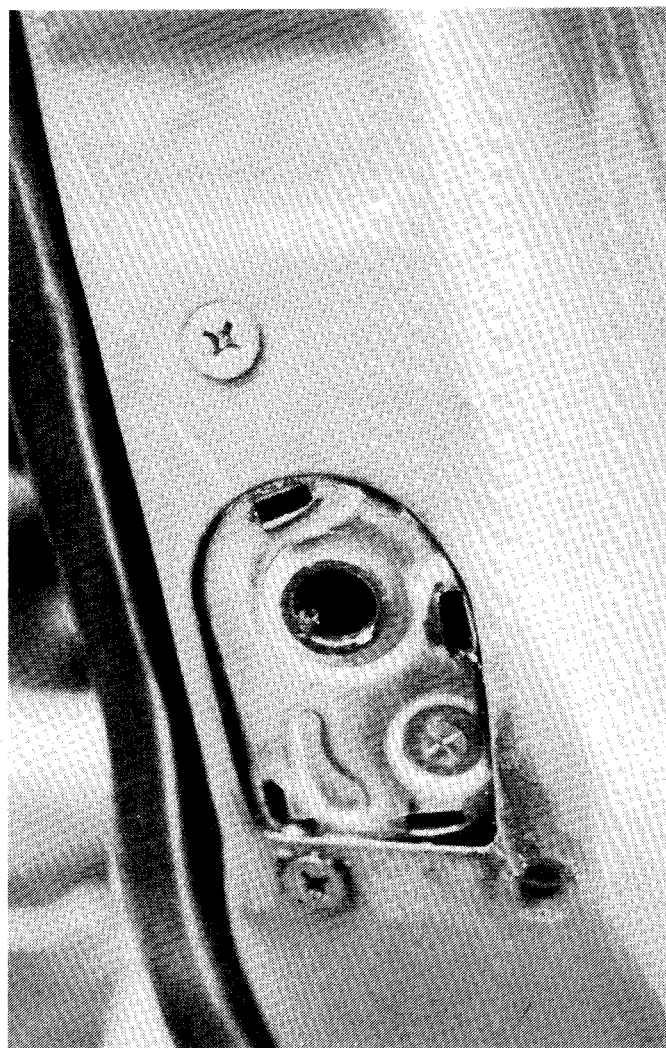
FIGURE 4.10:

The extent of the intrusion into the passenger compartment is shown in Figure 4.8, whilst evidence of the severe longitudinal load can be seen in the amount of deformation of the door striker mounting plate (Figure 4.9). The four slots through which the staked attaching lugs of the keeper plate were pulled are shown in Figure 4.10. The keeper plate (Figure 4.11) was found at the accident site about 15 metres away from the vehicle.

Slots through which the staked attaching lugs of the keeper plate were pulled (See Figures 4.7 to 4.11)

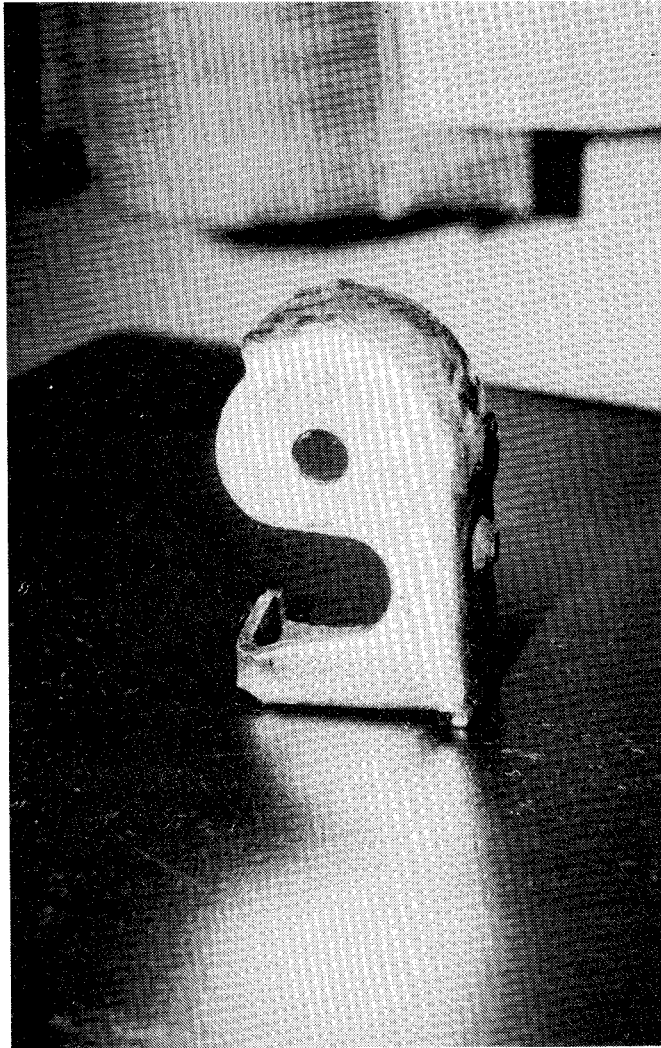
FIGURE 4.11:

Keeper plate detached
from latch (See
Figures 4.7 to 4.10)

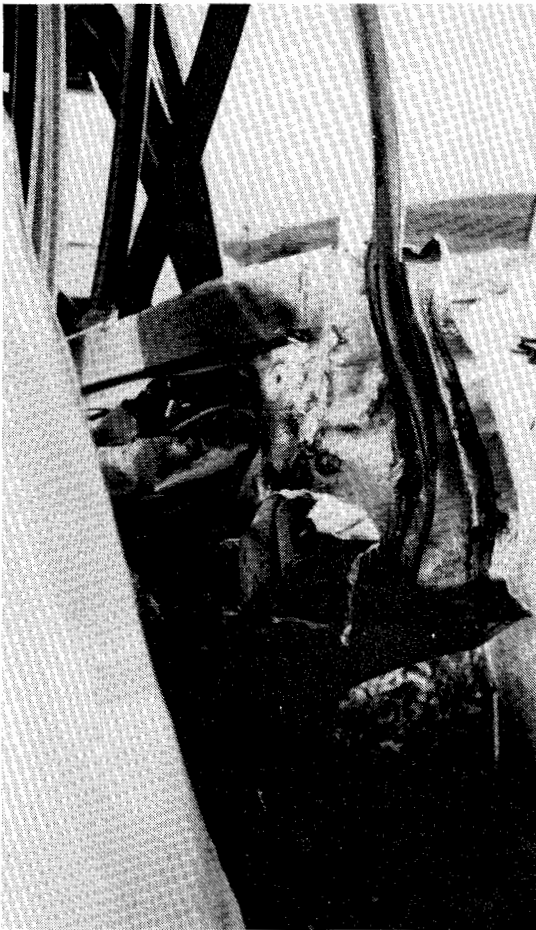
The deformation of the right hand side of the Lancer is shown in Figures 4.12 and 4.13. The latch itself on the right hand rear door did not separate (i.e. the striker was retained in the latch) but the striker plate was torn from the body sheet metal to which it was attached (Figures 4.14 and 4.15).

FIGURE 4.14:
Sheet metal torn from body by
striker plate of door latch
(See Figures 4.12 to 4.15)

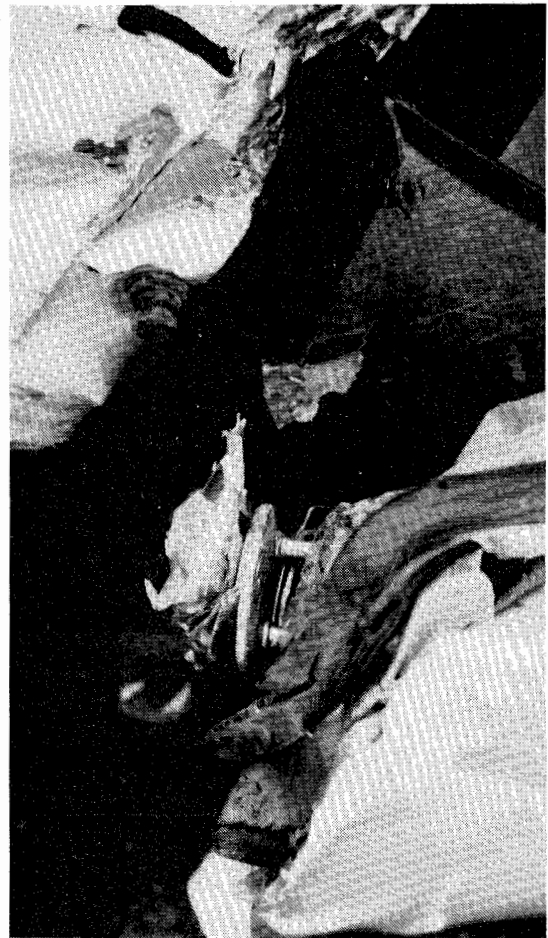
FIGURE 4.15:
View of side of striker plate
(See Figures 4.12 to 4.14)

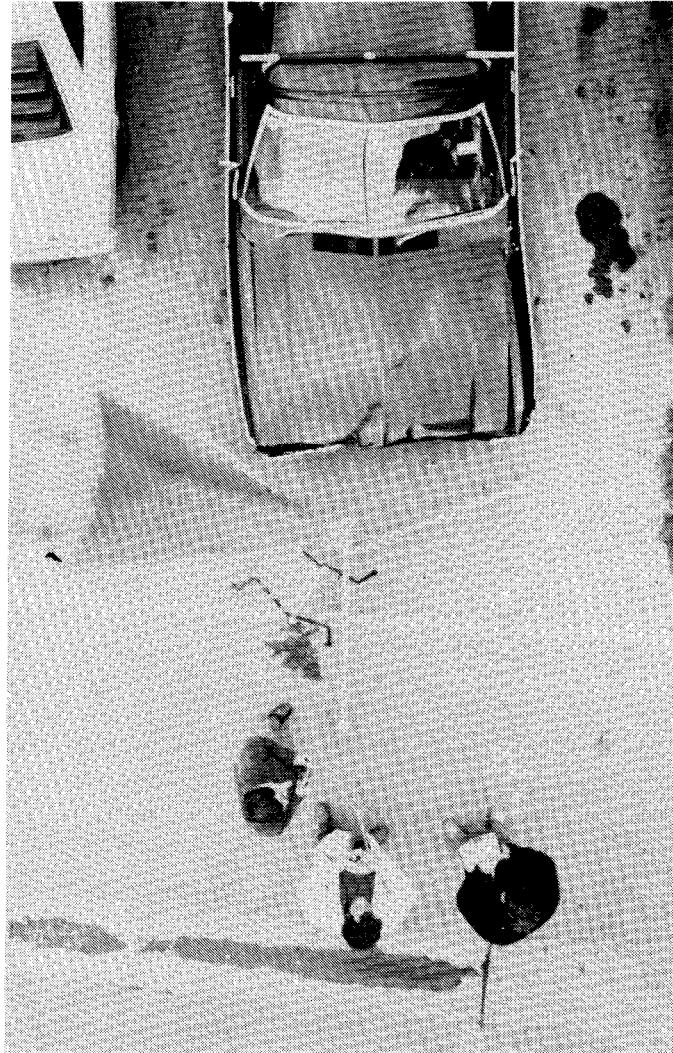
FIGURE 4.18:

The discussion of forward bending of the seat back emphasised the importance of the loads imposed by unrestrained occupants in the rear seat. In three accidents the front seat was loaded by an object being carried behind it. Figure 4.17 shows the extent of forward bending of the back of the front seat of a 1972 HQ Holden panel van (Accident 066). The 17 year old male driver sustained a bruised chest and a sprained neck when an electronic organ pushed the seat back forwards in a frontal collision. The driver was wearing a seat belt. The extent of the damage to the front of the car is shown in Figure 4.18.

Extent of damage
to Holden panel
van in Accident
066 (see Figure
4.17)

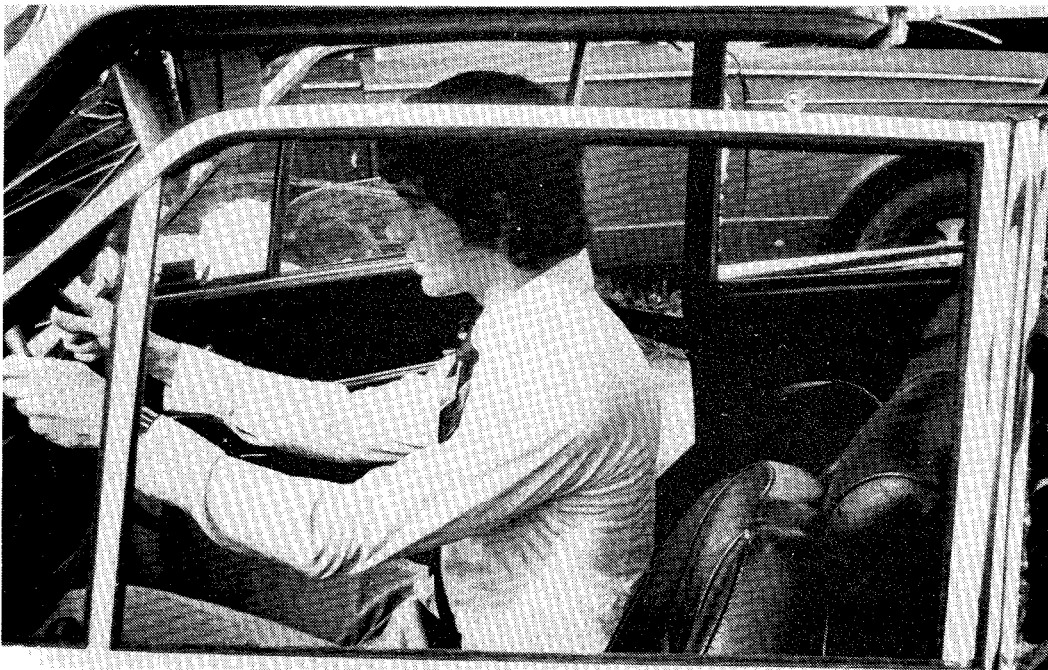
FIGURE 4.21: Approximate normal seating position for driver
in Fiat 124 coupe (See Figures 4.19 to 4.23)

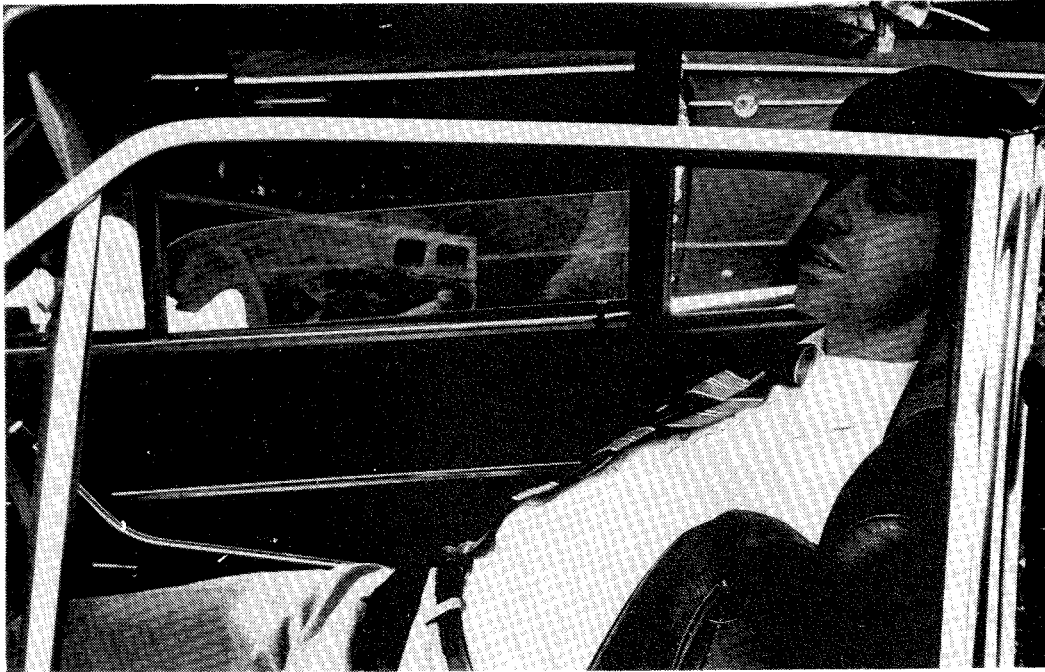
FIGURE 4.22: Approximate position of driver following rearward movement of seat back in rear impact (See Figures 4.19 to 4.23)

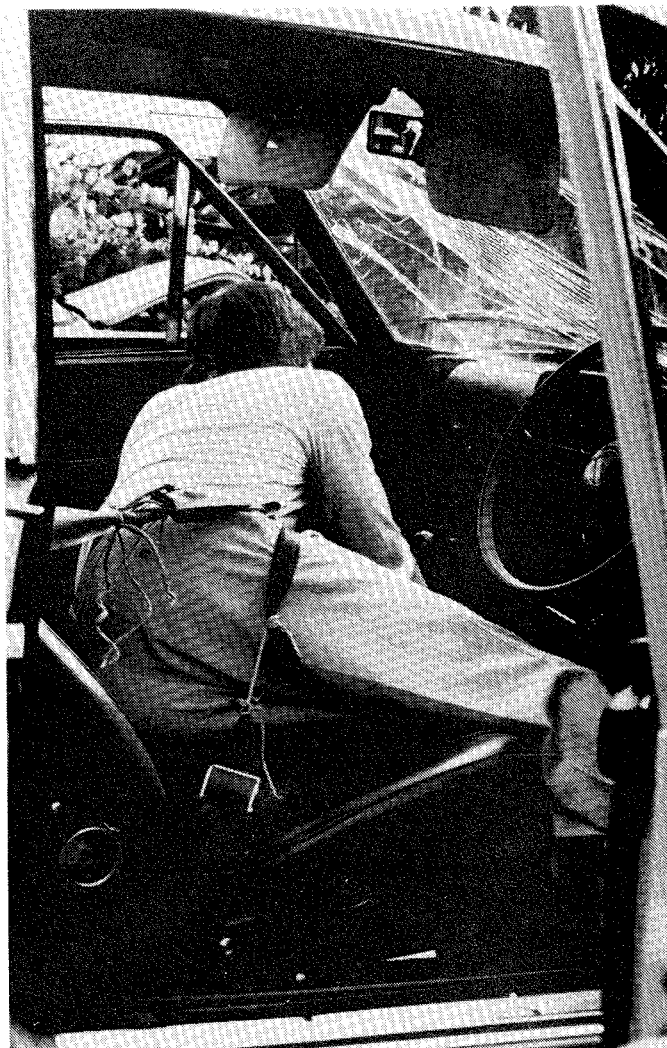
FIGURE 4.23:

Approximate position of driver during frontal collision following a rear impact (see Figures 4.19 to 4.22). Seat belt was cut to release injured driver; it is shown here joined with cord to illustrate location of belt.

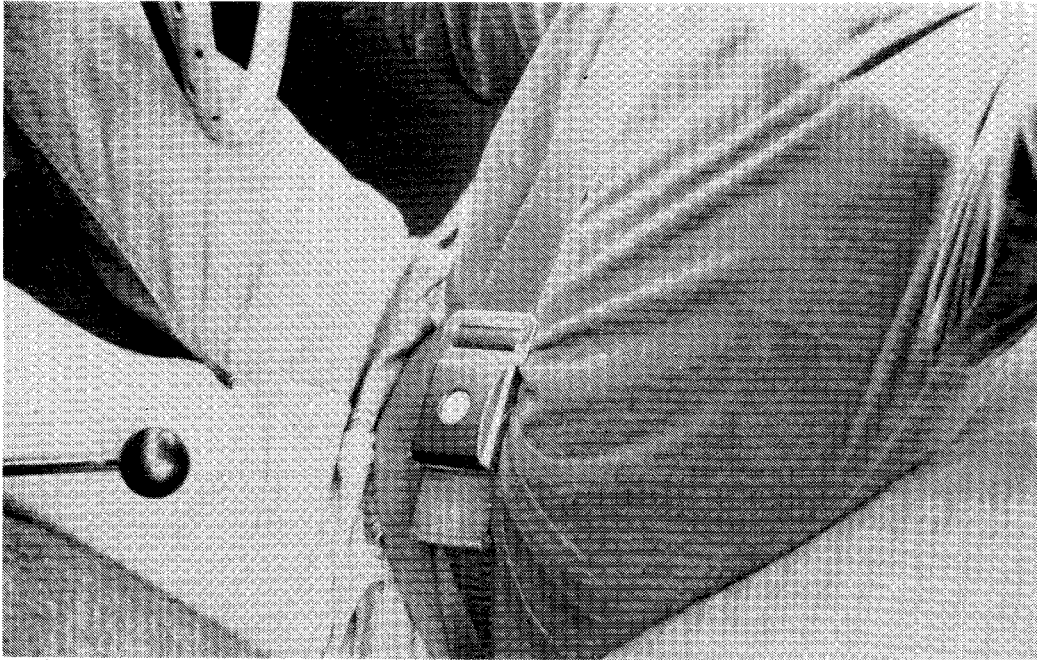
FIGURE 4.26: Incorrectly positioned buckle of seat belt worn by driver in Accident 061 (See Figures 4.25, 4.64)

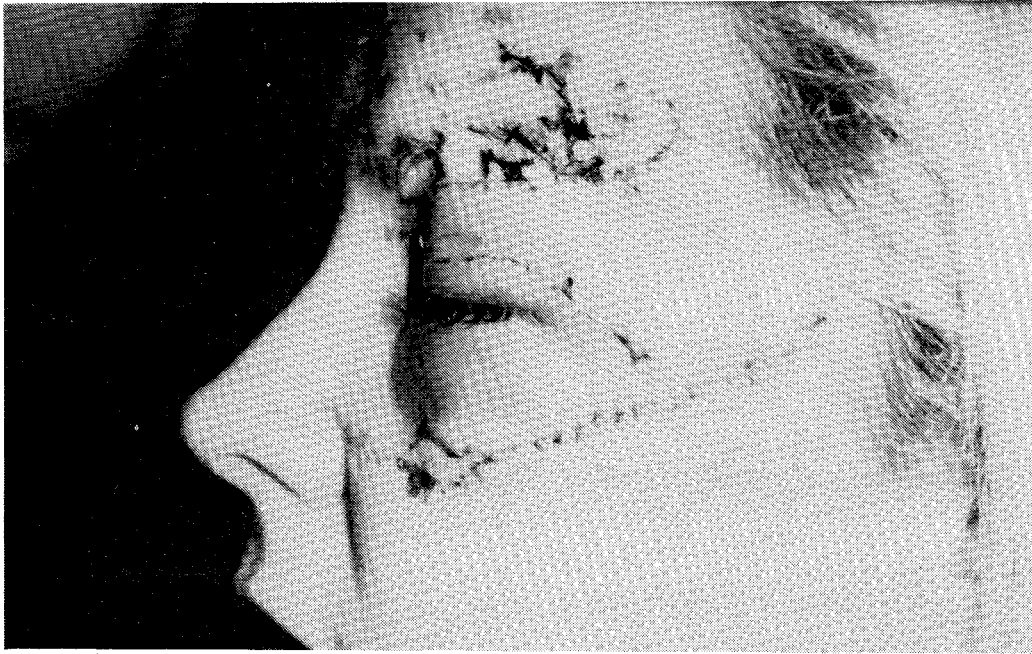
FIGURE 4.32: Facial lacerations from striking edge of broken glass in shattered toughened glass windscreen (one week after the crash) (Accident 009, see Figure 4.33)

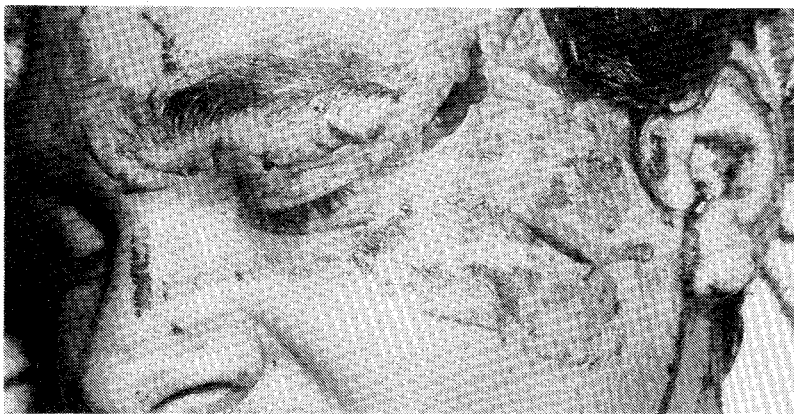
FIGURE 4.35: Lacerations sustained on penetrating toughened glass windshield (Accident 259, see Figures 4.36, 4.52, 4.80)

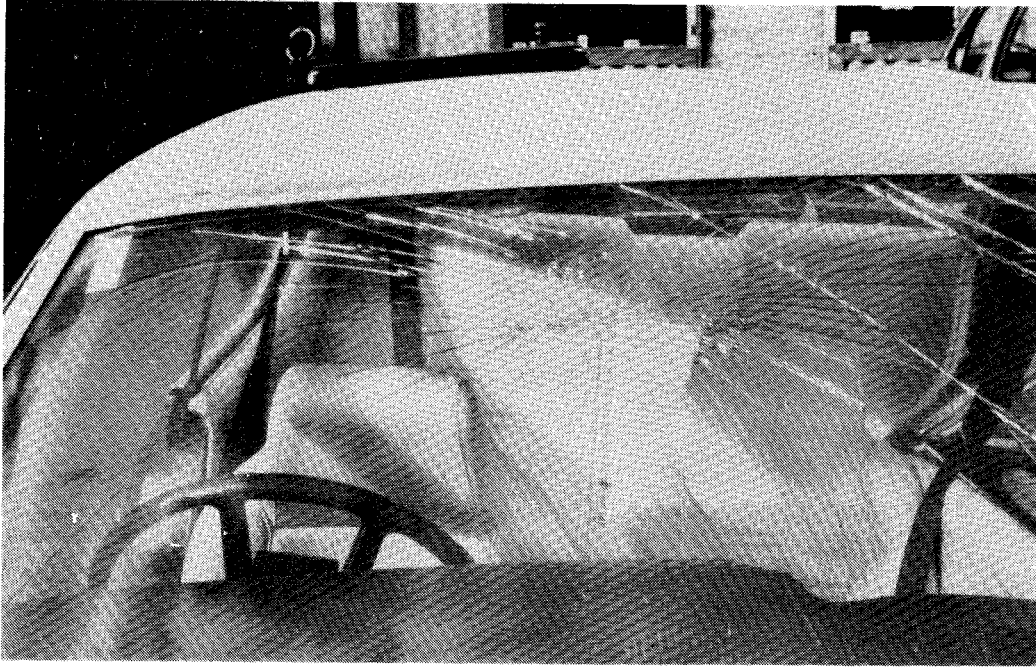
FIGURE 4.38: Point of impact of driver's head on laminated windscreen. (Accident 124, See Figures 4.37, 4.39)

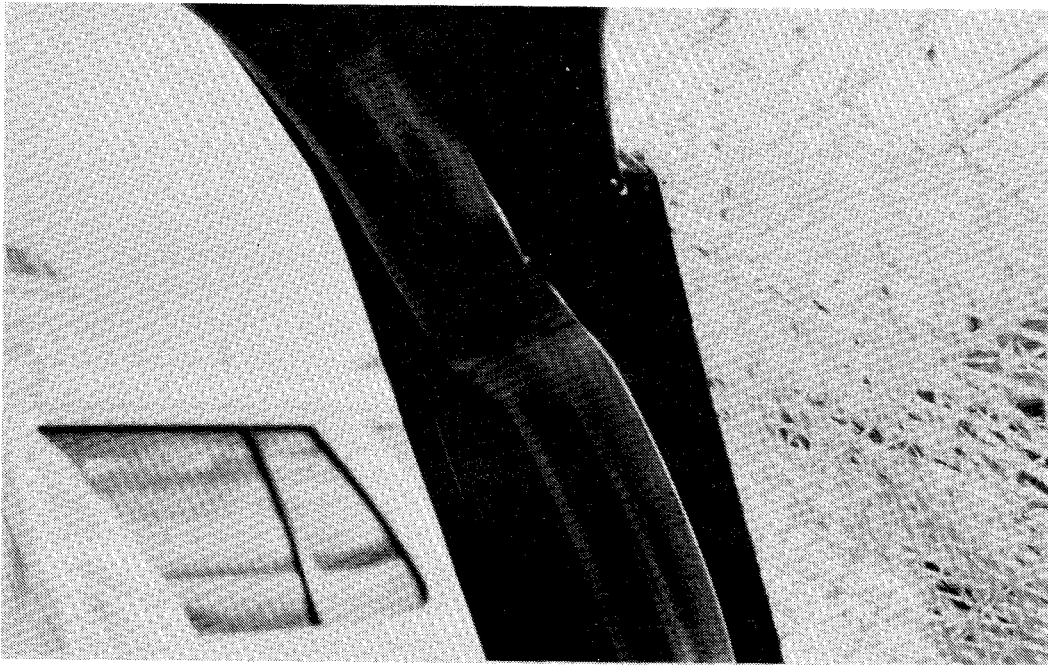
FIGURE 4.39: Point of impact of driver's head on left hand A pillar. (Accident 124, See Figures 4.37, 4.38, 4.40).

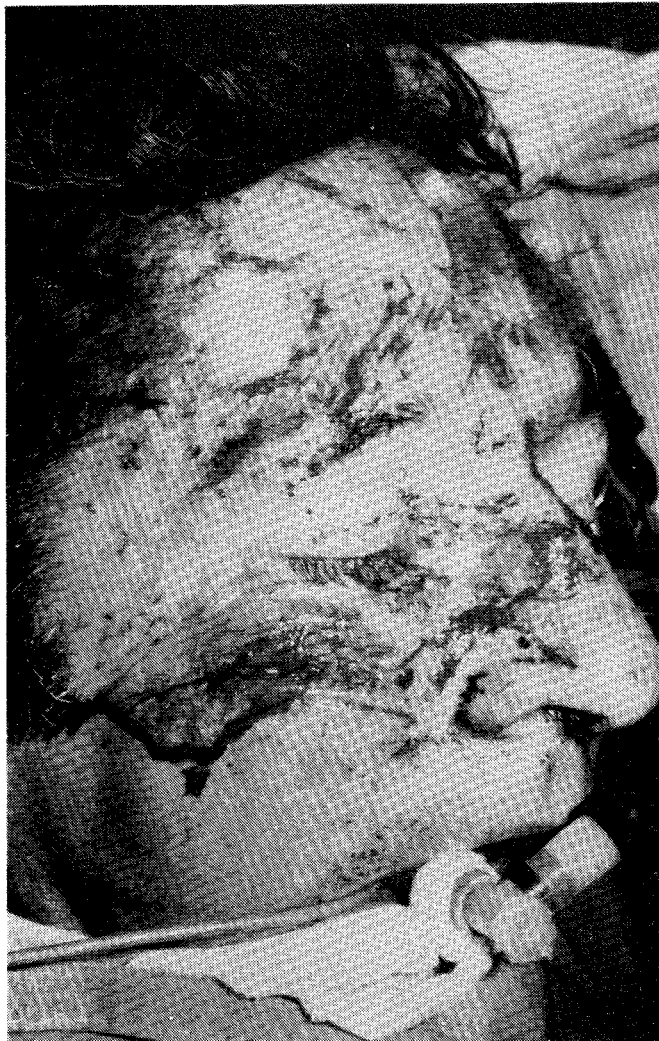
FIGURE 4.43:
Lacerations caused by impact with wind-screen shown in Figures 4.41 and 4.42.

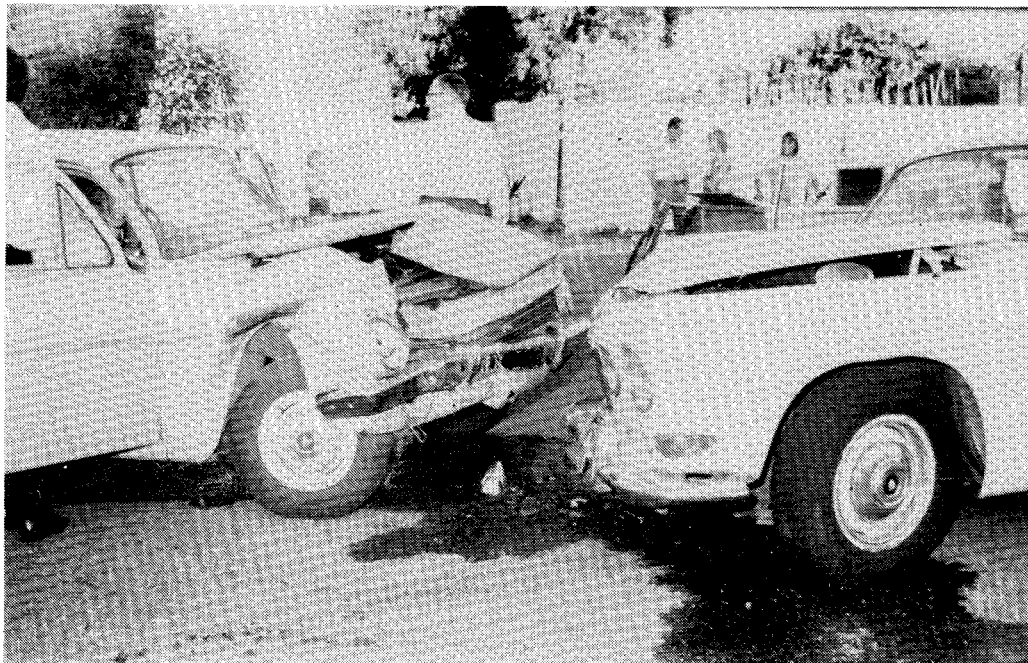
FIGURE 4.48: Head-on collision between a 1966 Holden sedan and a 1967 Jaguar 420G (Accident 245, See Figures 4.49, 4.81)

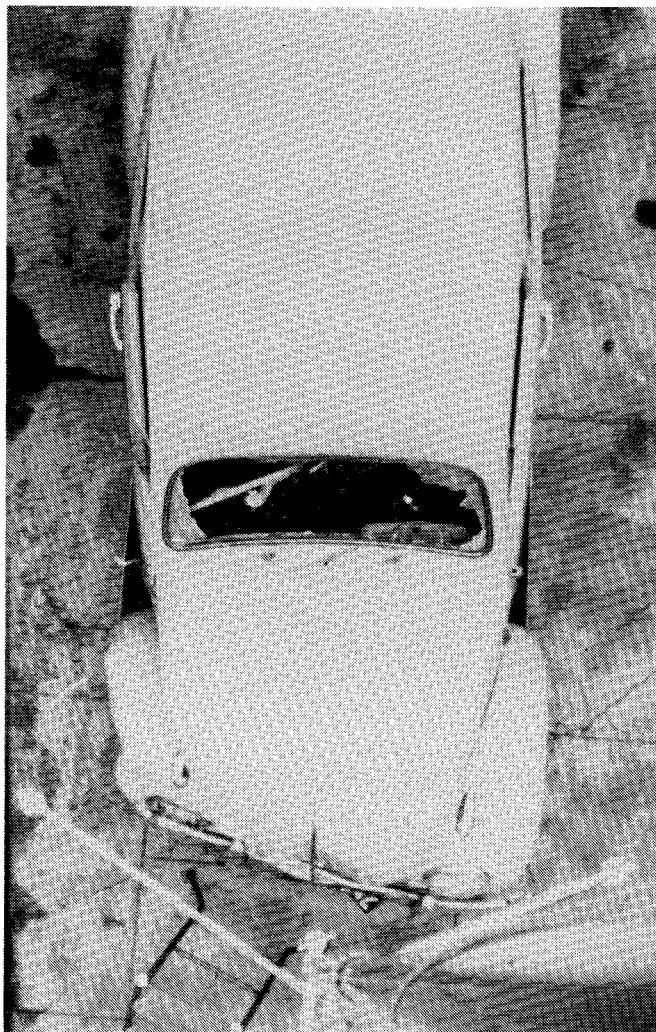
FIGURE 4.51: Unrestrained driver was virtually uninjured despite
damage to steering wheel and penetration of steering
column (See Figure 4.50)

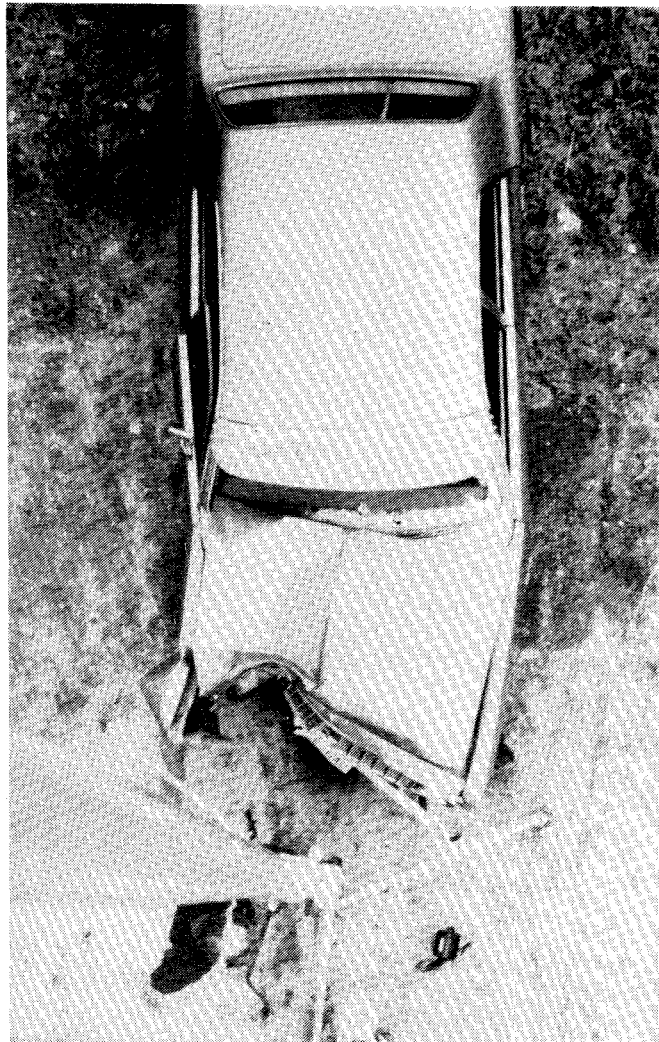
FIGURE 4.56:

Severe localised damage
to car following
collision with a tree.
(Accident 057, See
Figures 4.57, 4.58, 4.79)

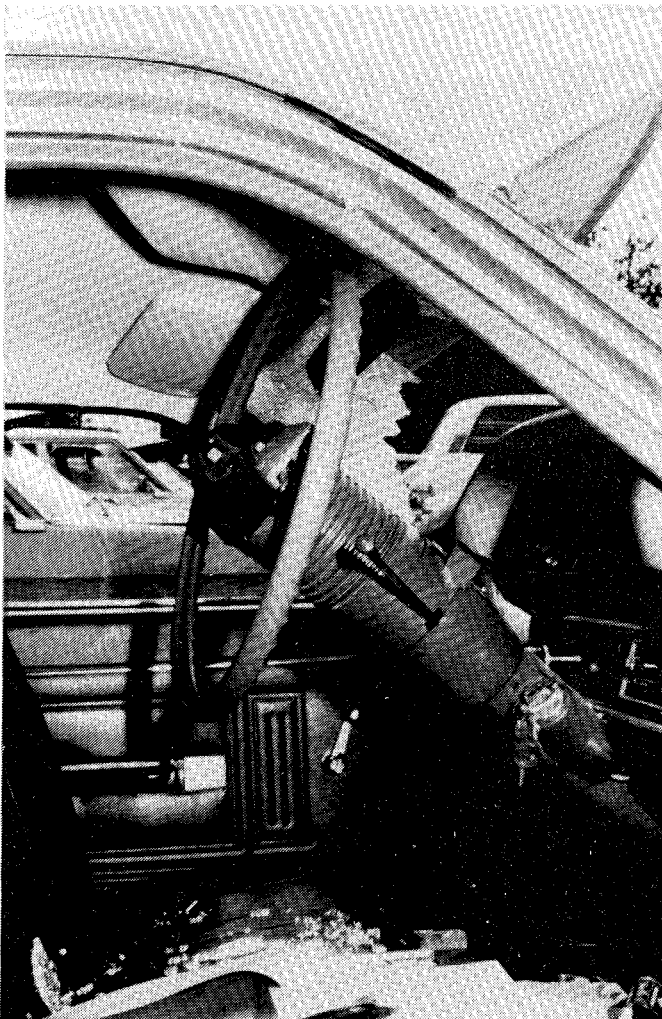
FIGURE 4.57:

Deformation of steering
wheel and penetration of
column into passenger
compartment.
(Accident 057, See also
Figures 4.56, 4.58, 4.79)

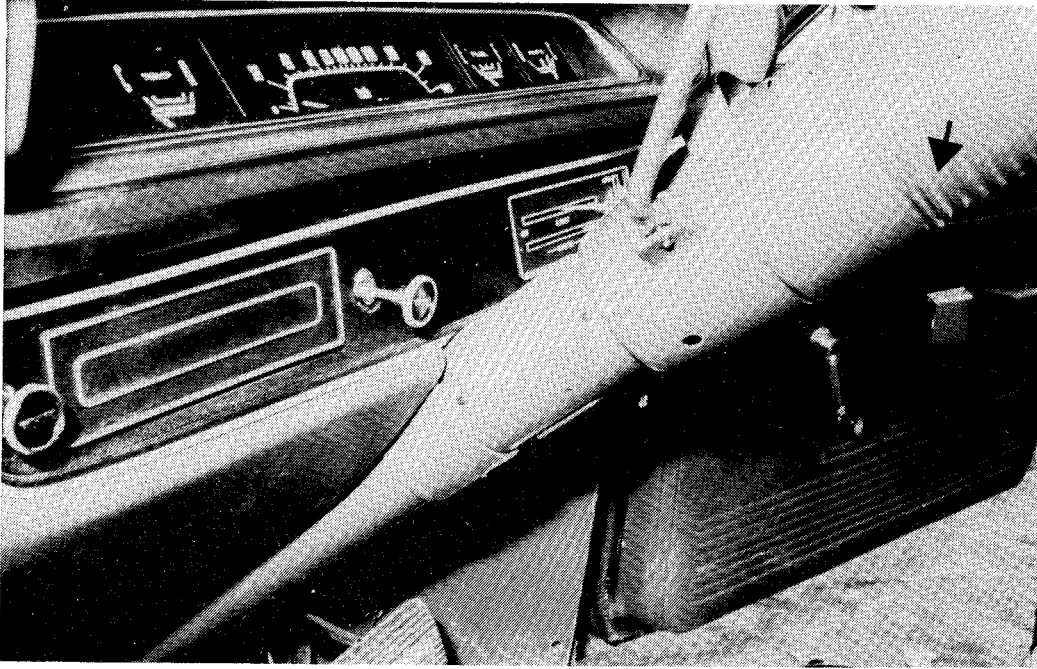
FIGURE 4.58: Collapse of energy-absorbing element at top of steering column (arrowed) and penetration of column into passenger compartment. (Accident 057, See Figures 4.56, 4.57)

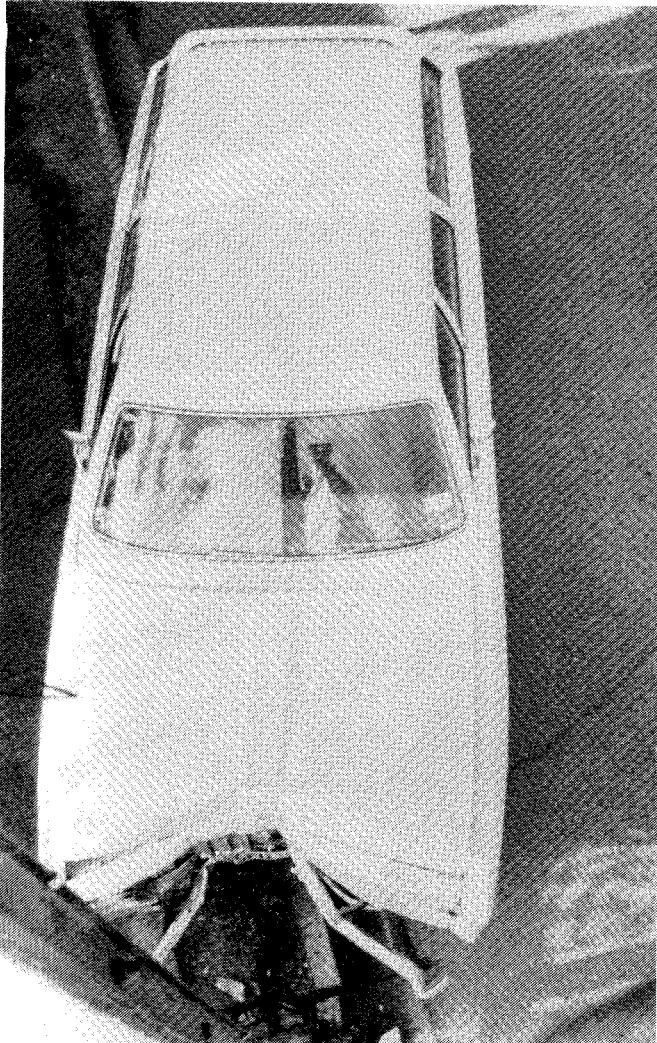
FIGURE 4.59:

Damage to front of car following collision with utility pole. (Accident 294, See Figure 4.60)

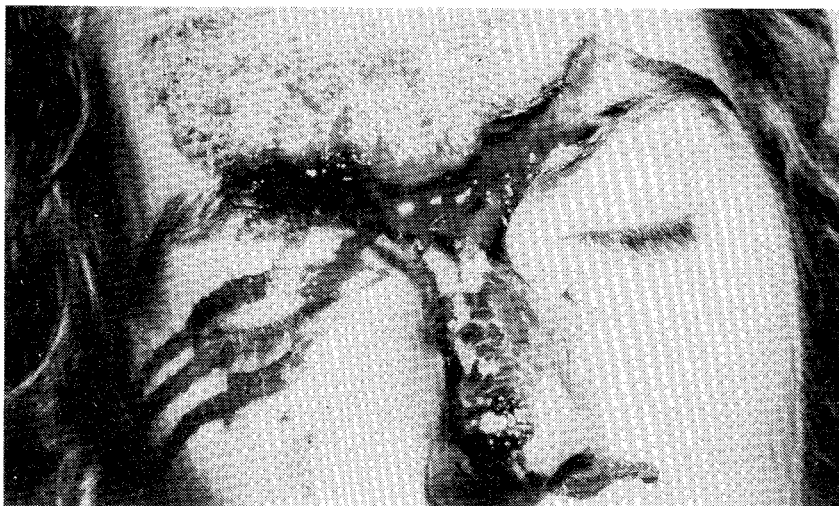
FIGURE 4.62: Facial injuries from contact with the rim of the steering wheel shown in Figure 4.63. (Accident 096, See Figure 4.27)

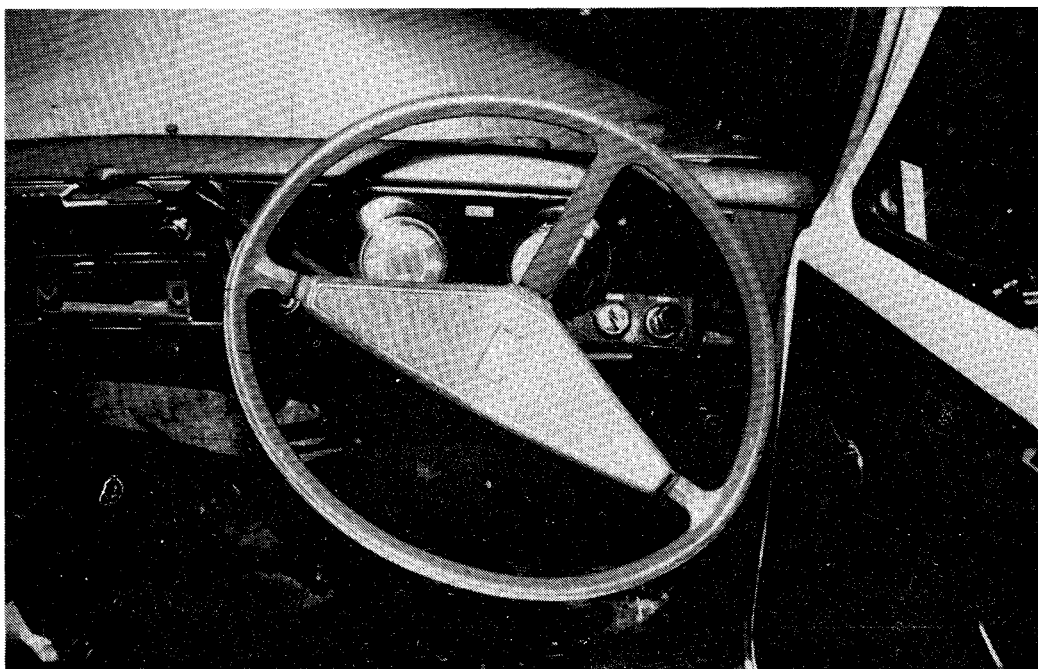
FIGURE 4.63: Steering wheel contacted by driver shown in Figure 4.62.

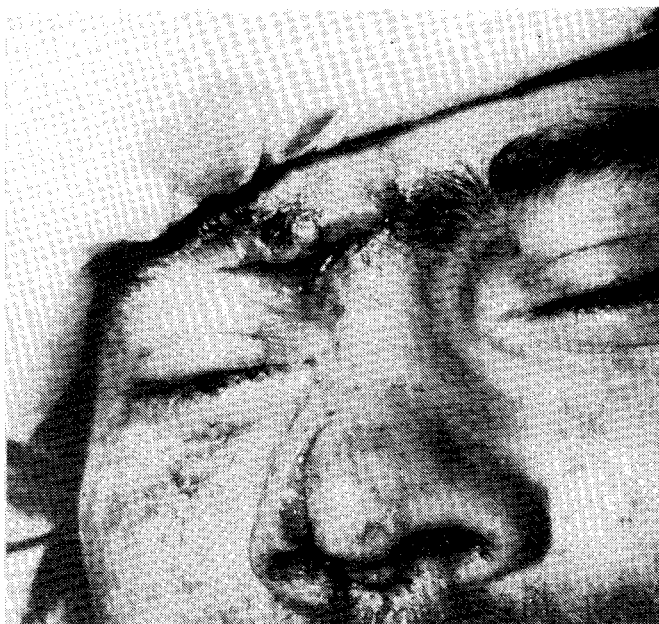
FIGURE 4.64:

Facial lacerations caused by striking the rim of the steering wheel shown in Figure 4.65. (Accident 094, See Figure 4.30)

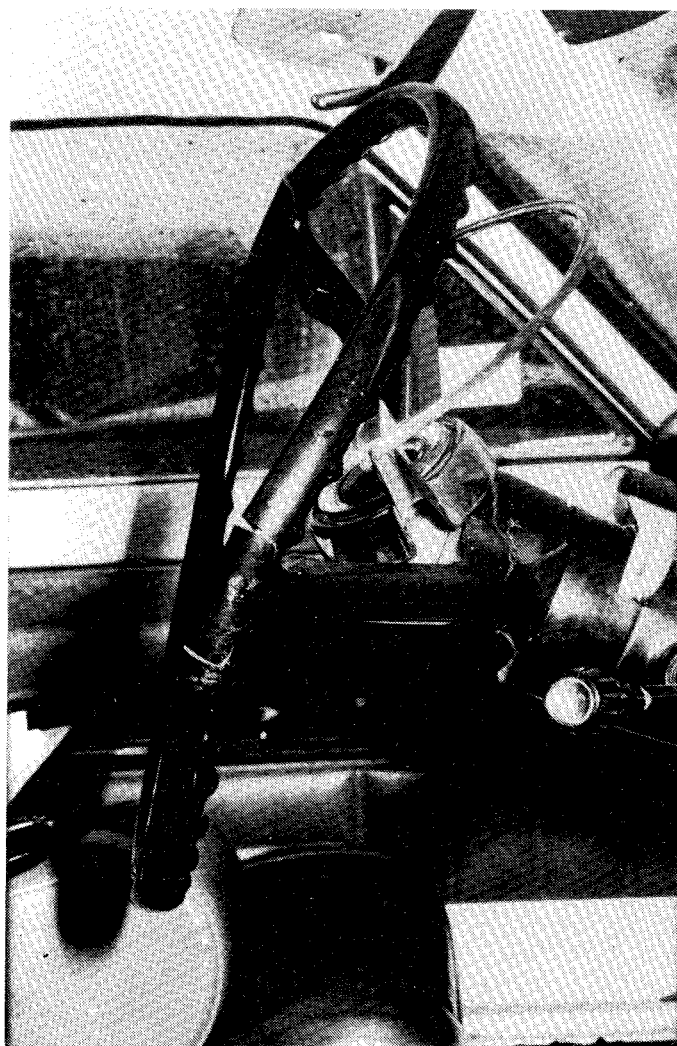
FIGURE 4.65:

Deformation of steering wheel following impact by driver's head and face (See Figure 4.64)

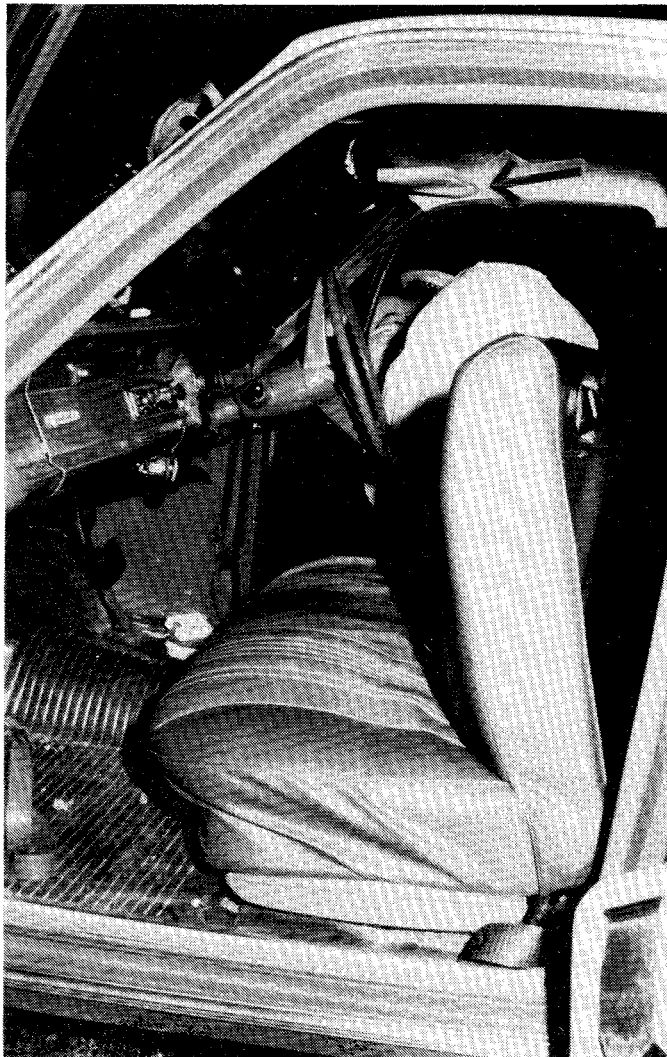
FIGURE 4.66:

Sunvisor (arrowed) struck by unrestrained rear seat occupant shown in Figure 4.67. Note deformation of back of front seat. (Accident 206.)

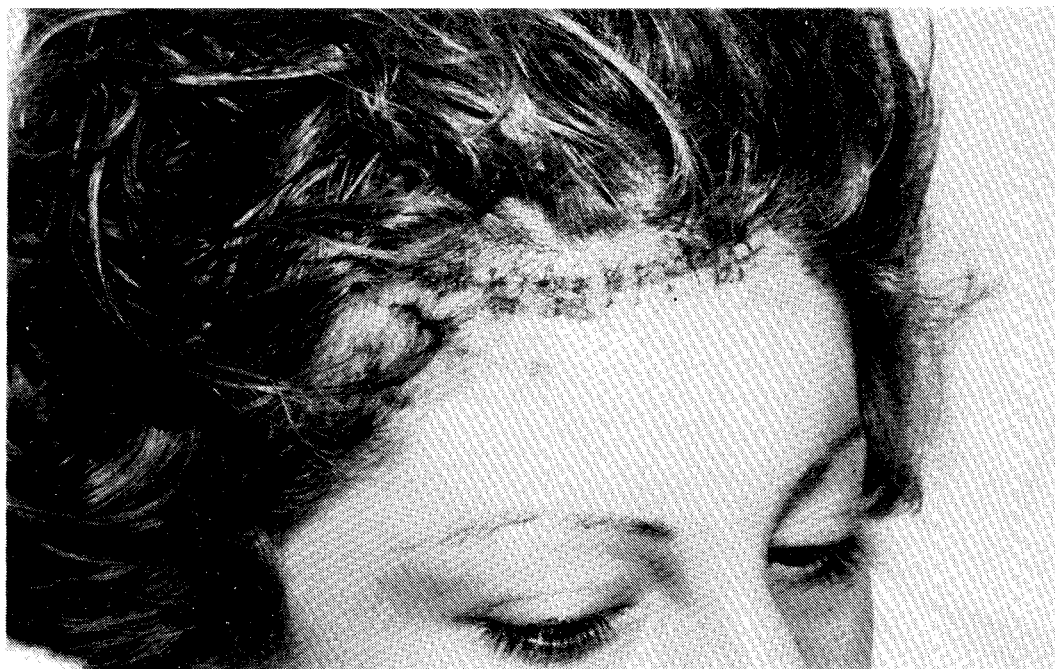
FIGURE 4.67: Sutured laceration across the upper forehead resulting from impact with sunvisor and header area. (Accident 206, See also Figures 4.66 and 4.68)

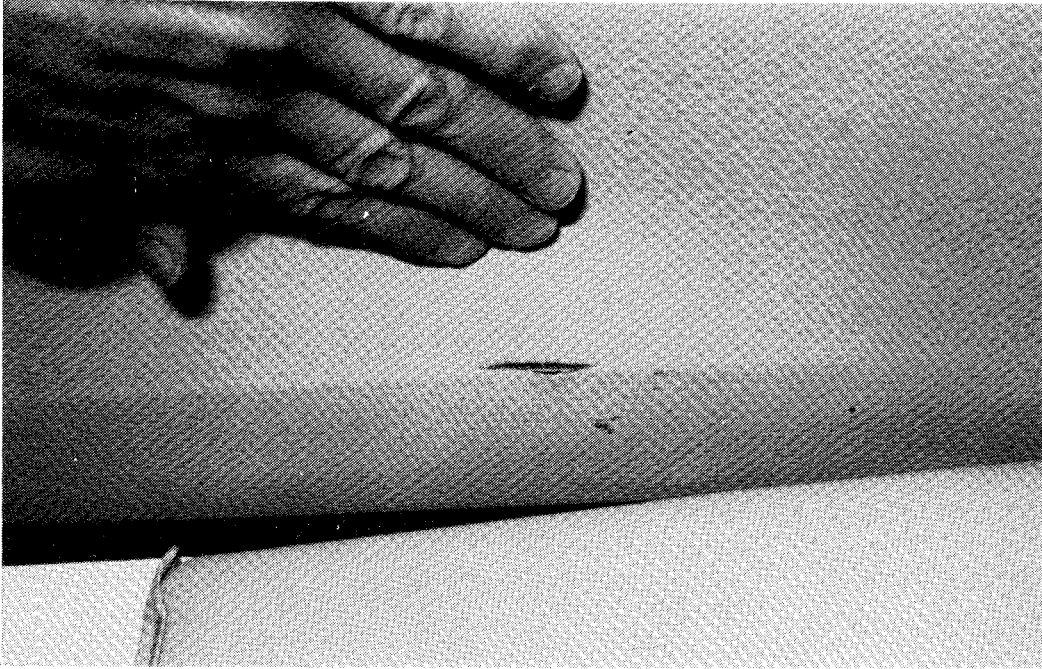
FIGURE 4.68: Tear in head-lining along edge of sheet metal section of header area that was struck by the rear seat passenger shown in Figure 4.67.

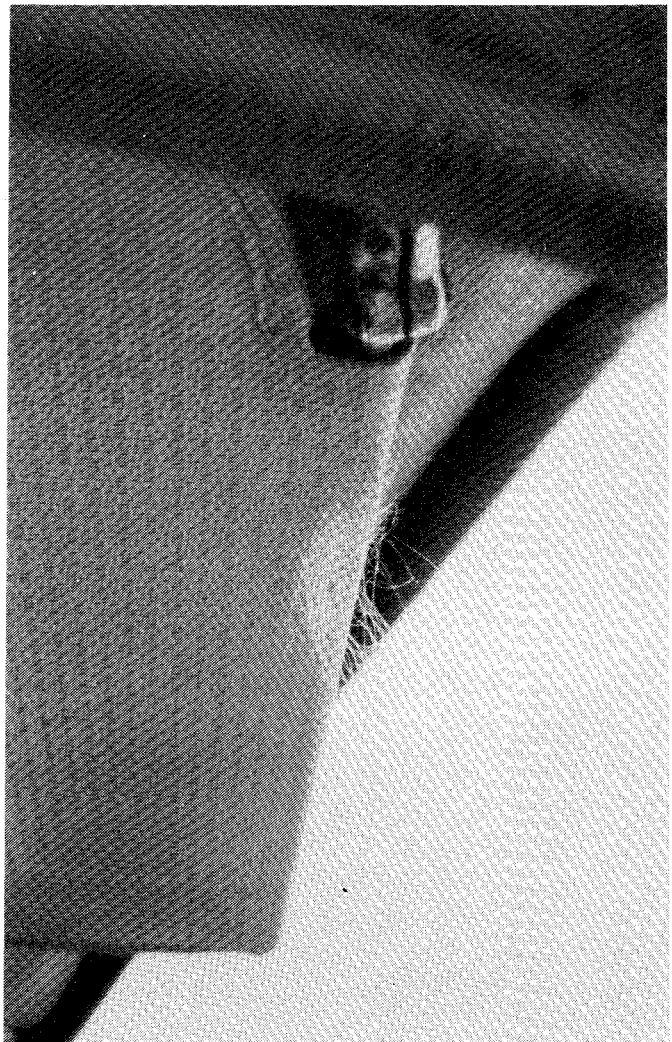
FIGURE 4.69:

Hair adhering to the leading edge of a sunvisor following impact by driver's head. (Accident 245, See also Figure 4.48)

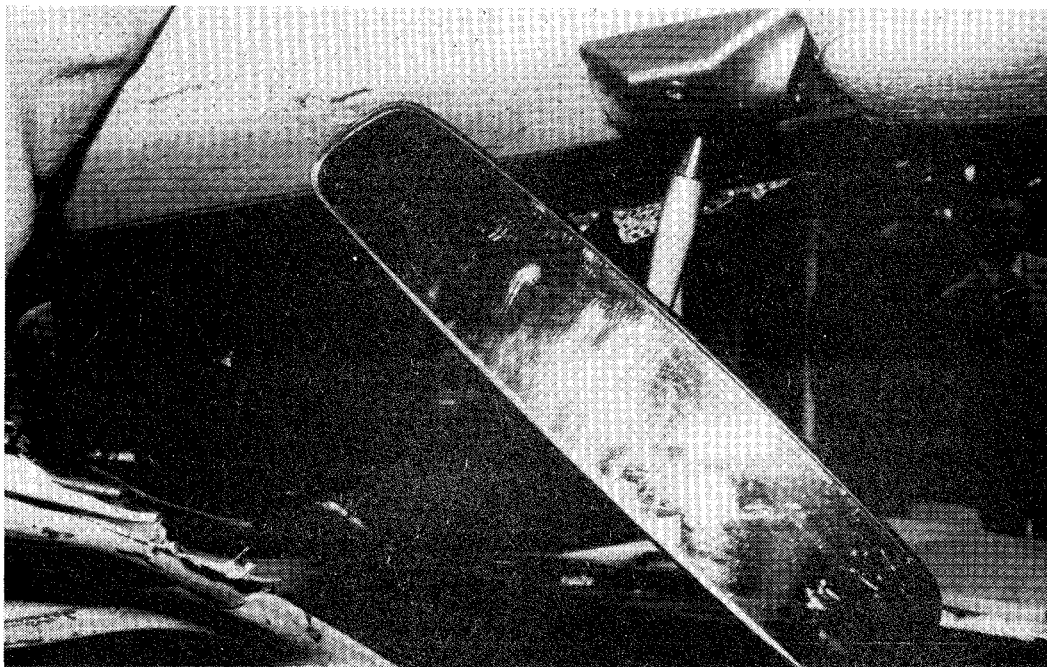
FIGURE 4.71: See Figure 4.70.

FIGURE 4.70: Lacerations to the forehead caused by the rear vision mirror and the edge of the sheet metal section forming the header area. (Accident 076, See also Figure 4.71)

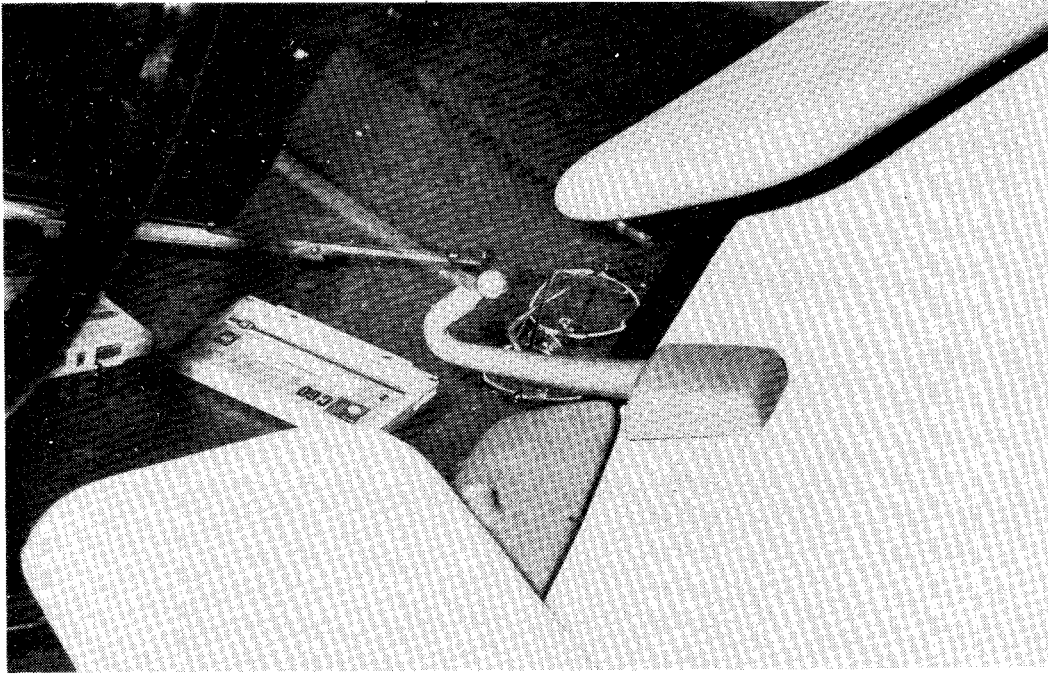
FIGURE 4.72: Mirror support arm still in position after mirror housing separated at the swivel joint (car is upside-down). (Accident 074, See Figure 4.73)

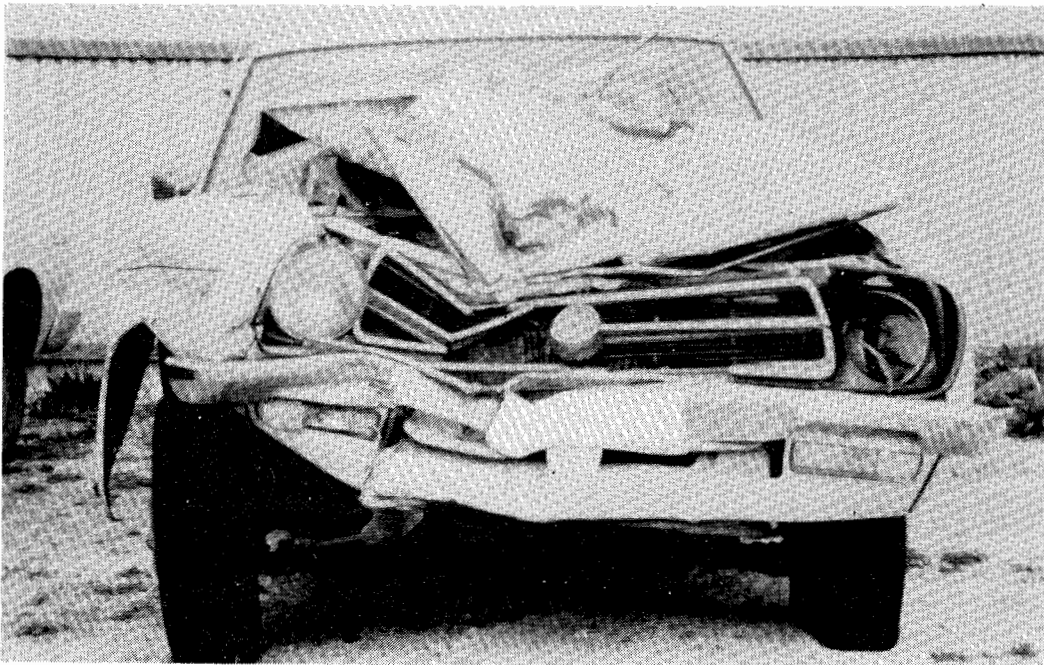
Twenty drivers injured their knees by striking them on the steering column or on associated hardware. These injuries were mostly minor contusions and abrasions but some of them would not have occurred had not the plastic housing around the column shattered on impact by the knee (eg: Figures 4.83 and 4.84). The retaining bolt for the upper mounting bracket on the column also caused knee injuries. For example, those shown in Figure 4.85 were sustained by an otherwise uninjured driver who was wearing a seat belt in the car shown in Figure 4.87.

FIGURE 4.87: 1972 Datsun 1200 coupe following a two-car collision. (Accident 150, see Figures 4.85 and 4.86).
