ADELAIDE IN-DEPTH ACCIDENT STUDY

1975-1979

PART 6: CAR ACCIDENTS

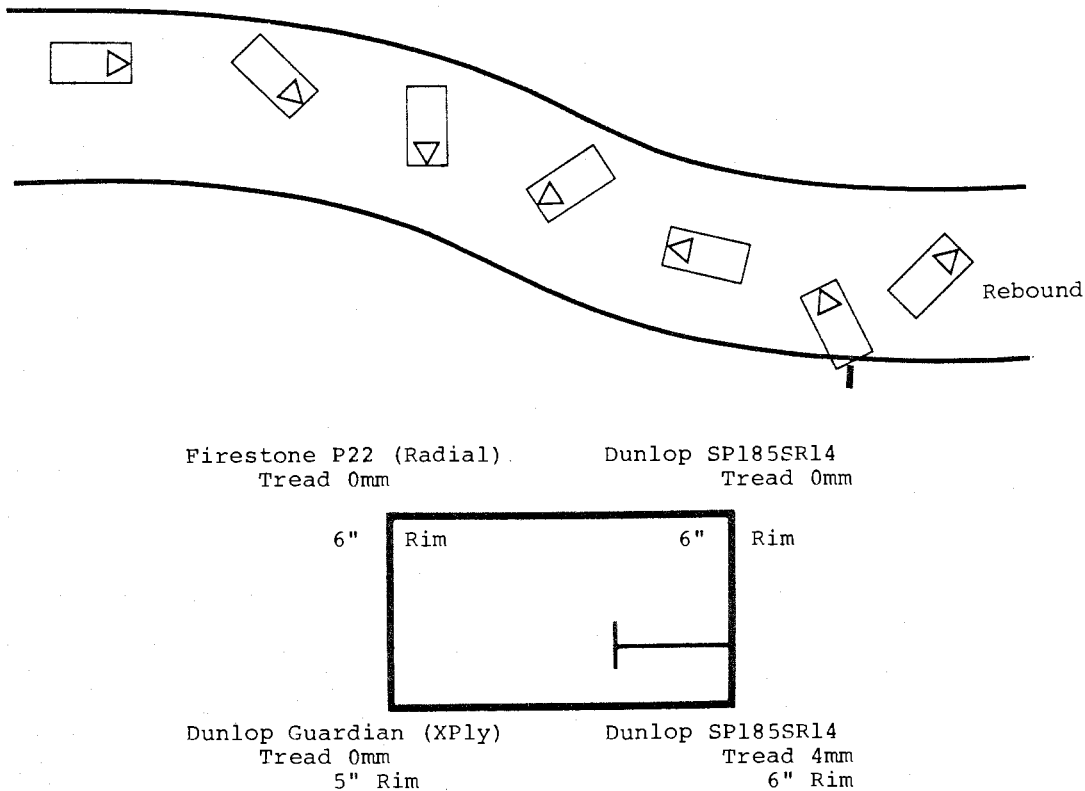
Both rear tyres were devoid of tread pattern over at least half of the width of the tyre. In addition, the left hand rear tyre was of radial-ply construction mounted on a six inch wide rim which was offset to increase the wheel track, whereas the right hand rear tyre was a cross-ply mounted on a standard five inch wide rim.

Although the inexperience of the driver was relevant in that he entered the curve at too high a speed and was not able to regain control of the car once the slide began, the low coefficient of friction between the wet bitumen and the bald rear tyres was a major factor in the causation of the accident.

FIGURE A2.1: Accident 062: Vehicle Movements and Tyre Specifications

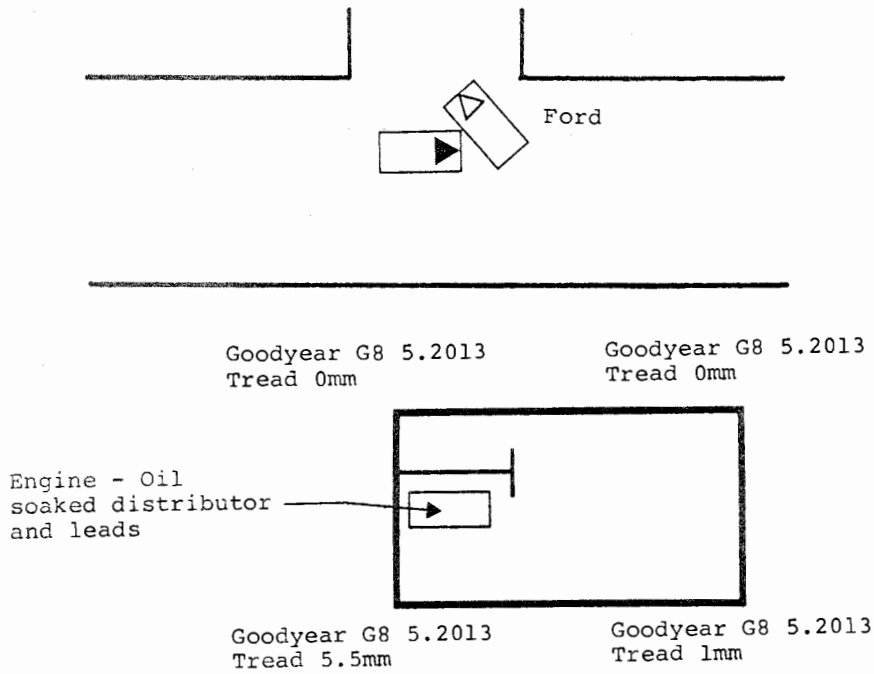
FIGURE A2.4: Accident 012: Vehicle Movements and Tyre Specifications

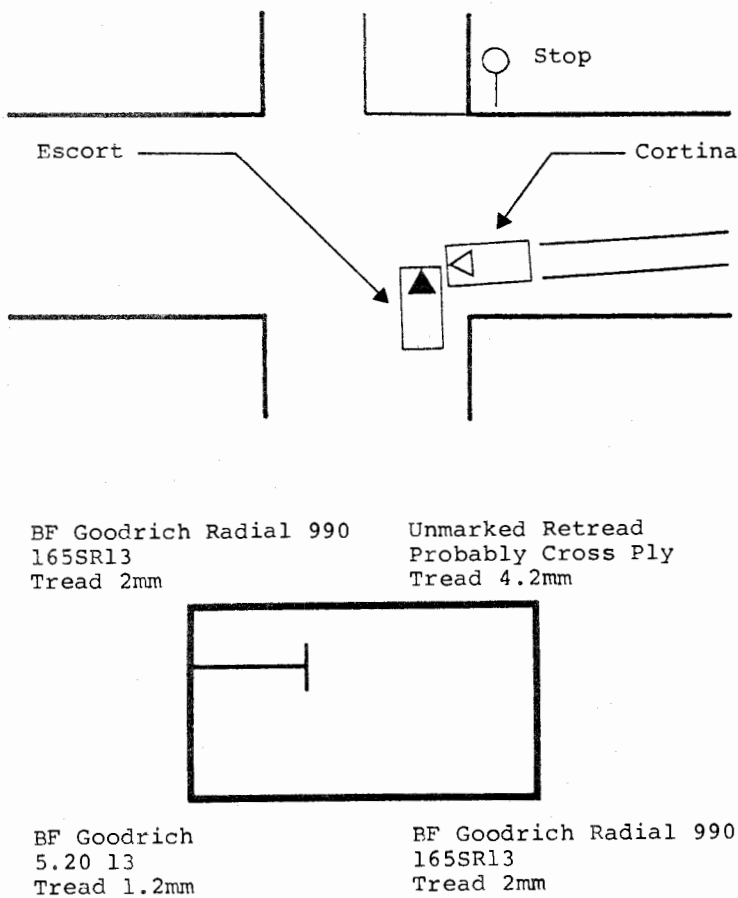
Even with the estimated approach speed of the Cortina, it seems likely that the collision would have been avoided if the car had decelerated more quickly and in line with its original heading. This probably would have been achieved if the wheels had not locked under braking. Whilst driver skill is obviously relevant in this context, the demand on the driver would have been reduced if the vehicle had been fitted with tyres of the same size and construction and with adequate tread depth.

FIGURE A2.5: Accident 047: Vehicle Movements and Tyre Specifications

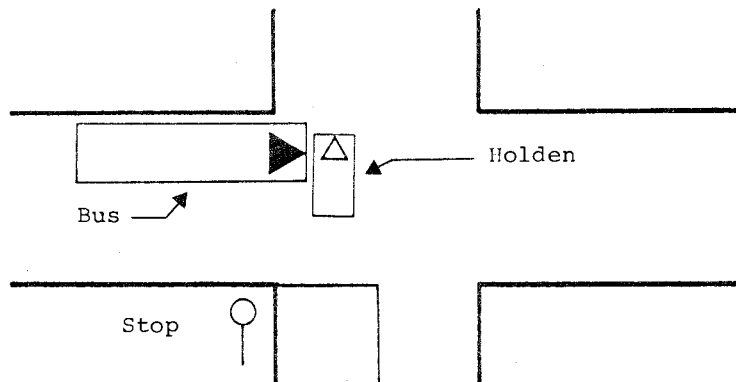
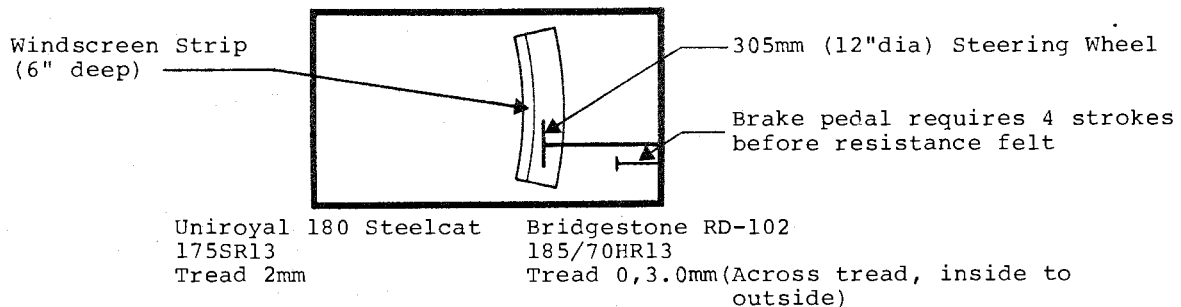
The car also had a black vinyl strip fitted across the top 150mm of the windscreen. This strip markedly restricted the driver's field of view, particularly to the sides (in the direction of the Stop sign). It was also illegal, because it encroached on that area of the windscreen swept by the wiper blades.

Other defects on this vehicle, but which were not of obvious relevance in this accident, included both front tyres worn bald at the inner shoulders, and a smaller-than-standard steering wheel which was 300mm in diameter.

Uniroyal 180 Steelcat
175SR13
Tread 2mm

Bridgestone RD-102
185/70HR13
Tread 0,4,4mm (Across tread, inside to outside)

FIGURE A2.6: Accident 053: Vehicle Movements and Defects

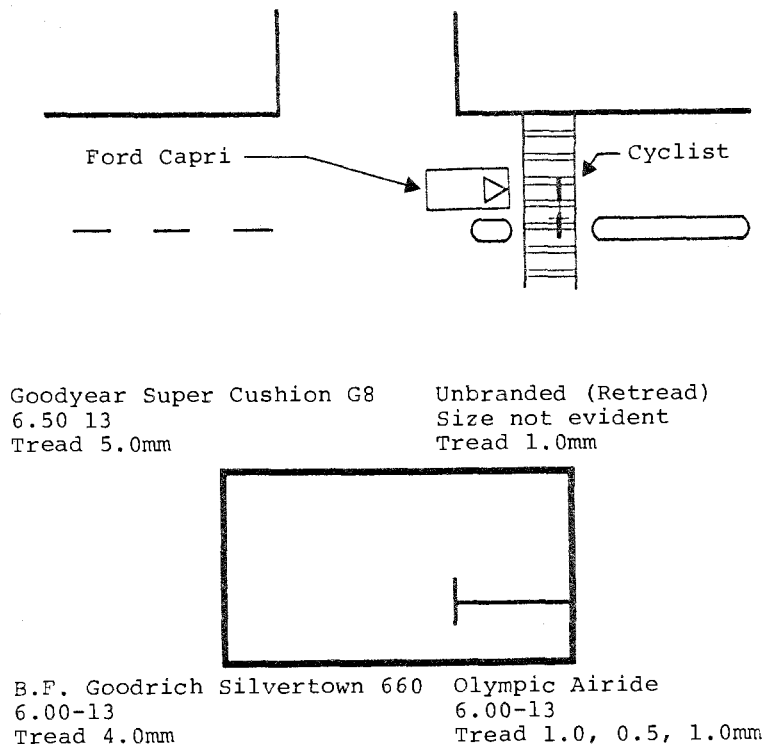
FIGURE A2.7: Accident 087: Vehicle Movements and Tyre Specifications

The front tyres on the car were virtually bald, the one on the right having a tread depth varying between 0.5 and 1.0mm and that on the left having a tread depth of 1.0mm (Figure A2.7)

The point of impact on the Ford was in the area of the front bumper and the leading edge of the bonnet to the right of the centre line of the vehicle, whilst the damage to the bicycle was confined to the rear wheel. This suggests that if the car's rate of deceleration had been a little better then the collision may have been avoided, hence the importance of the worn tyres on the wet road.

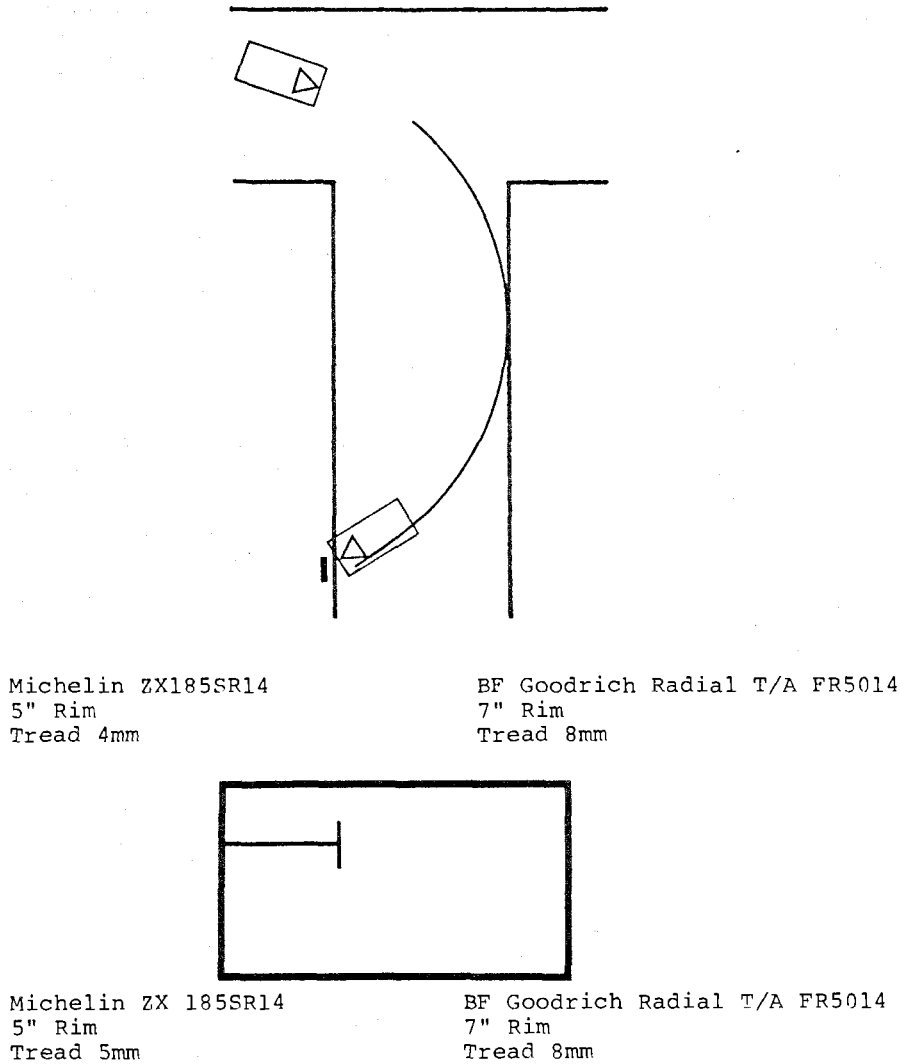
FIGURE A2.8: Accident 108: Vehicle Movements and Tyre Specifications

The "defect" in this accident relates to the requirement under the South Australian Road Traffic Act that a vehicle subject to Australian Design Rule 24 (Tyre Section) shall throughout its life be fitted with those tyres listed on the approved tyre

The effects of gross mismatch in tyres such as displayed on this vehicle will depend on the nature of the vehicle manoeuvre and the condition of the road surface. In this accident the road surface was dry bitumen, free of stones or gravel. The vehicle was executing a right angle, right hand turn and, according to eyewitnesses, was accelerating hard from a stationary position. A tyre mark evident at the scene was generated by the left front tyre and indicated that the vehicle was in a severe understeer condition throughout the greater part of the turn. On the basis of the difference in rim widths, section widths and aspect ratios (shown in Figure A2.9)

it is not unreasonable to conclude that the FR5014 tyre and rim combination would run at a substantially lower slip angle

for a given cornering load than the 185SR14 and that this imbalance was a contributory factor to the accident.

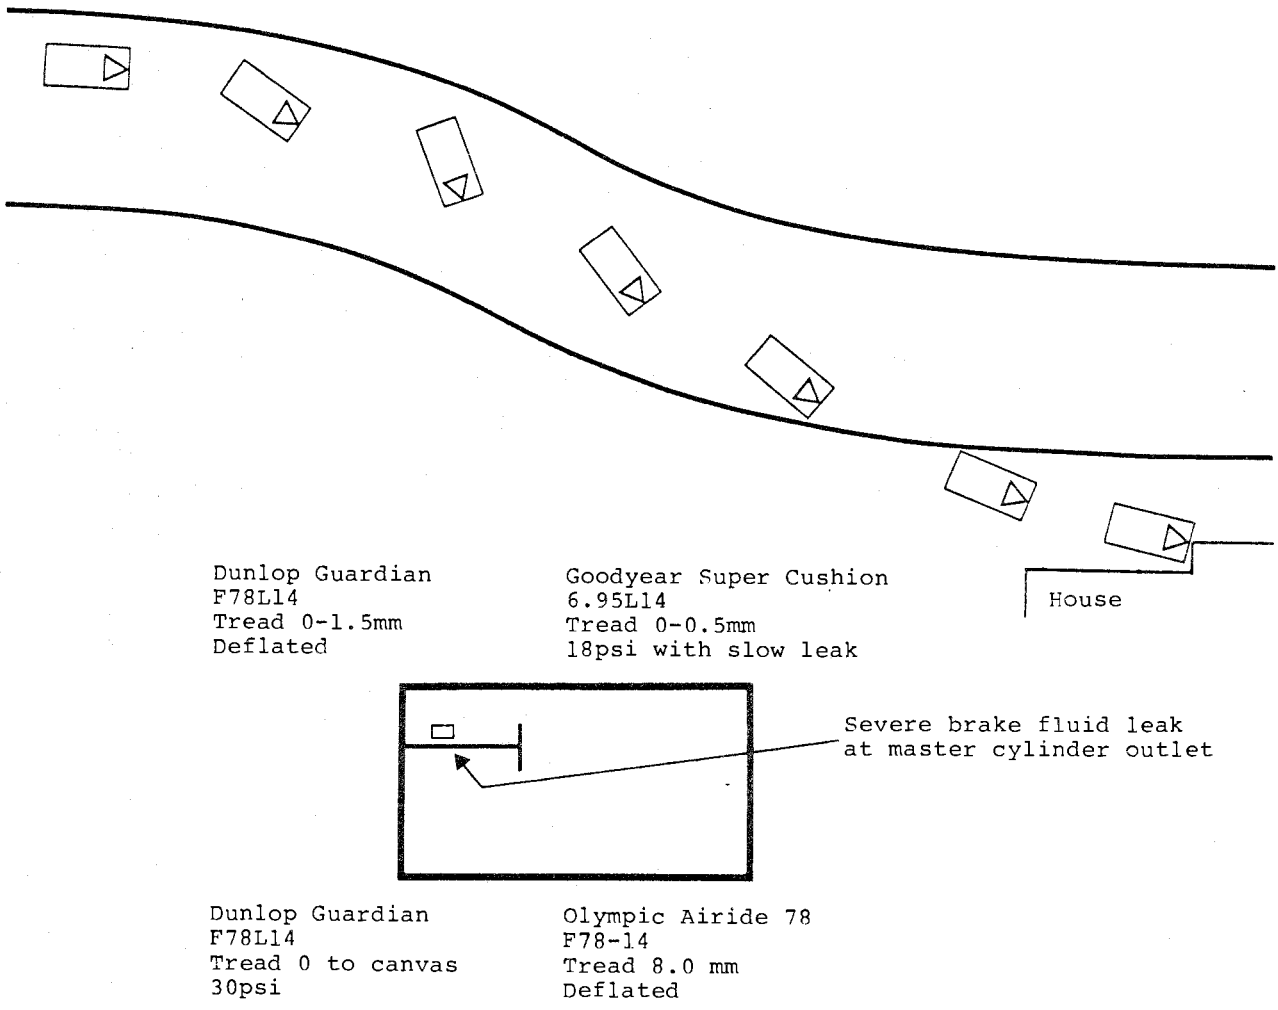
FIGURE A2.10: Accident 119: Vehicle Movements and Tyre Specifications

The braking system was inoperative after the impact due to a severe leak at the union at the master cylinder outlet. It was not possible to conclude whether this failure was present before the impact, but examination of the path of the vehicle, which included some distance travelled

over grass, showed no evidence of brake application.

The driver of the vehicle alleged that the bitumen surface of the road was wet and slippery at the time of the accident, and that he entered the S-bend at 45-50 km/h. However, the research team was at the scene seven minutes after the ambulance was summoned and the road surface was quite dry. In addition, the driver, who had a blood alcohol level of 0.11, was engaged in chasing a car, following a fight with the occupants of that vehicle. Under these circumstances it would seem unlikely that he would have slowed to 45-50 km/h to negotiate a relatively minor S-bend. It appears more likely that he approached the S-bend at about 80-90 km/h, and failed to slow down, or was unable to slow due to the faulty brakes. The car then began to yaw in a clockwise direction on entering the bend due to the larger slip angle of the left hand rear tyre relative to the three worn out tyres, over-corrected (the driver's allegation) and yawed in an anti-clockwise direction, mounted the footpath and hit the corner of the front wall of a house. The house and the vehicle were severely damaged to an extent that was consistent with a 50-60 km/h impact.

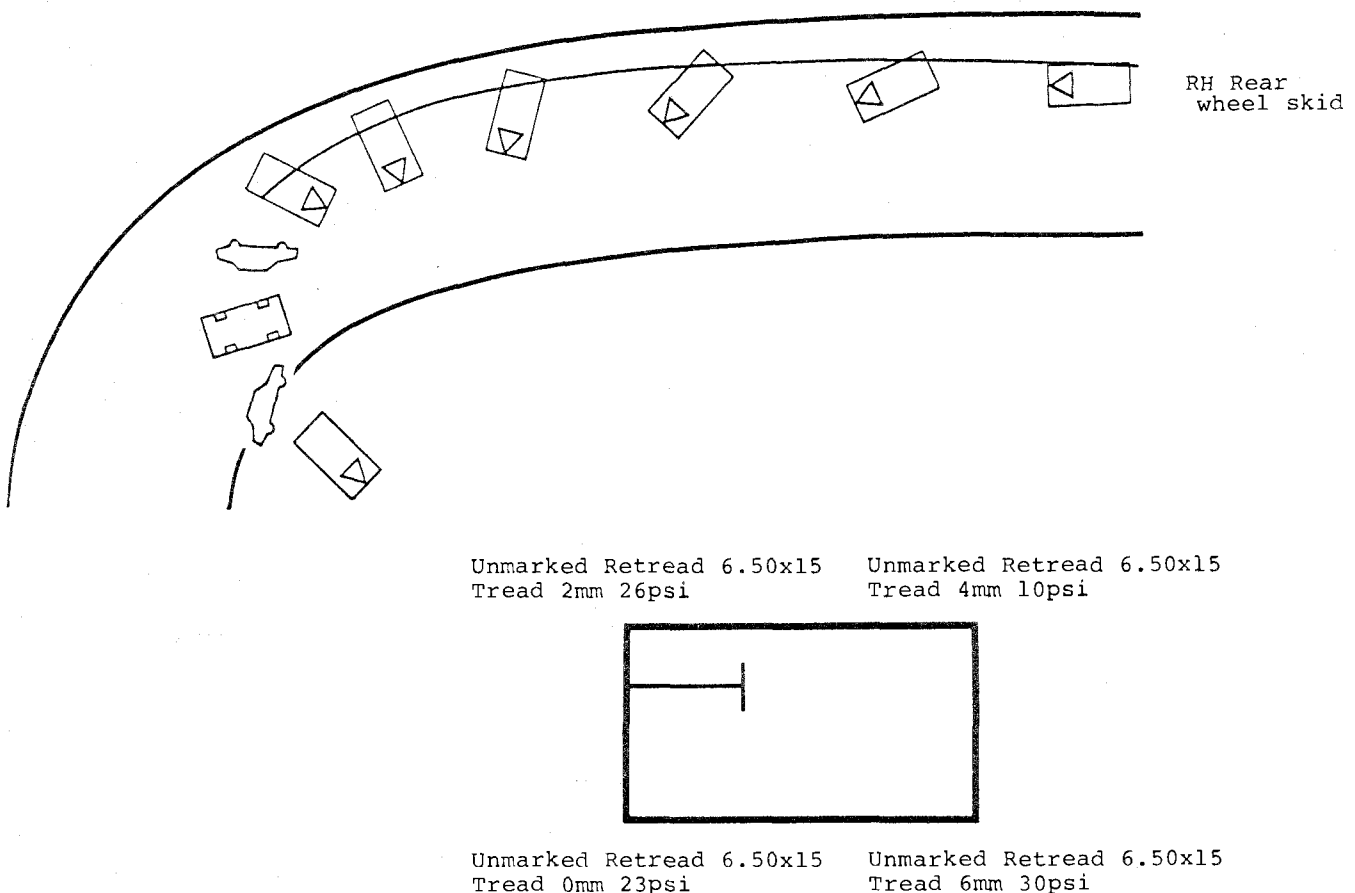
FIGURE A2.12: Accident 189: Vehicle Movements and Tyre Specifications

It was alleged by the mechanic who normally serviced the striking car that he had disconnected the front disc brake power booster unit. This had been done at the owner's instruction when he had been advised that the power booster required an expensive overhaul. This action meant that the braking power of the vehicle was severely impaired, with the expectation of rear wheel locking at very low decelerations.

Other defects on the striking car included a left hand front tyre which had a tread depth that varied from 0 to 5.0mm across the tyre from outer to inner shoulder and a replacement muffler pipe which was abrading and melting its way through the flexible brake hose which runs from the body to the rear axle.

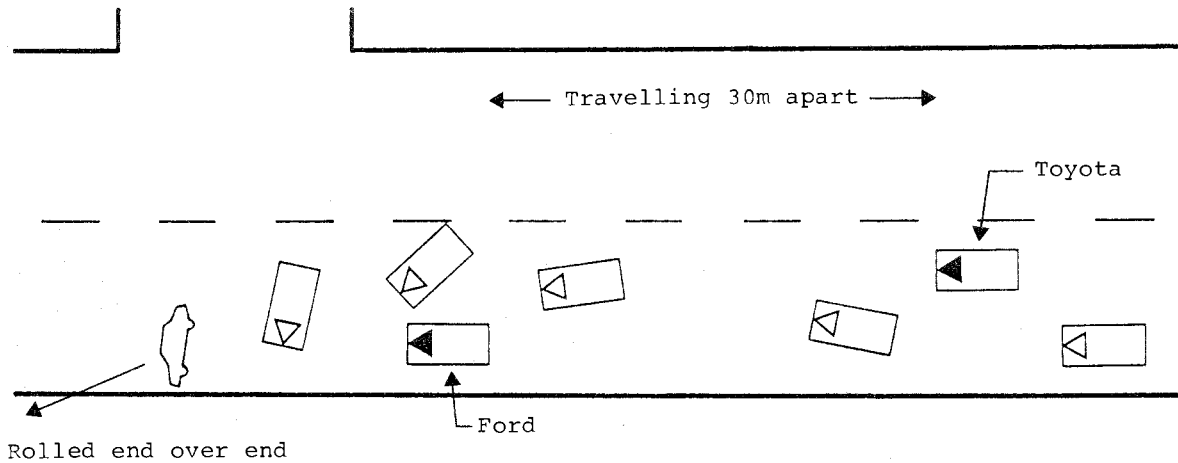
The vehicle was fitted with Goodyear 6.15 L13 tyres with tread depths of between 7 and 8 mm except for the right hand rear tyre which was of smaller section (Goodrich 5.20 13) and which had no tread pattern remaining. In addition, the standard steering wheel, which has a diameter of 365 mm (14 3/8"), had been replaced by a wheel of 290mm (11 3/8") diameter.

The loss of control was typical of that which can result from a rapid lane change manoeuvre, but it is probable that the mismatch in the rear tyre properties, such as tread stiffness and carcass stiffness, and the variation in steering effort and "ratio" due to the reduced diameter of the steering wheel would have made the task of controlling the vehicle substantially more difficult.

Goodyear 6.15L13
Tread 7mm

Goodyear 5.20-13
Tread 0mm

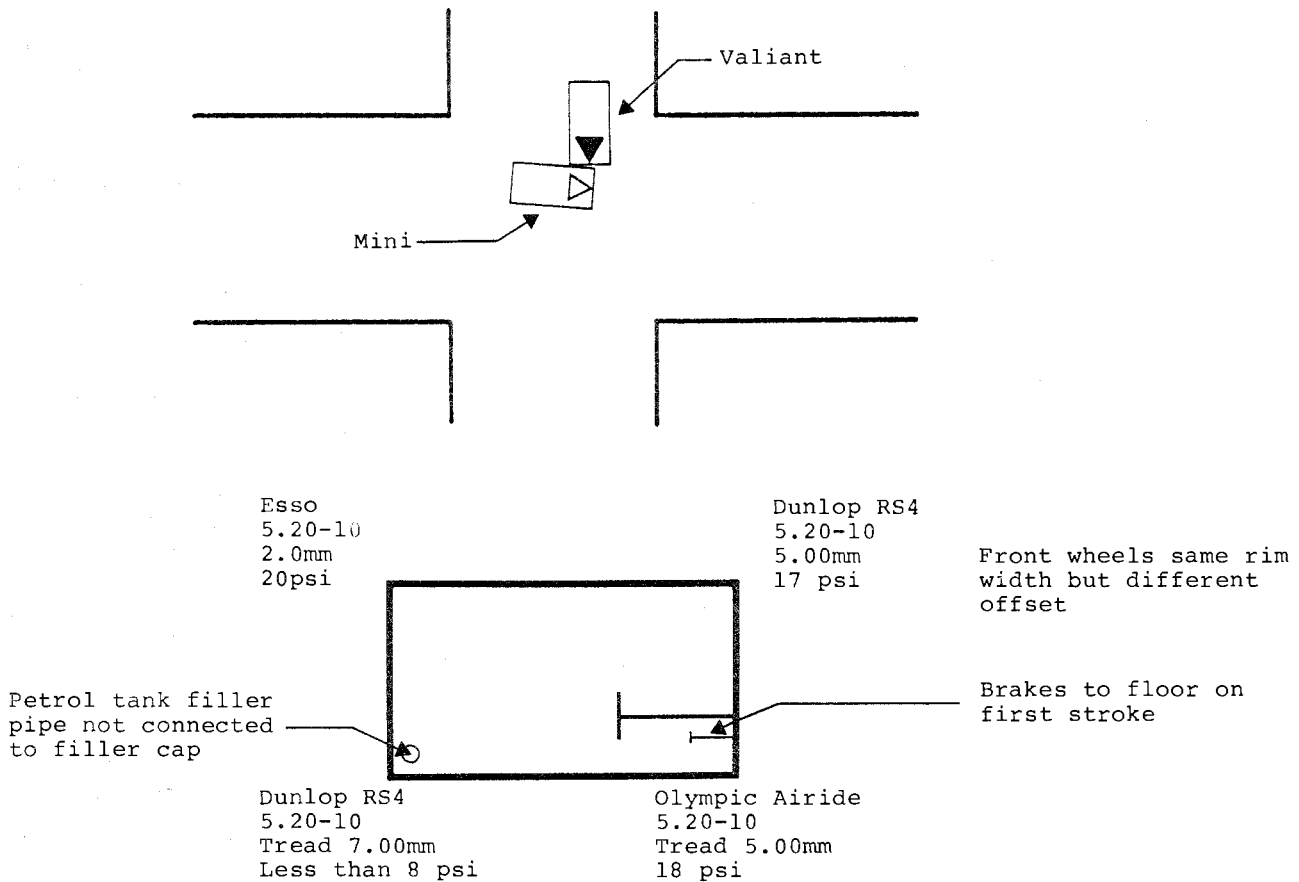
FIGURE A2:14: Accident 048: Vehicle Movements and Defects

The possible vehicle defect contribution lies in the fact that the brake pedal on the Mini went straight to the floor when pressure was applied, a "pedal" only being achieved by pumping. There was no accident damage to the braking system or obvious fluid leaks and so it was concluded that the lack of pedal on the first stroke was due to incorrect adjustment of the brake shoes.

Other items related to the standard of maintenance of the vehicle were the right hand rear tyre running at less than 8 psi (not loaded during impact, or accident-damaged), the front wheels were of different design (1" difference in offset) and the right hand petrol tank filler pipe had not been connected to the filler cap.

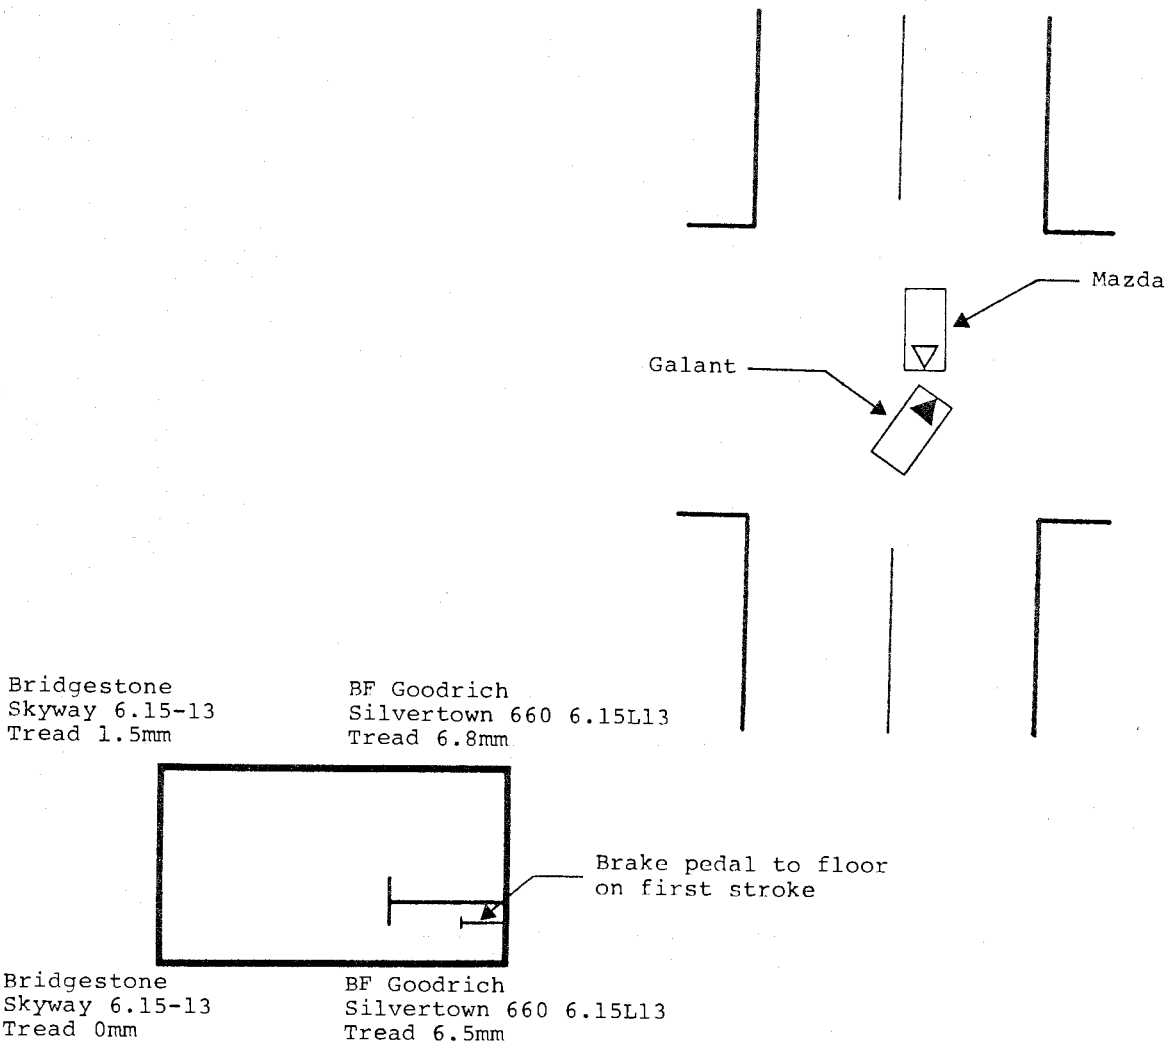
FIGURE A2.15: Accident 050: Vehicle Movements and Defects

The brake pedal on the Mazda went straight to the floor on the first application, pedal resistance only being achieved by "pumping" the pedal. There was no accident damage to the braking system and it is concluded that the lack of pedal on the first stroke was due to the incorrect adjustment of the brake shoes. It is probable that this accident would have occurred regardless of this brake defect, but the severity of the impact may have been reduced had the brakes been in better condition.

The other defect on this vehicle was a right hand tyre without any tread pattern remaining.

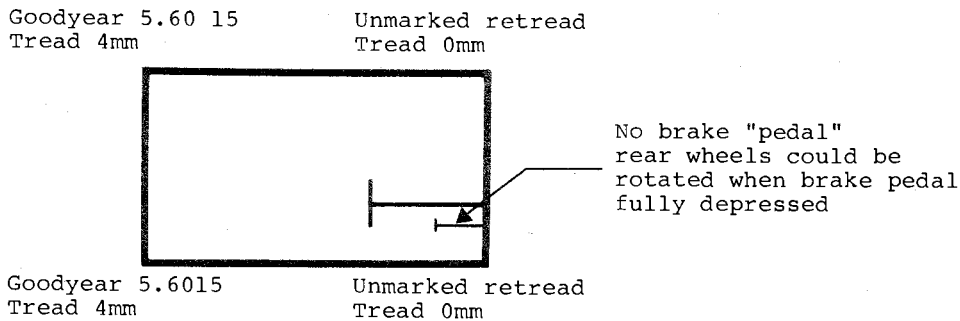
FIGURE A2.16: Accident 109: Tyre Specifications.

Other defects included two bald front tyres and two front seat belts that would not remain latched (Figure A2.16).

Computer simulation of the accident (McHenry, 1971) showed the pre-impact speed for the Volkswagen to be 50 km/h. Since the safe approach to the intersection for the Volkswagen was 10 km/h, it is probable that the collision would have occurred even if the braking system had been in first class condition.

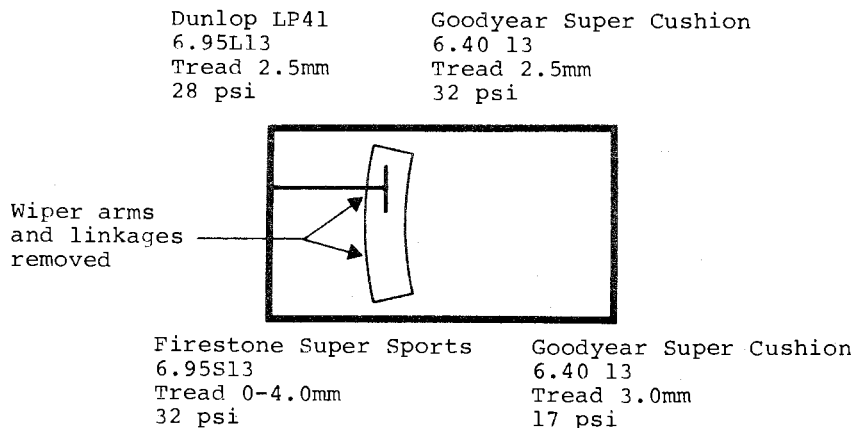
FIGURE A2.17: Accident 021: Vehicle Defects

The other defect on this vehicle was a left hand front tyre on which the tread depth varied from 4mm at the outer shoulder, to 0mm at the centre and 1.5mm at the inner shoulder (Figure A2.17).

This defect was classified as a possible causal factor because of the uncertainty that the windscreen was obscured by rain and because the driver had a BAC of 0.23, which in itself would account for this type of crash.
